RE: KRRP Value Engineering Summary and Advancement to 90% Design

KP was tasked with leading seven VE analyses, which are listed below and described in the following sections of this letter:

VE-1 Submittals: Drawdown Model and Assessment

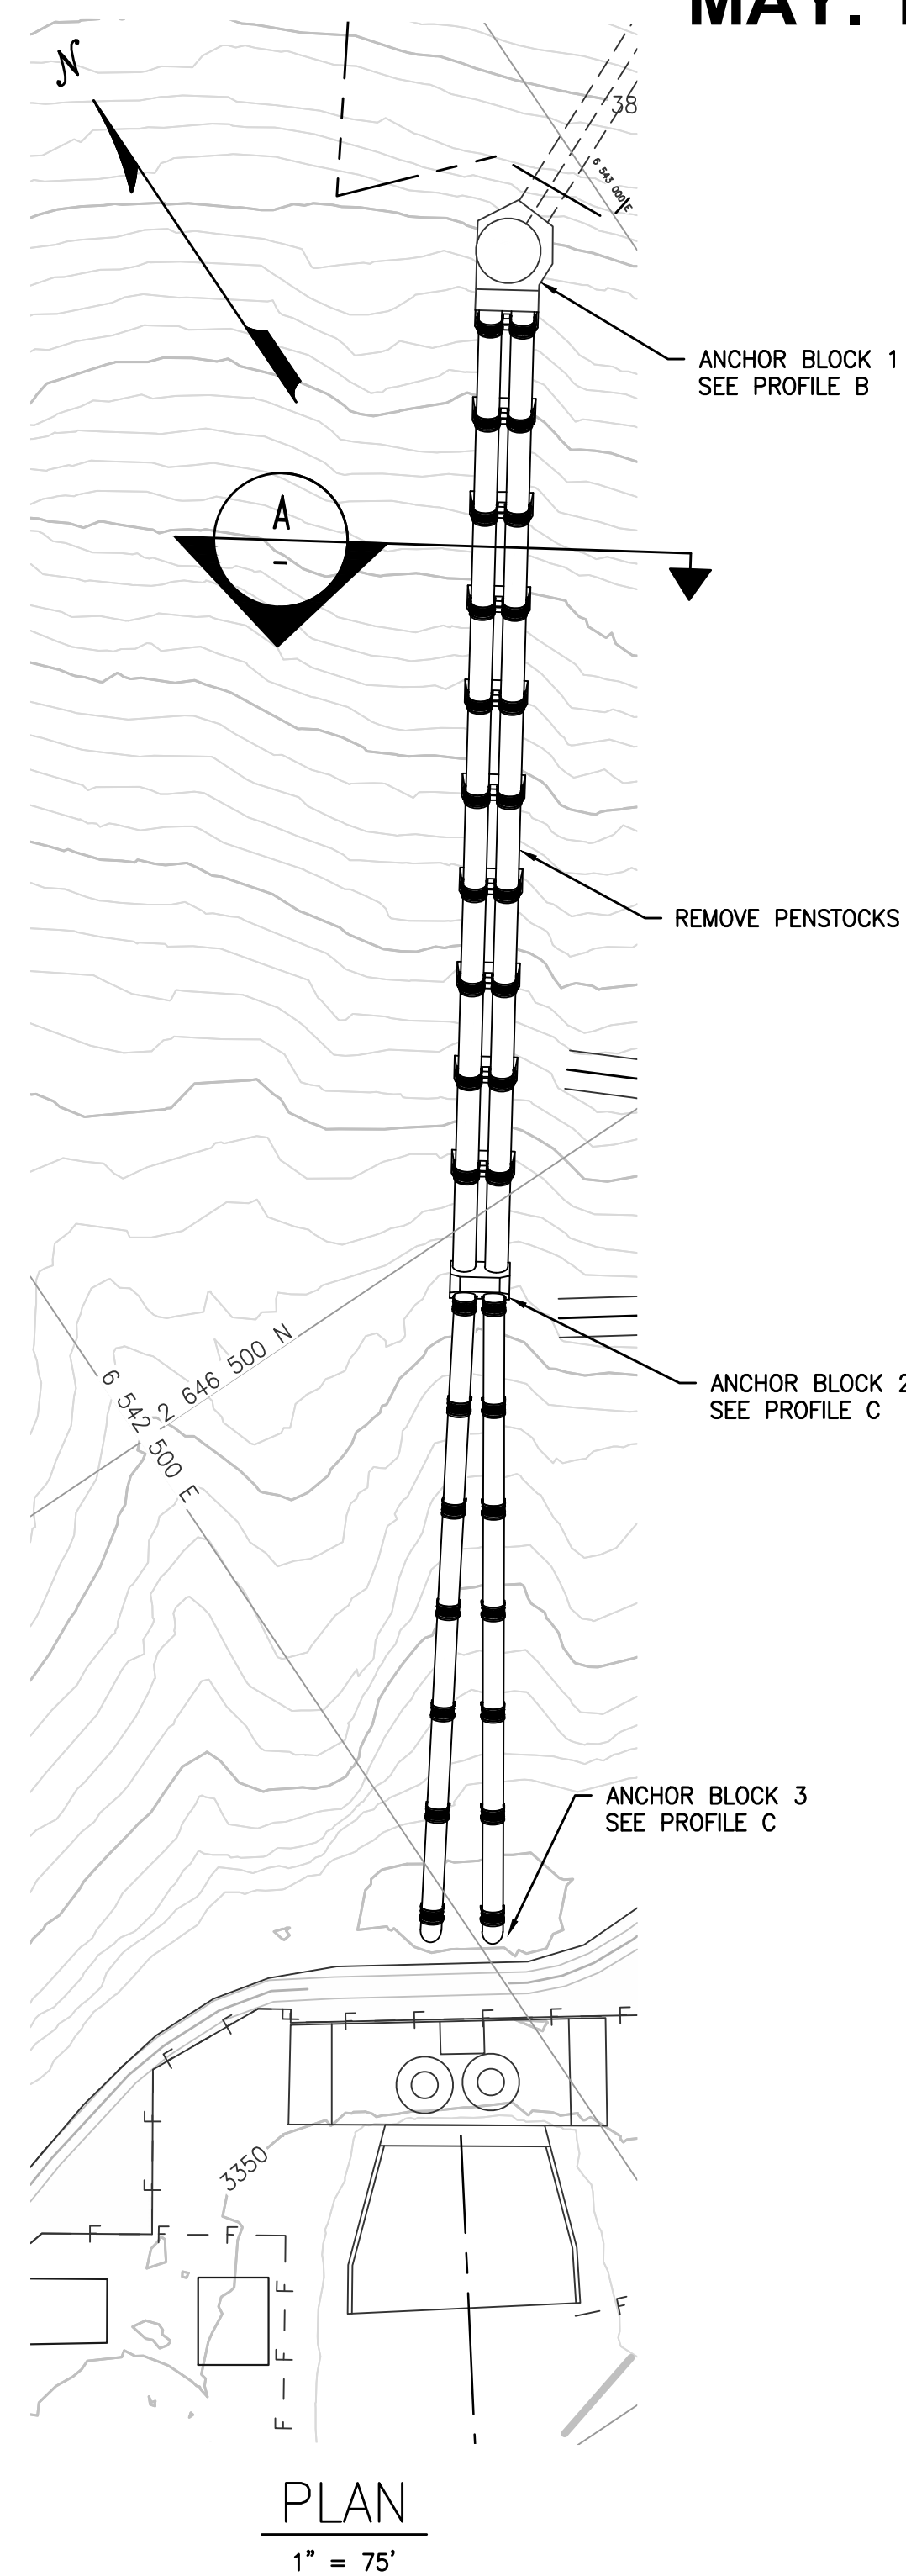
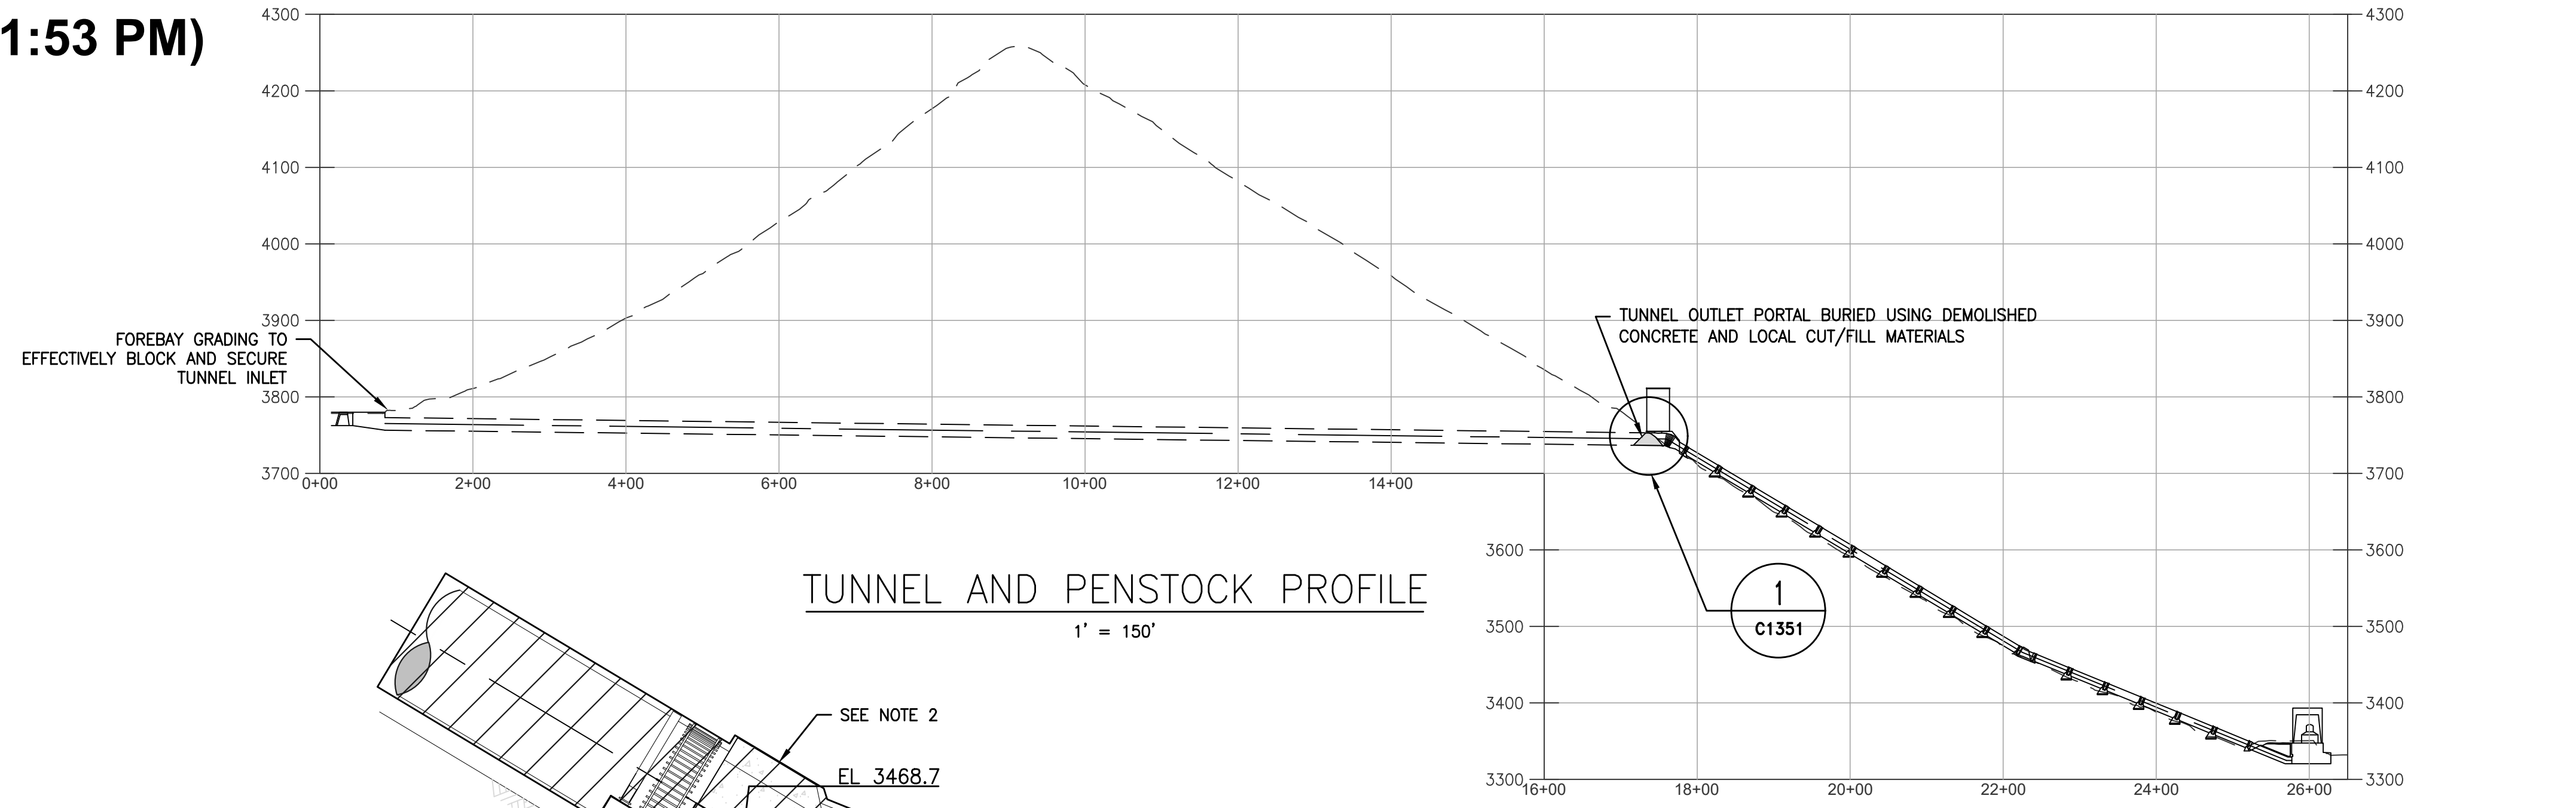
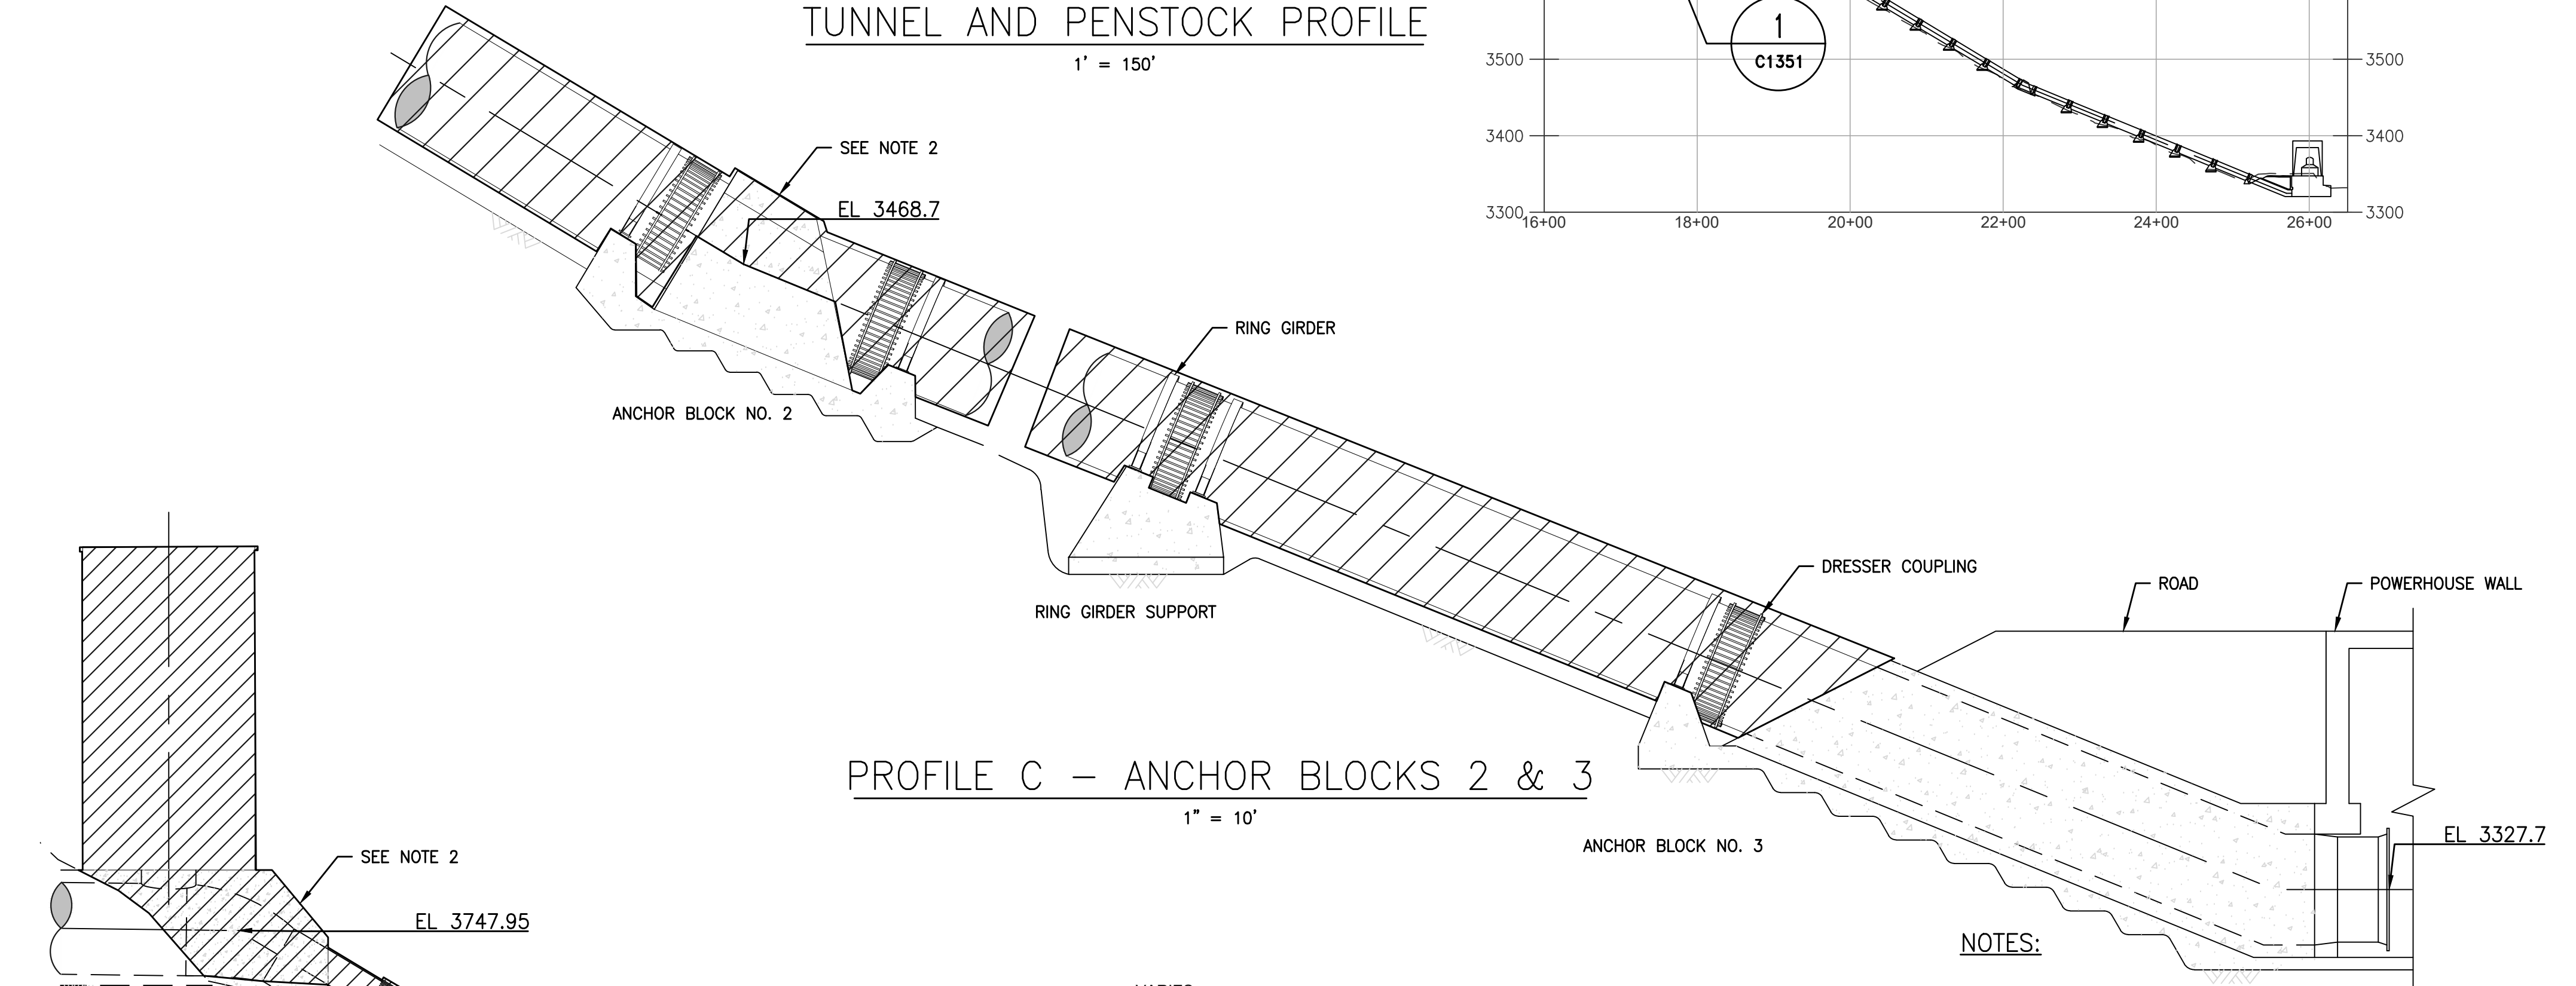
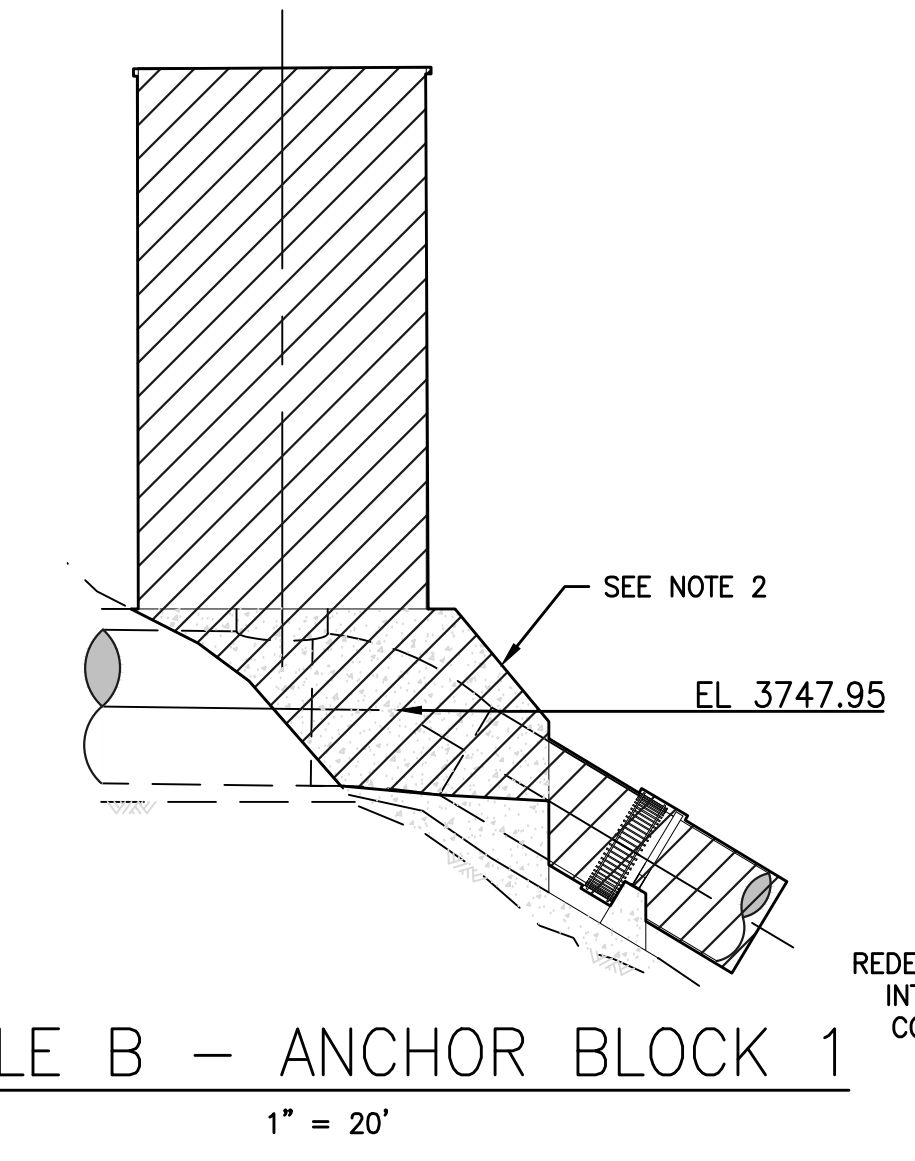
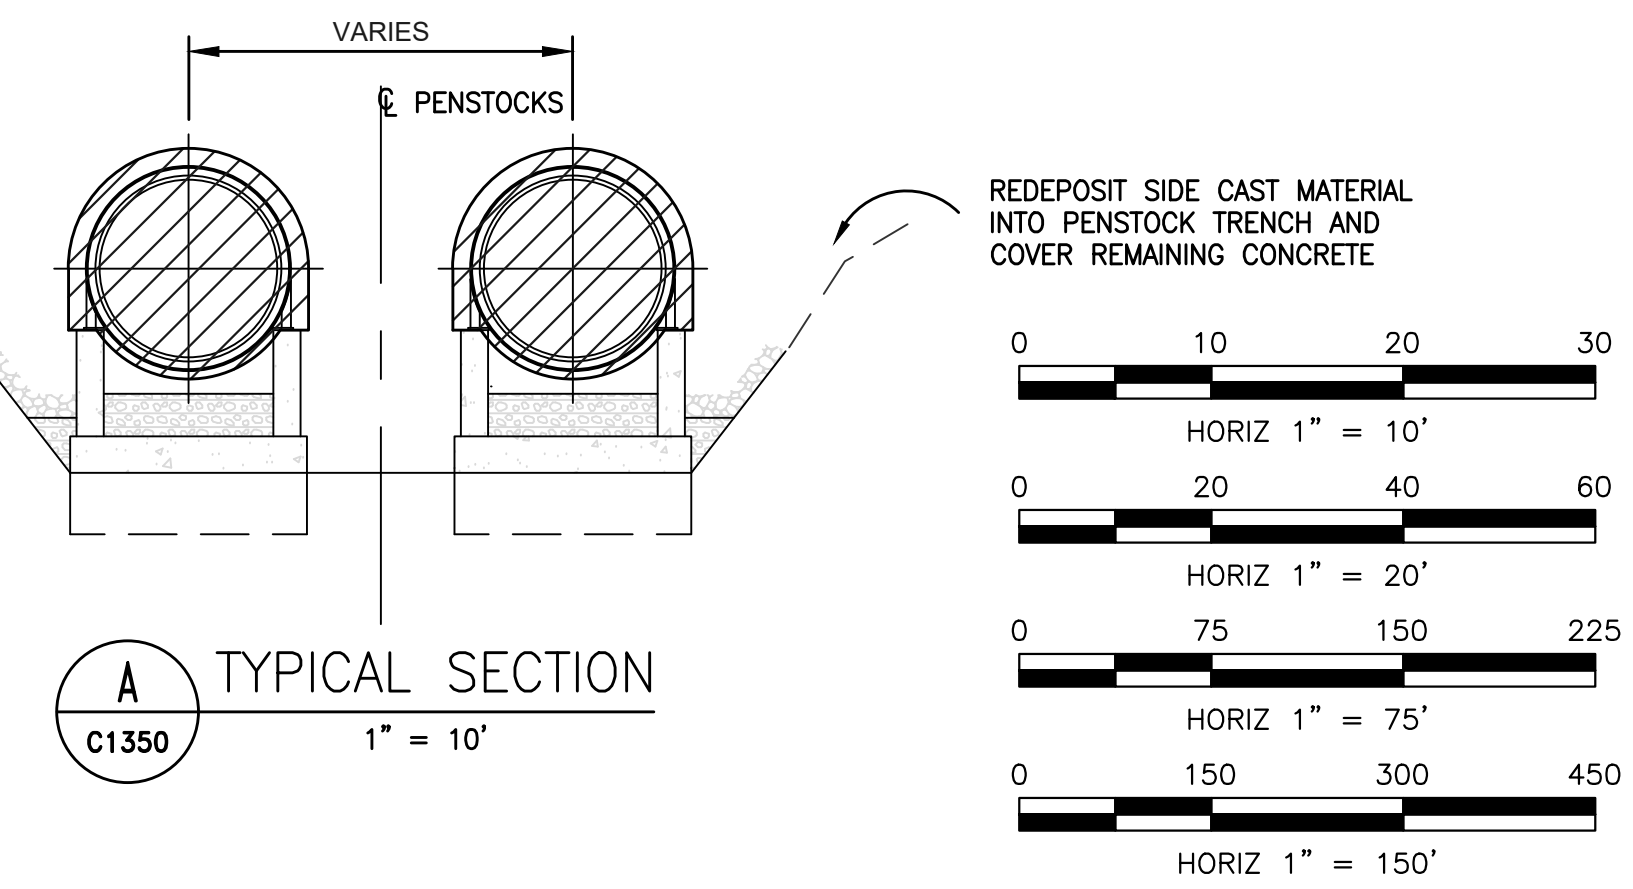
PROJ #	VA103-640/1
DATE	02/07/2020
DWG	C1350

- NOTES:
- ALL NON-CONCRETE FEATURES ASSOCIATED WITH THE POWERHOUSE PENSTOCKS, INCLUDING THE STEEL PIPES, RING GIRDERS, COUPLINGS AND ATTACHING HARDWARE, AND SURGE TANK, ARE TO BE REMOVED.
 - REMOVE CONCRETE STRUCTURES TO SPRING LINE OF THE PENSTOCK AND BURY USING LOCALLY AVAILABLE SOIL MATERIAL MEETING THE TYPE E9 GENERAL FILL MATERIAL SPECIFICATIONS.
 - CONTRACTOR TO BACKFILL/REGRADE AREA TO MAINTAIN DRAINAGE WITH NO EXPOSED CONCRETE.
- LEGEND:
- REINFORCED CONCRETE (EXISTING)
 - DEMOLITION / REMOVAL

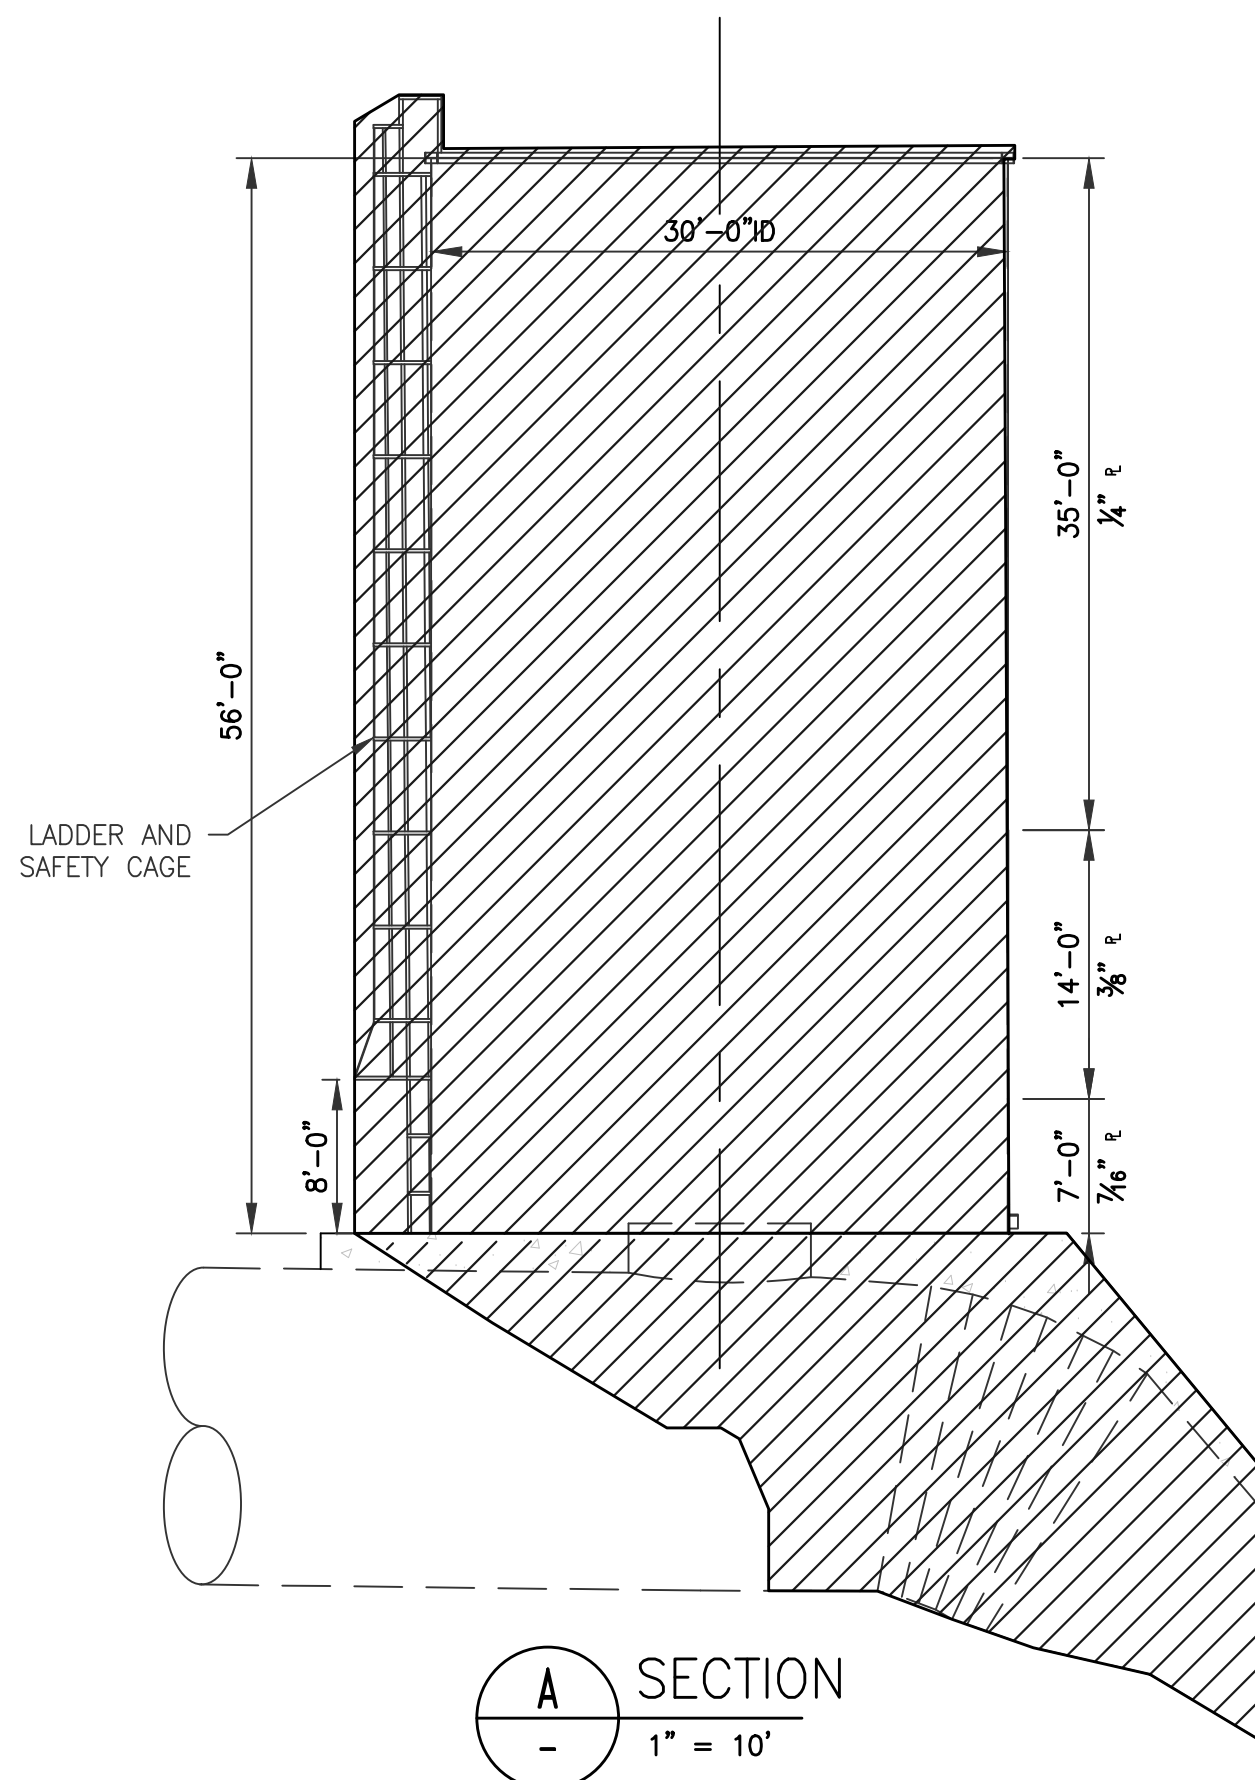
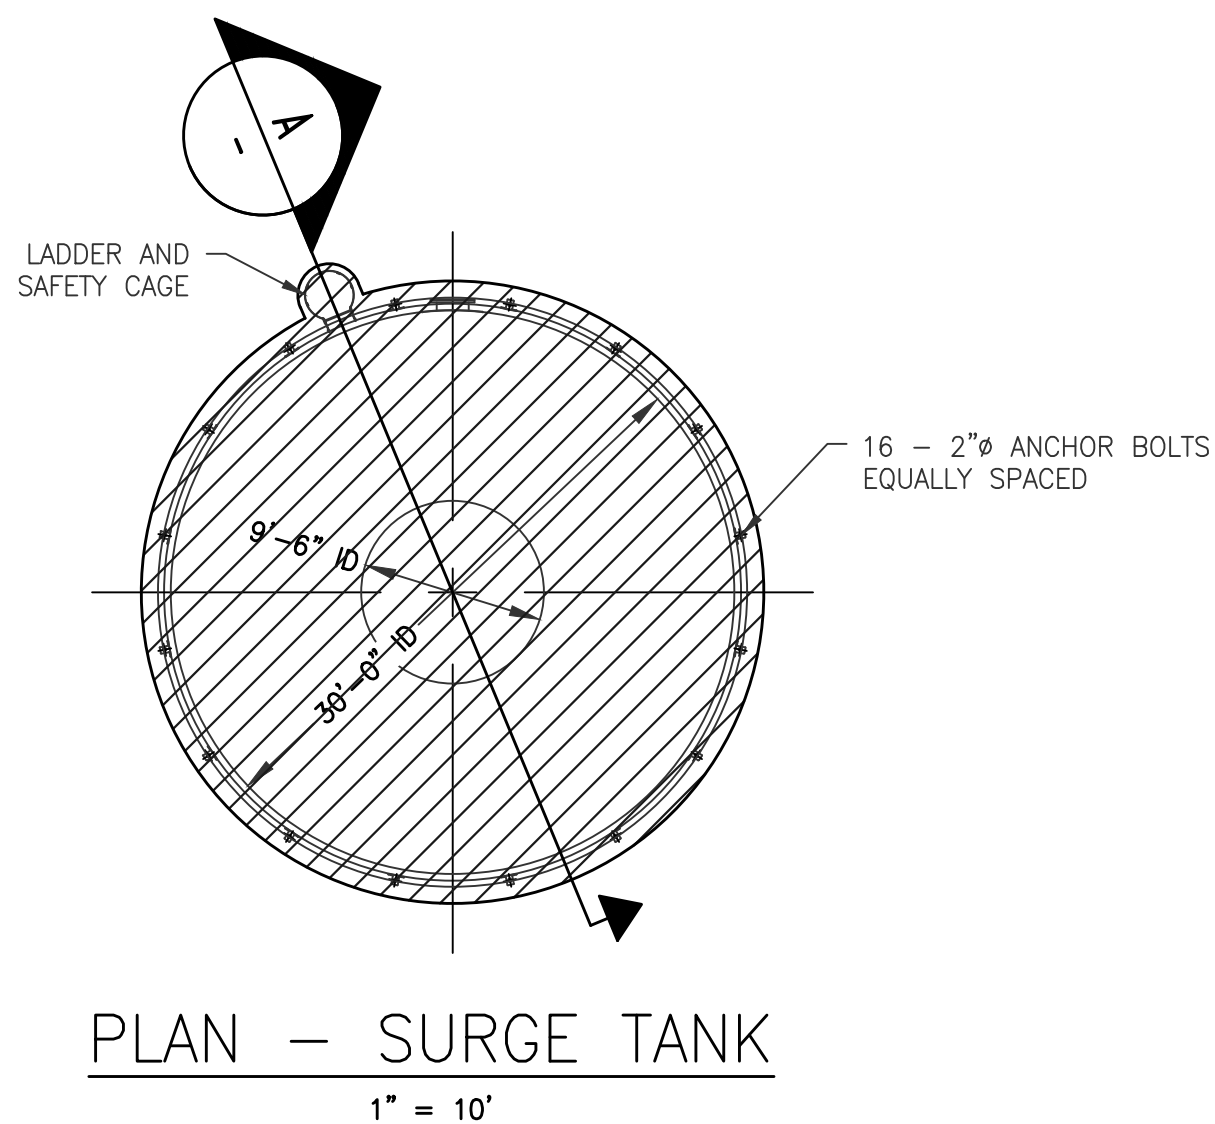
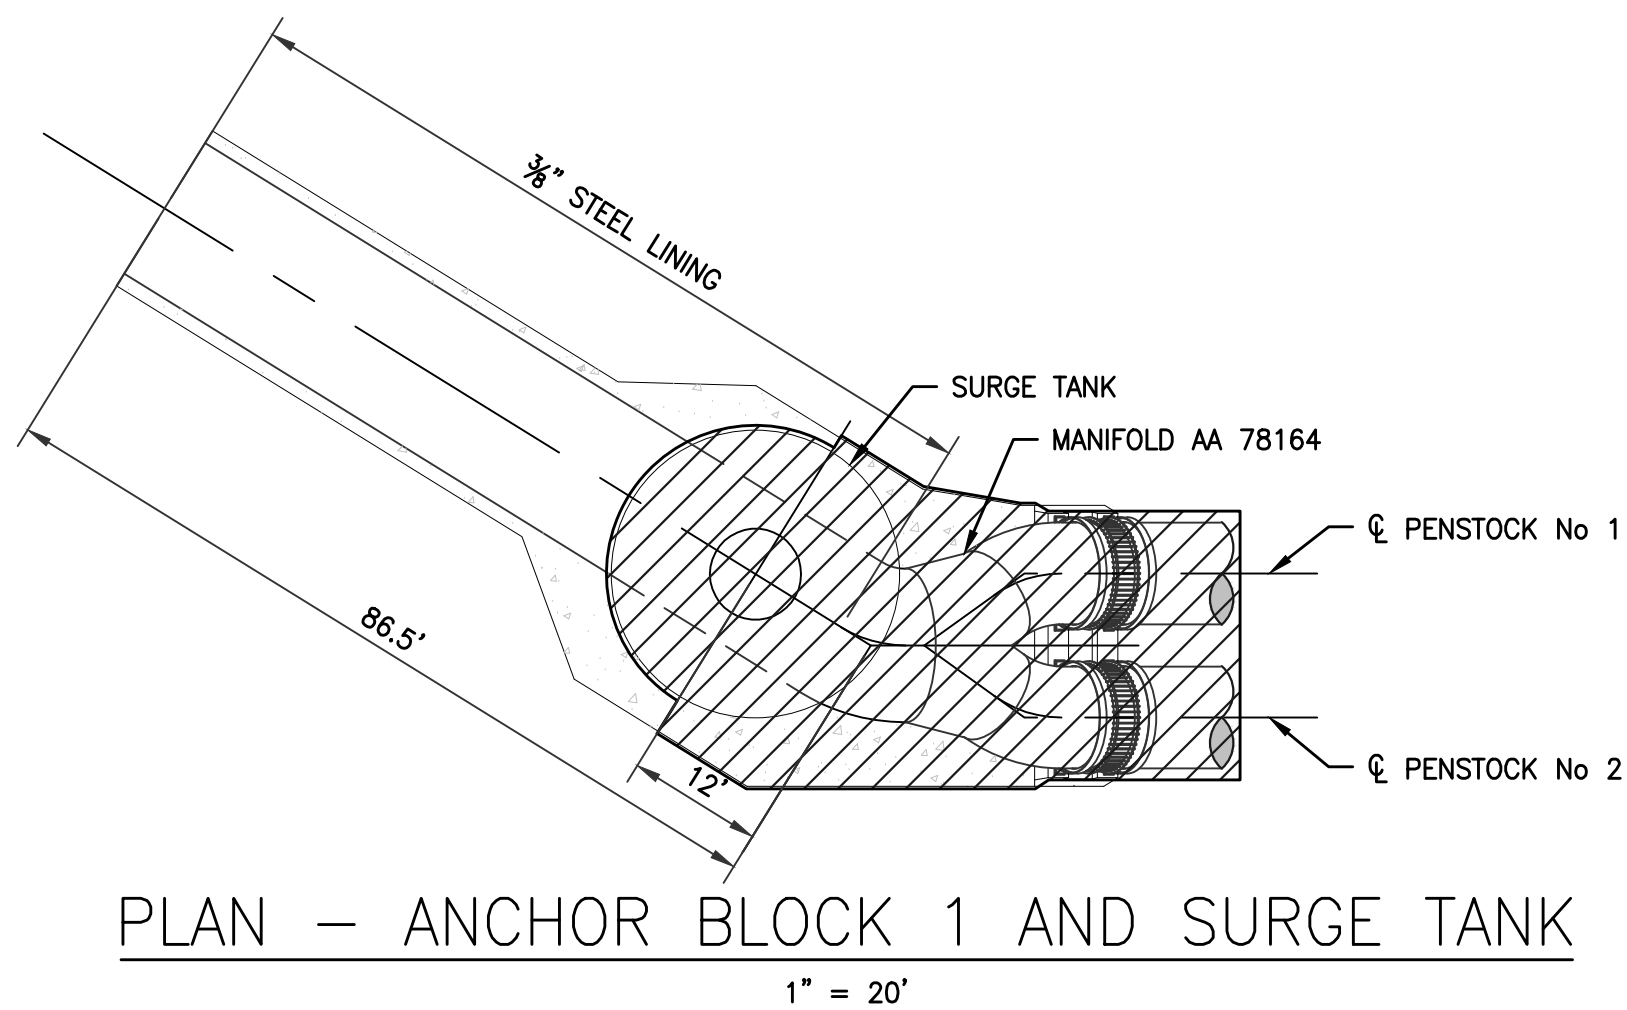
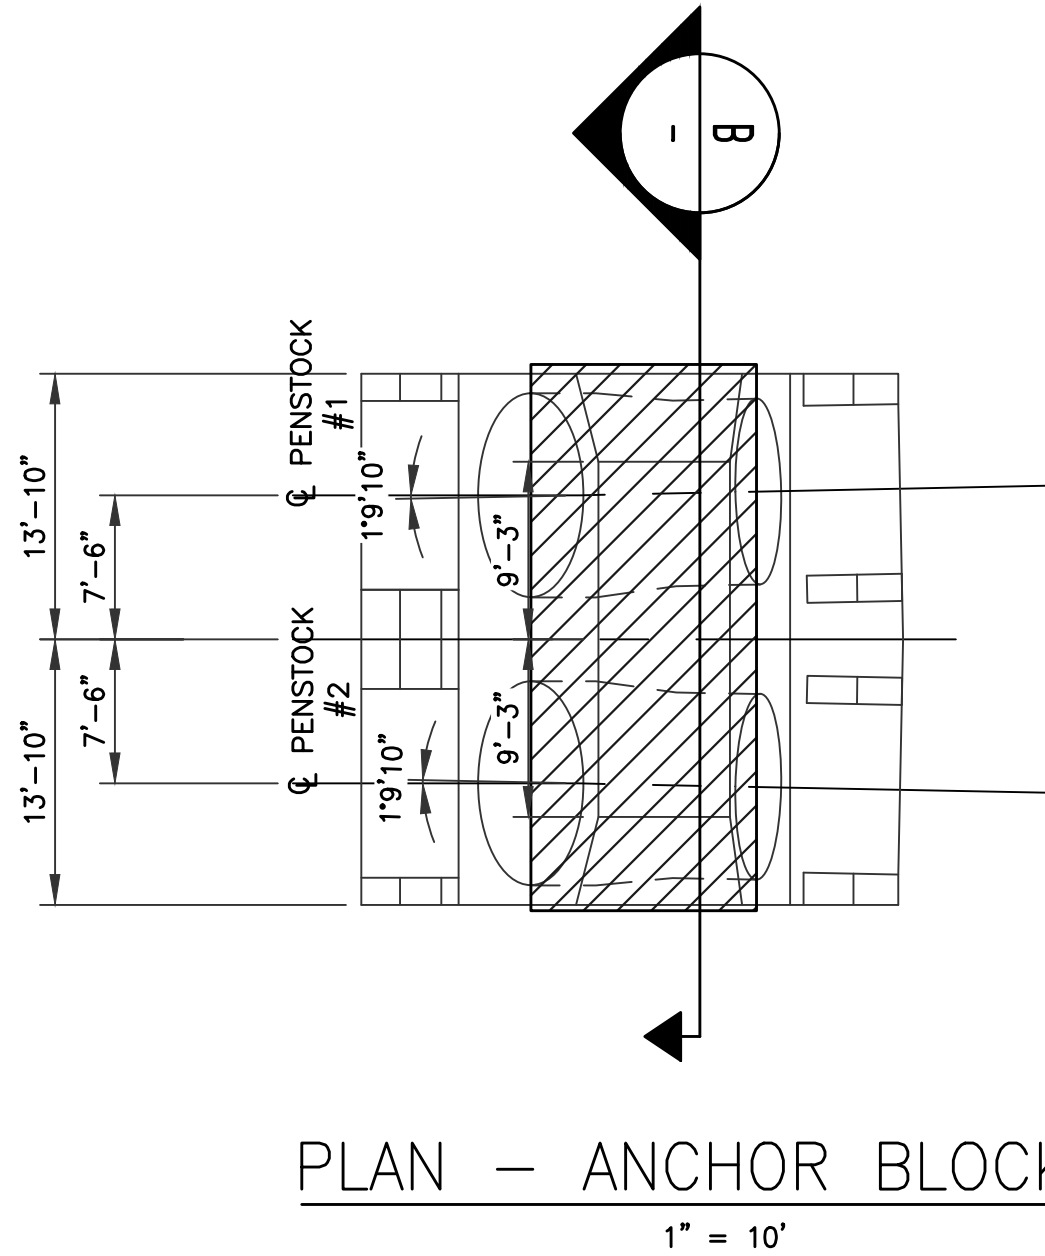
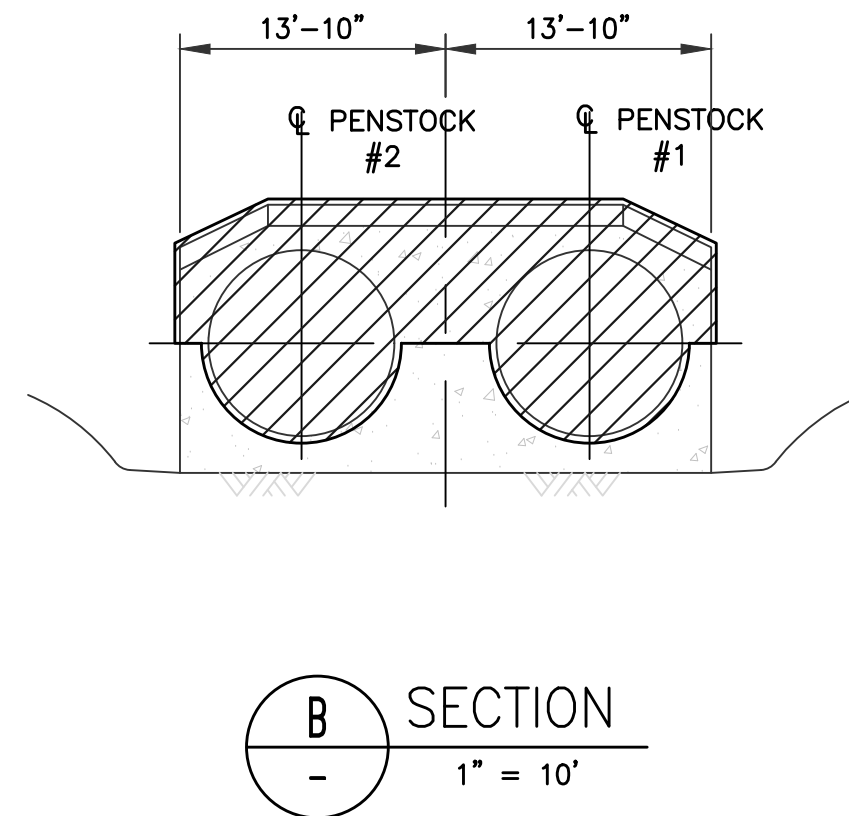
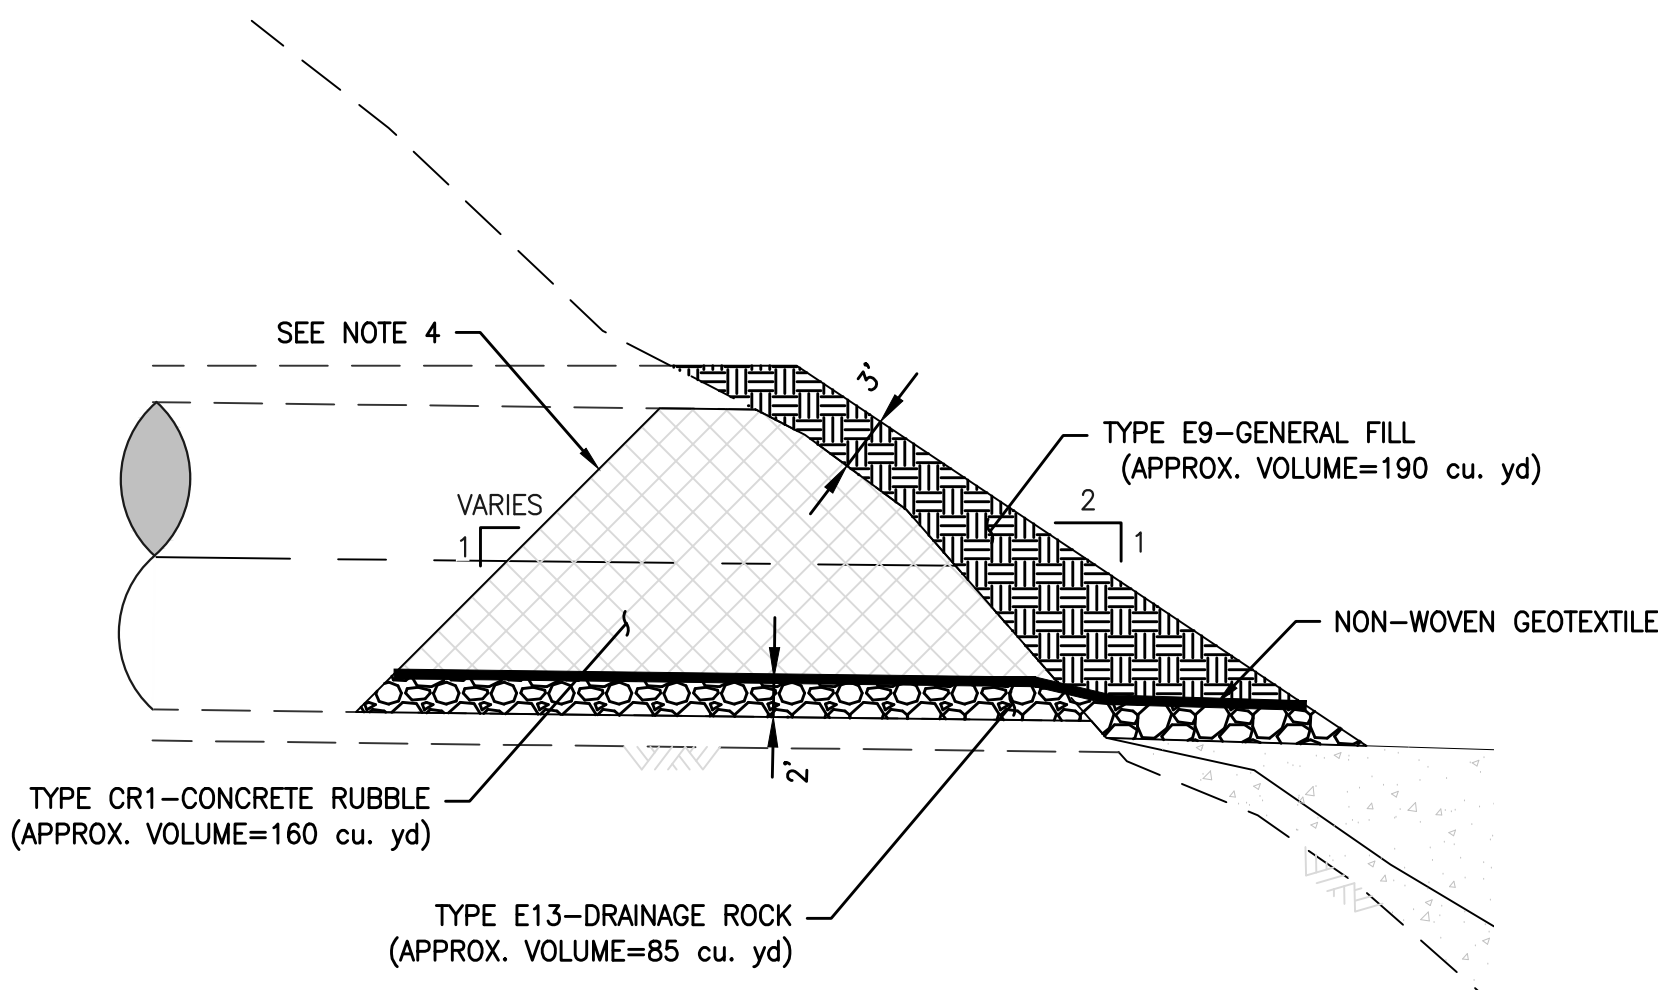
PROJ #
VA103-640/1
DATE
02/07/2020
DWG
C1351

1. ALL NON-CONCRETE FEATURES ASSOCIATED WITH THE POWERHOUSE PENSTOCKS, INCLUDING THE STEEL PIPES, RING GIRDERS, COUPLINGS AND ATTACHING HARDWARE, AND SURGE TANK, ARE TO BE REMOVED.
2. REMOVE CONCRETE STRUCTURES TO SPRING LINE OF THE PENSTOCK AND BURY USING LOCALLY AVAILABLE SOIL MATERIAL MEETING THE TYPE E9 GENERAL FILL MATERIAL SPECIFICATIONS.
3. CONTRACTOR TO BACKFILL/REGRADE AREA TO MAINTAIN DRAINAGE WITH NO EXPOSED CONCRETE.
4. CONCRETE RUBBLE PLACED IN TUNNEL AT ANGLE OF REPOSE.

PROJECT
KLAMATH RIVER RENEWAL PROJECT
SHEET TITLE
J.C. BOYLE FACILITY
PENSTOCK
DEMOLITION SECTIONS AND DETAILS

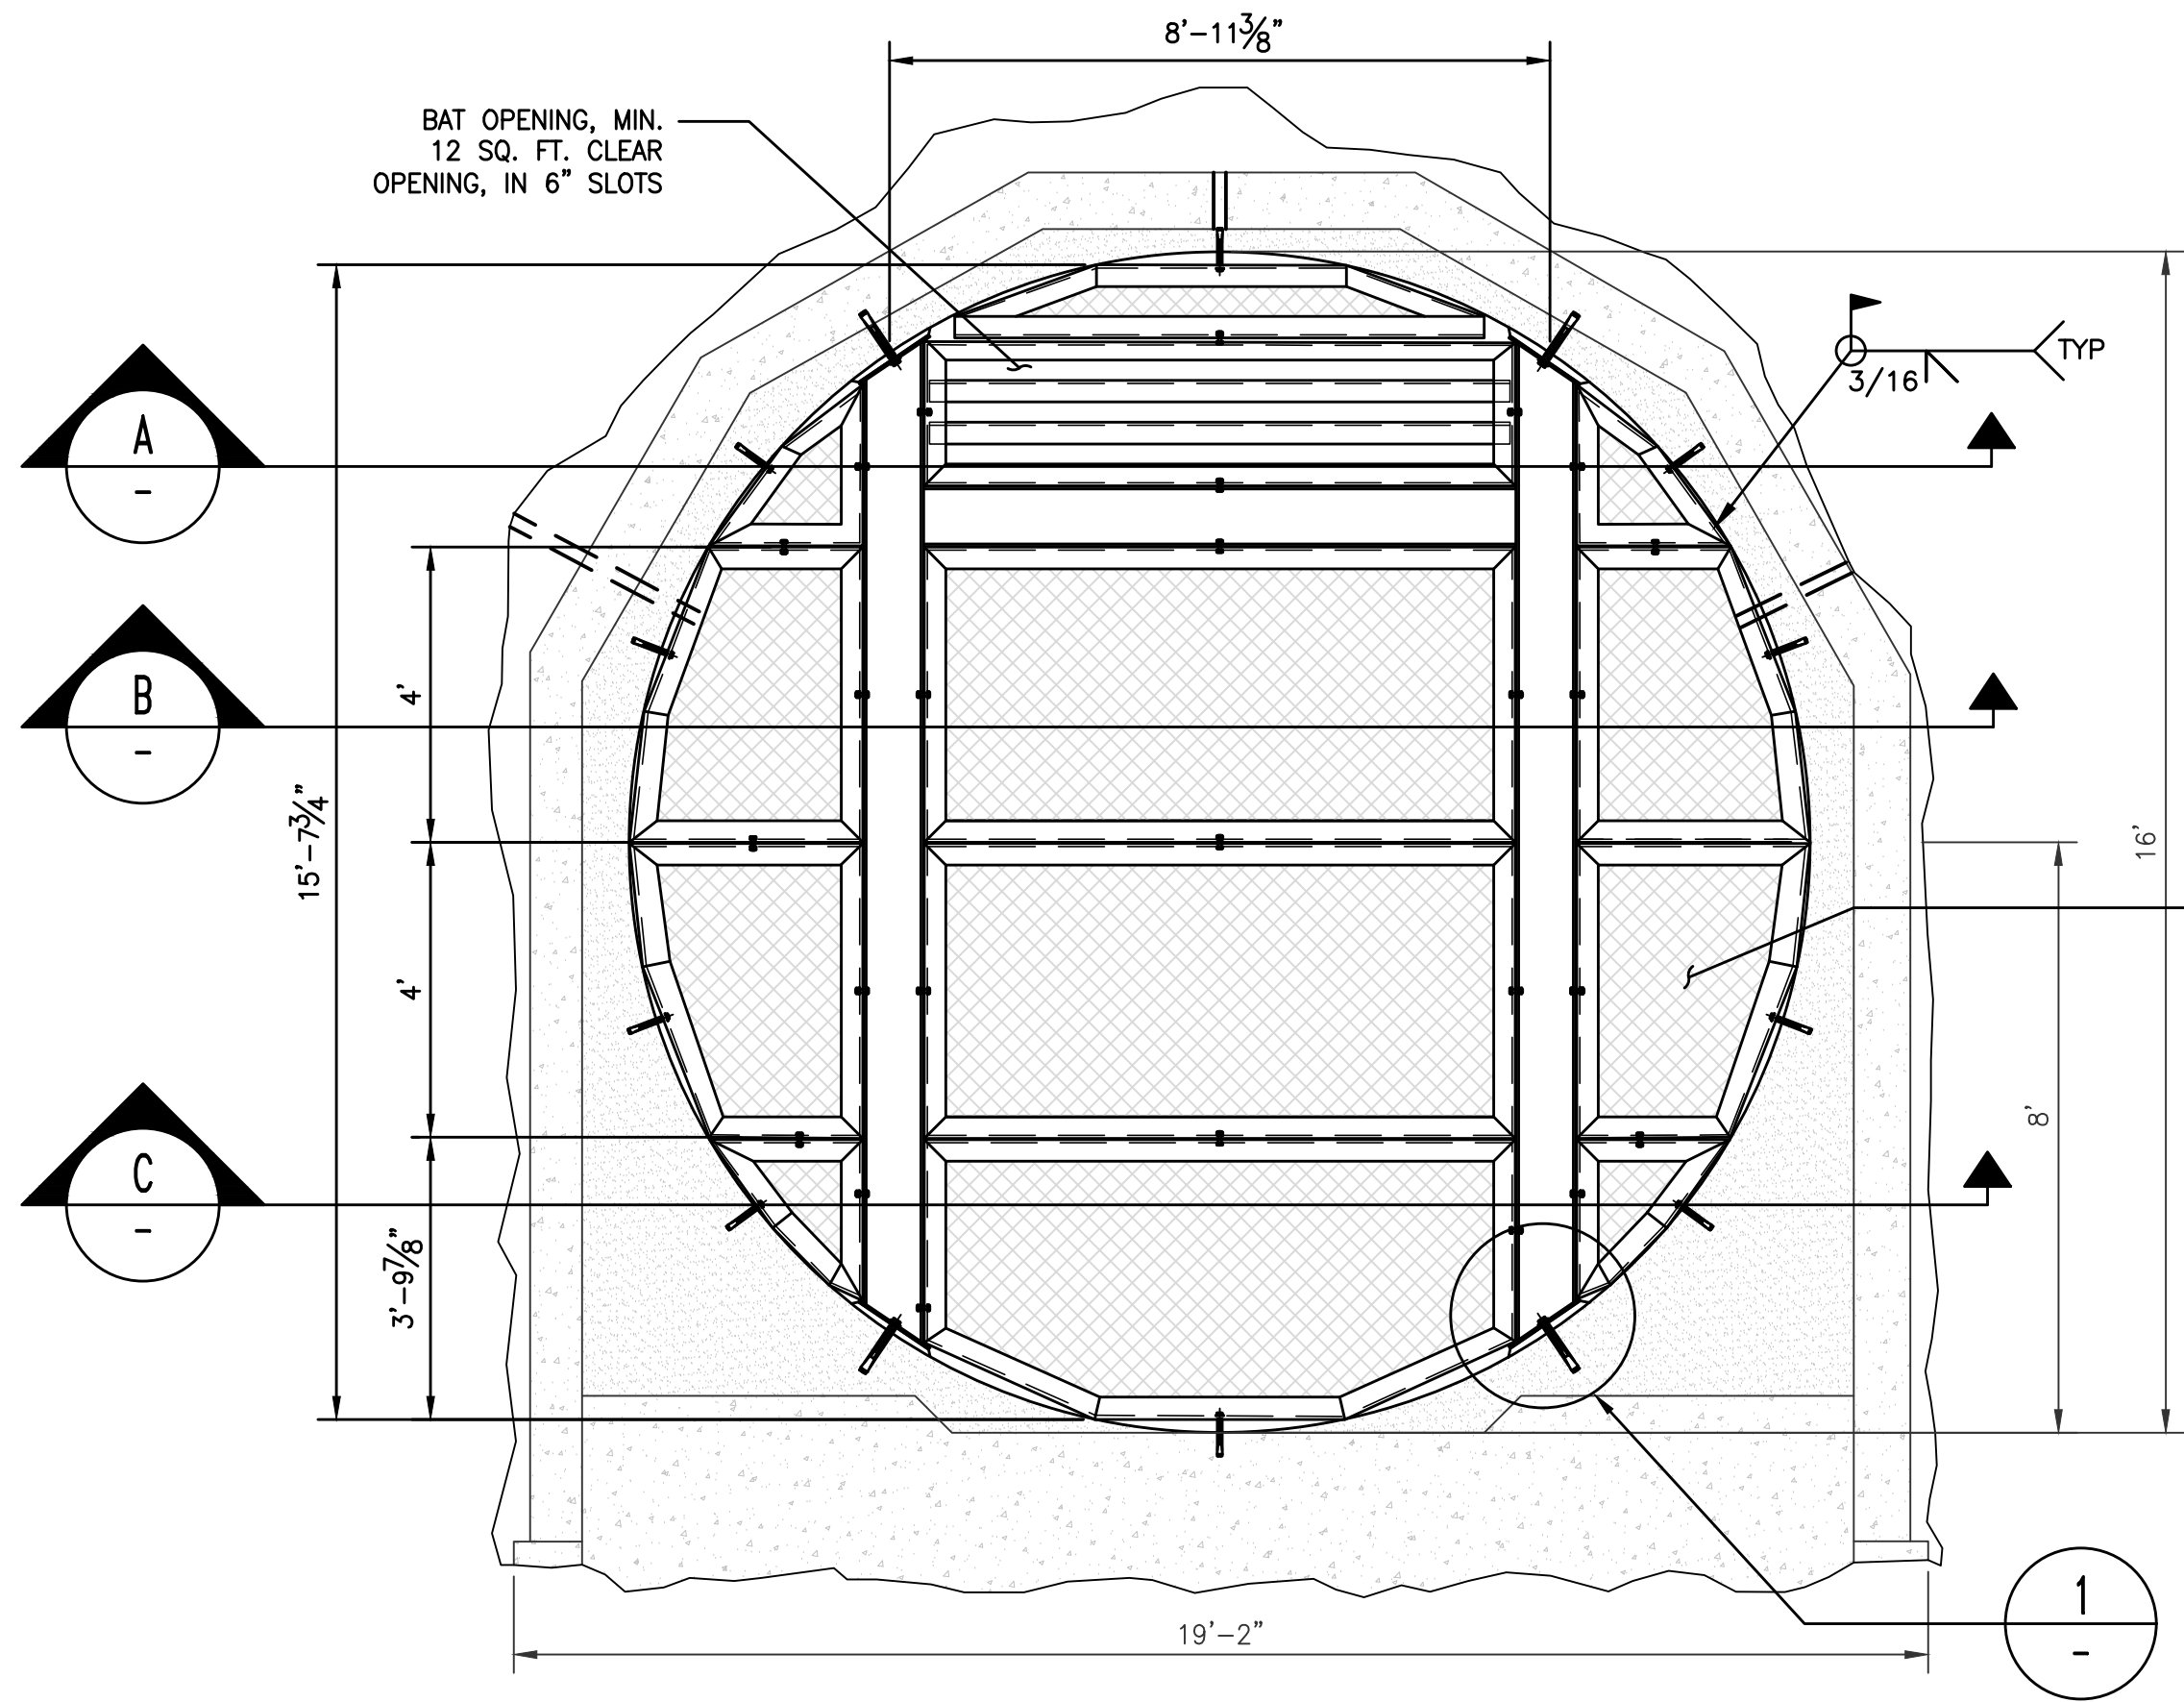
STEEL LINED TUNNEL SECTION

1" = 30'
