RE: KRRP Value Engineering Summary and Advancement to 90% Design

KP was tasked with leading seven VE analyses, which are listed below and described in the following sections of this letter:

VE-1 Submittals: Drawdown Model and Assessment

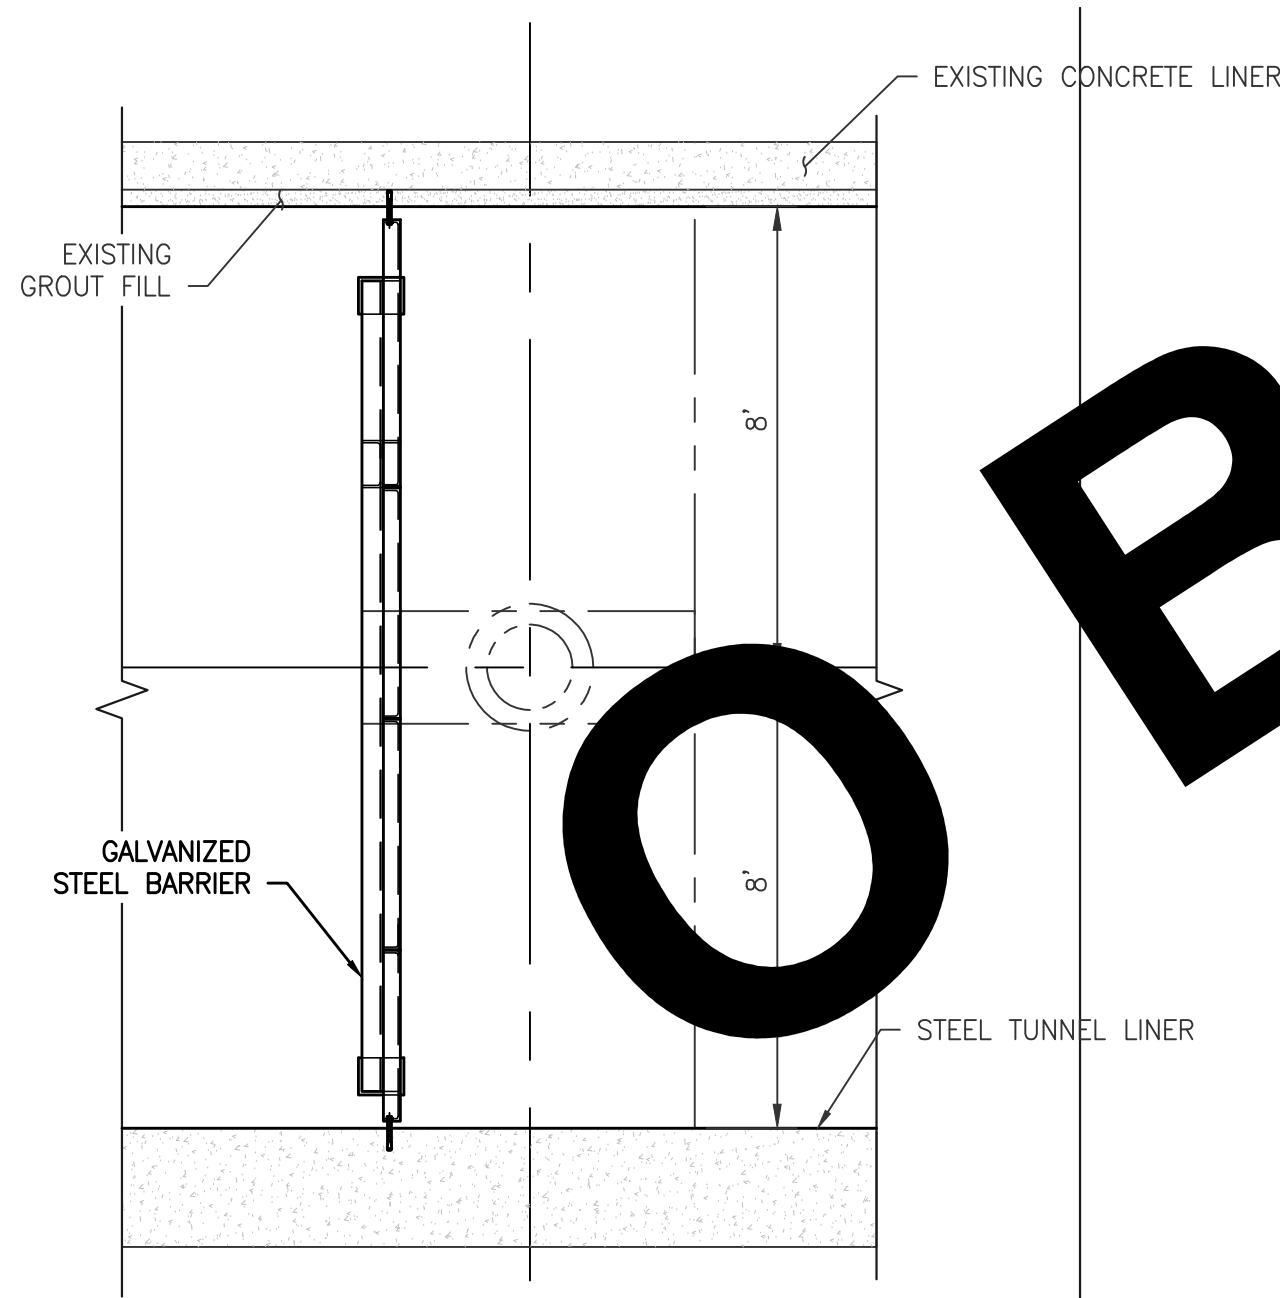
ELEVATION NEAR TUNNEL OUTLET

1" = 40'

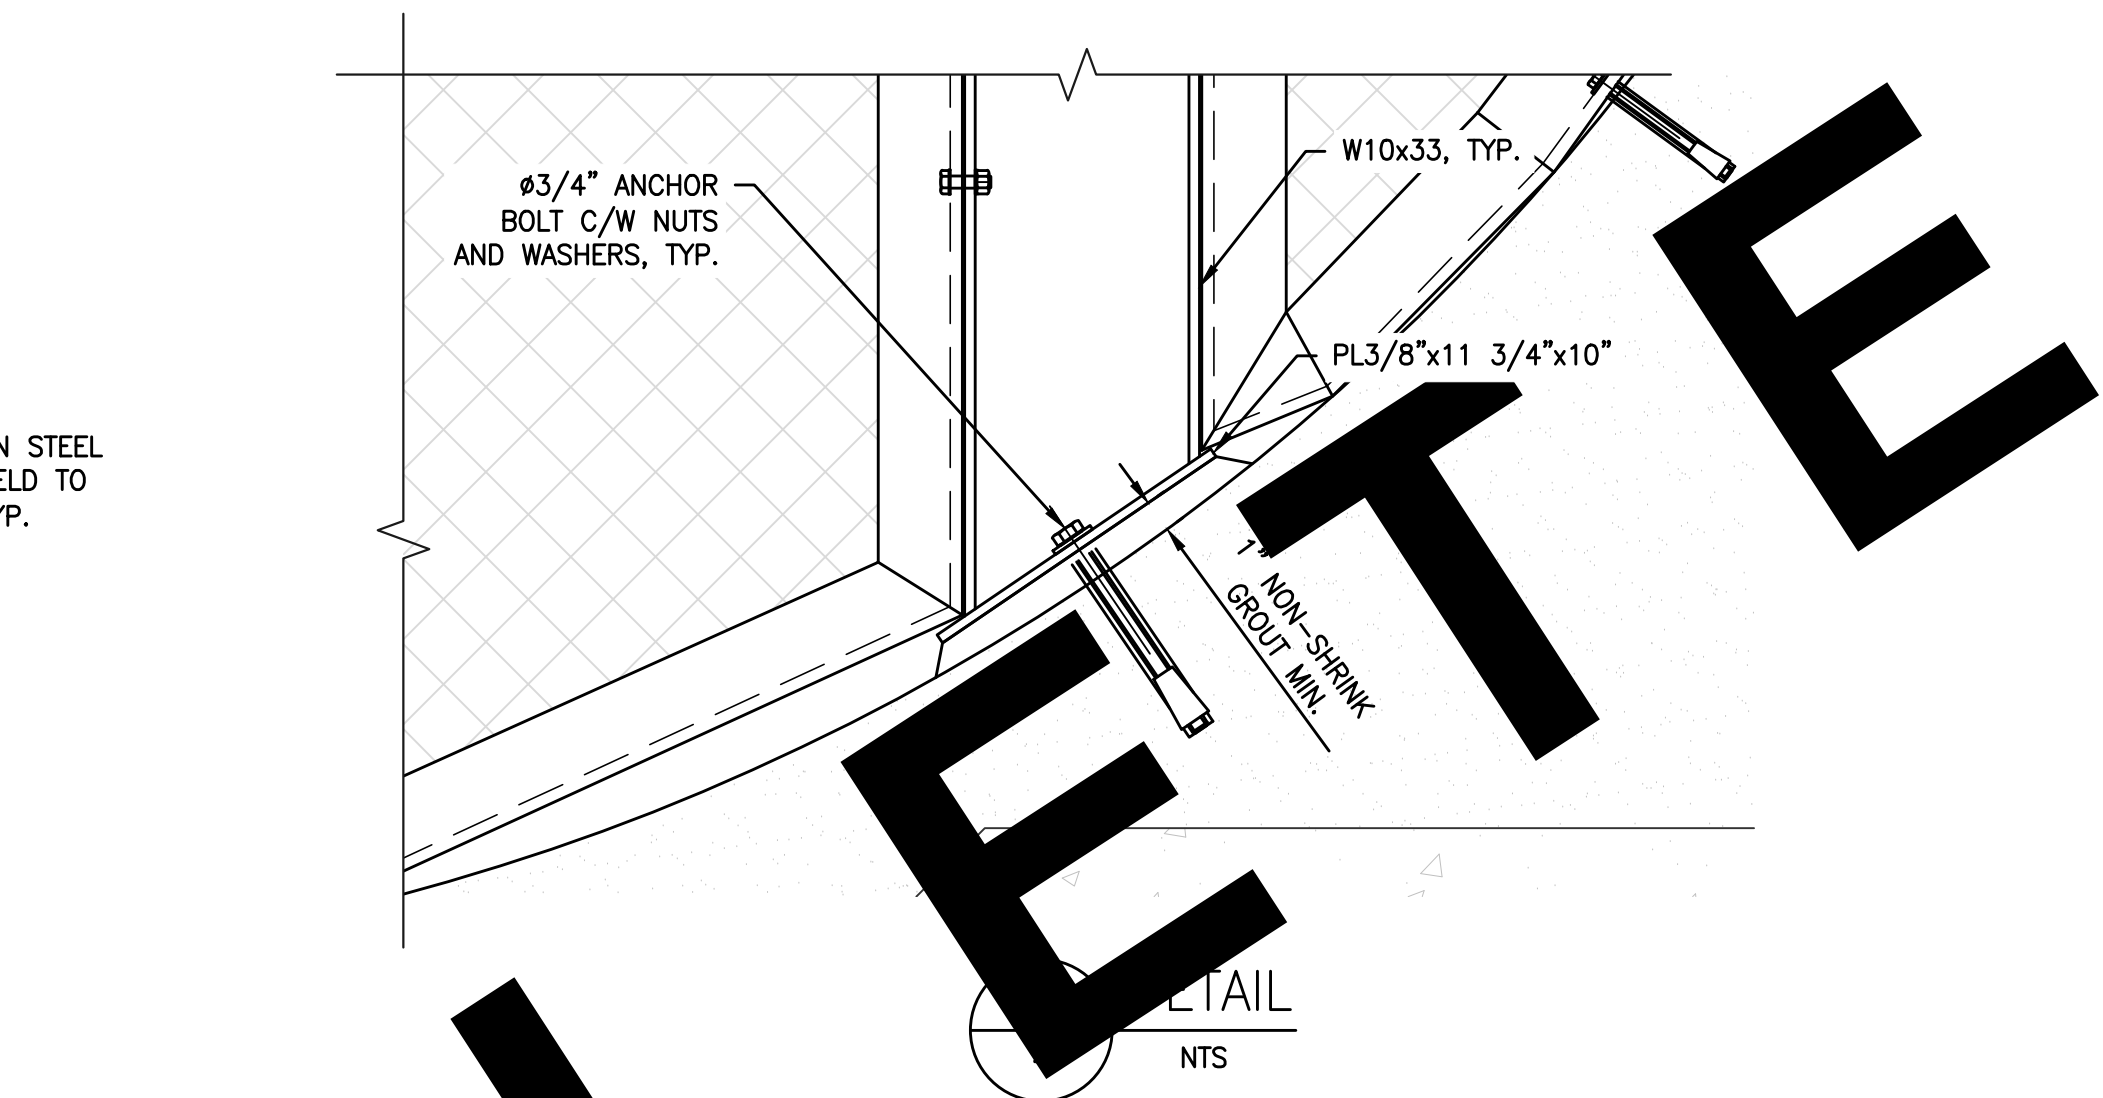
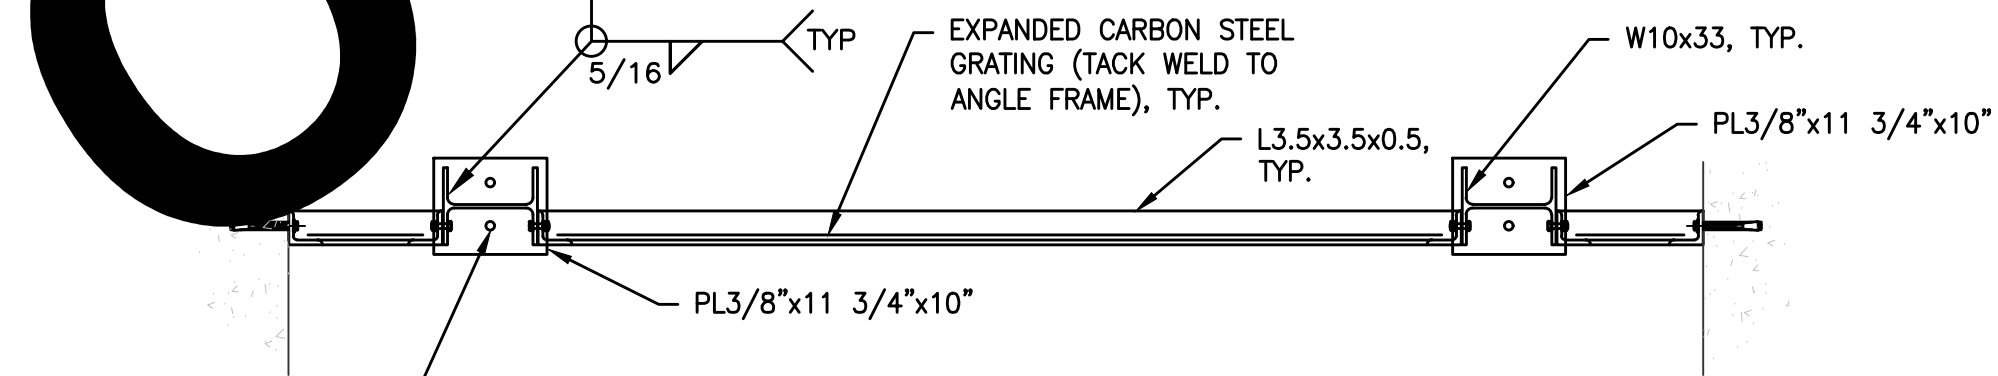
SECTION A

1" = 20'

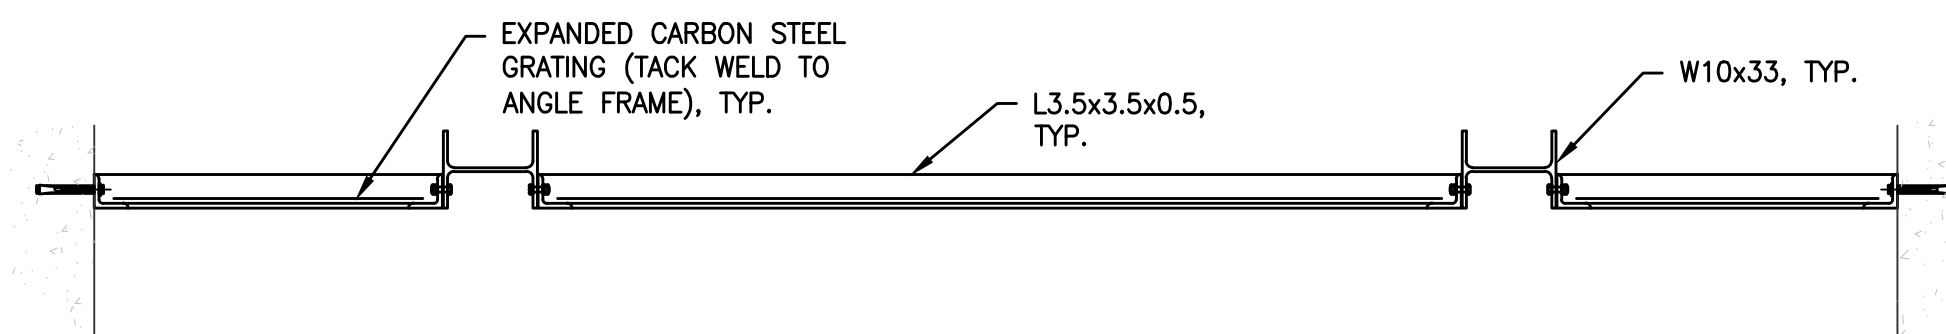
SECTION B

1" = 20'

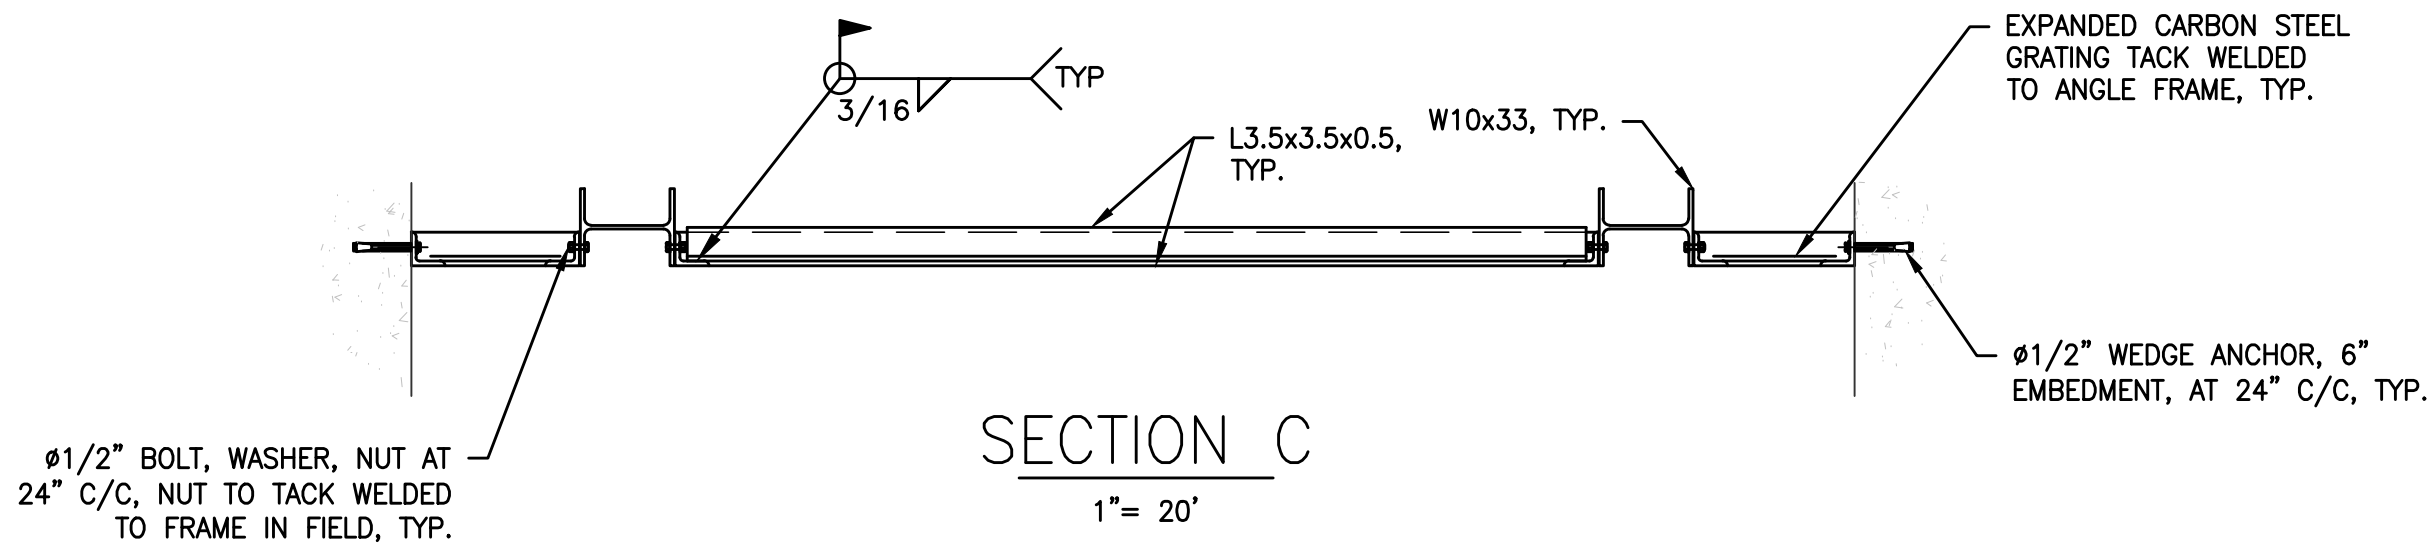
SECTION C

1" = 20'
