**Project Nos. 14803-001;
2082-063**

**AMENDED APPLICATION FOR SURRENDER OF LICENSE
FOR MAJOR PROJECT AND REMOVAL OF PROJECT WORKS**

**EXHIBIT J
Reservoir Area Management Plan**

Reservoir Area Management Plan

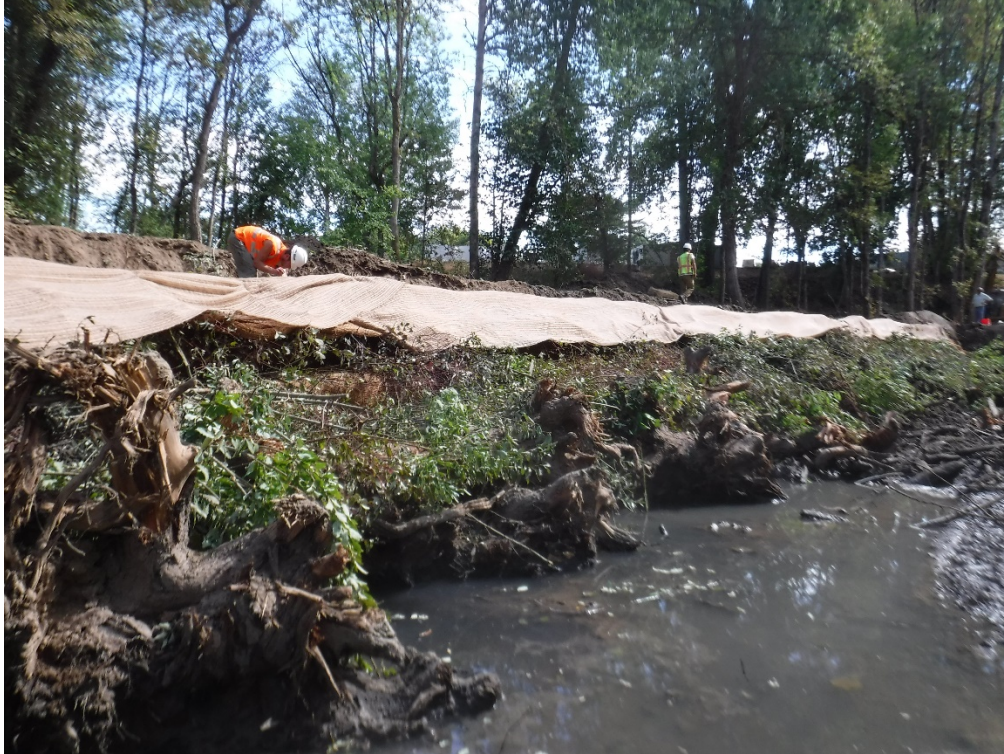
Figure 5-2. Example of Toe Wood Being Installed to Improve Fringe Complexity

Lack of initial roughness along channel margins results in higher than normal near-bank velocity and shear stress. This increase in active channel margin energy negatively affects aquatic species by requiring increased energy for migration and holding while also transporting desired gravels and materials that otherwise form depositional features downstream. Velocity shadows created by bankline complexity (i.e., vegetation, rootwads, etc.), large wood, and boulders create regions of complex hydraulic interactions that provide resting zones, feeding seams, cover, and velocity refugia during high flow (See Figure 5-2). Priority tributary reaches that will benefit from these treatments are typically single thread, where the channel is laterally confined. In addition, bank roughness can improve bank stability and reduce unnatural erosion that degrades water quality. Channel fringe complexity is best improved through the strategic addition of large wood as described in the following section and the establishment of riparian vegetation. Likewise, this restoration technique will not be implemented where it will disrupt natural, process-based channel and floodplain evolution within the reservoir areas.

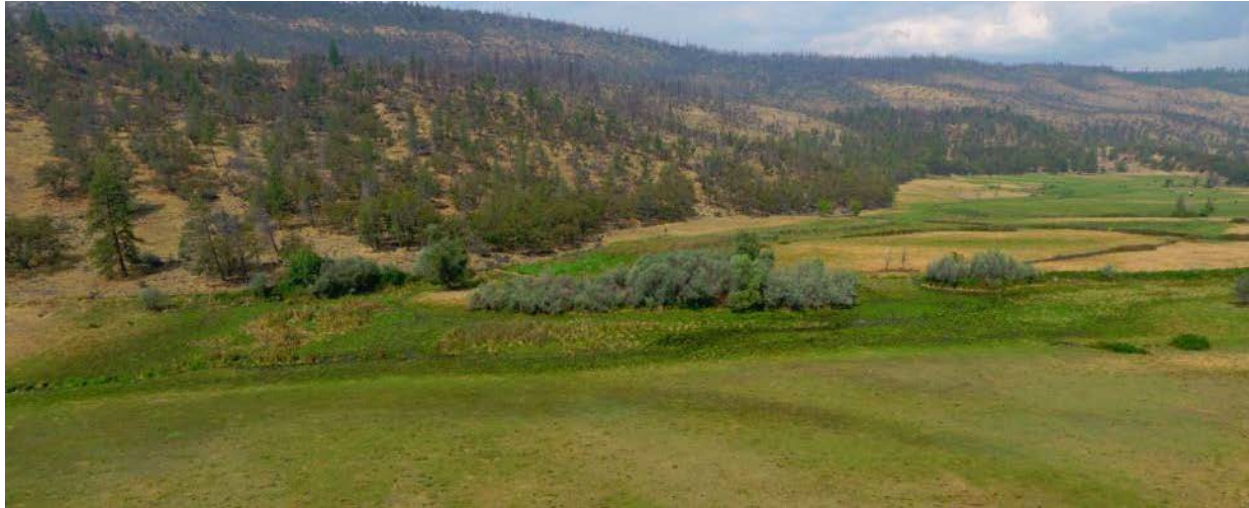
Figure 5-3. Example of Existing Floodplain Features Upstream of Copco No. 1 Reservoir (i.e., Wetland Area)

above to 0.5 ft below the existing or design floodplain surface. Brush, limbs, and wood in the soil will increase moisture retention, create protective microsites for establishing seed and plants, and promote soil development by introducing organic material. Ultimately, restoration actions should lead to vegetative cover, as illustrated in Figure 5-3.

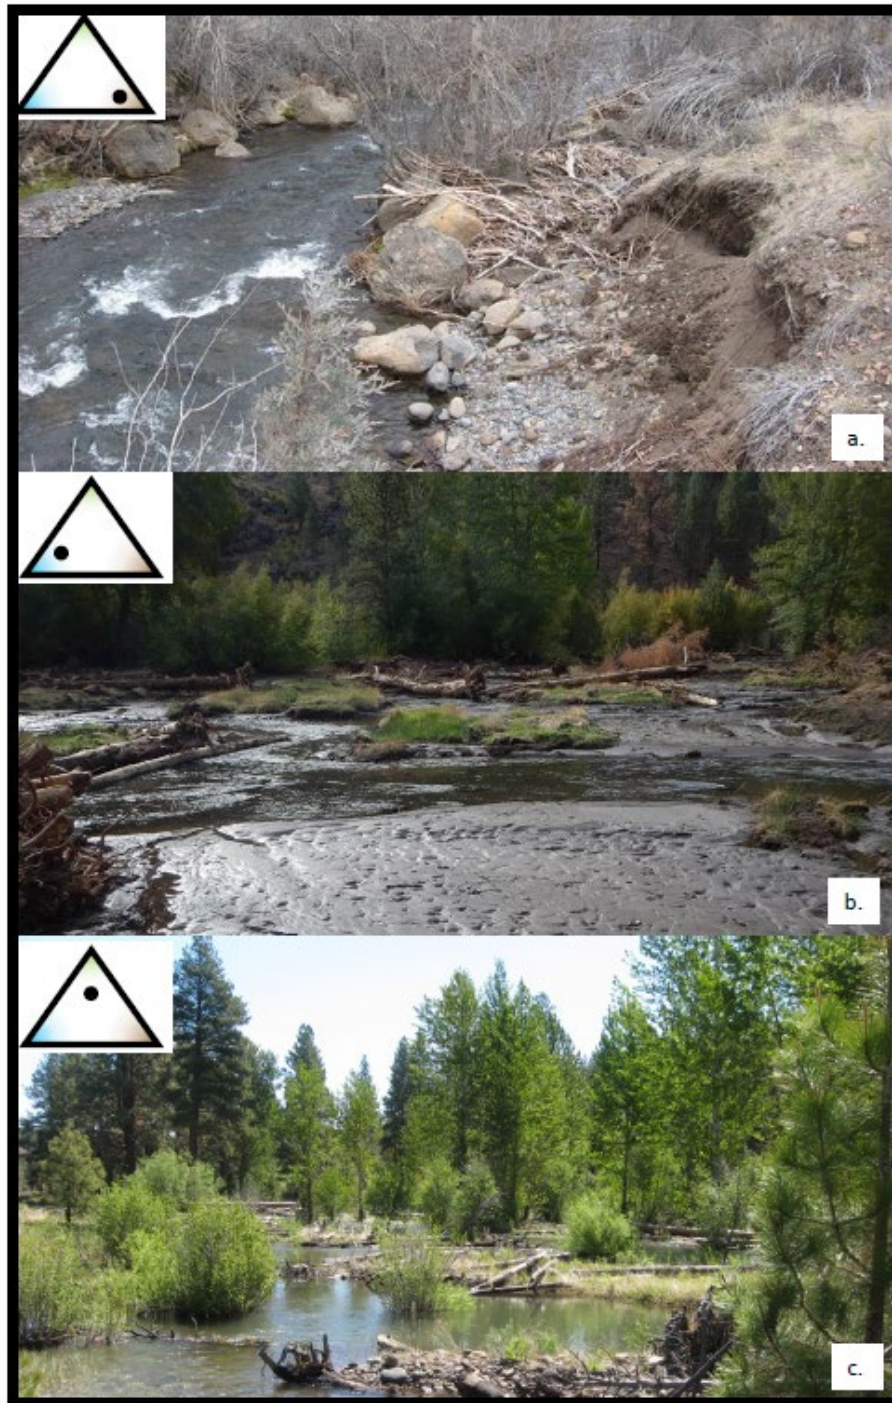
Figure 6-4. Stream Evolution Triangle Example
(a) Representing Pre-Implementation, (b) Immediately Following Restoration Construction,
and (c) One (1)-Year Following Construction

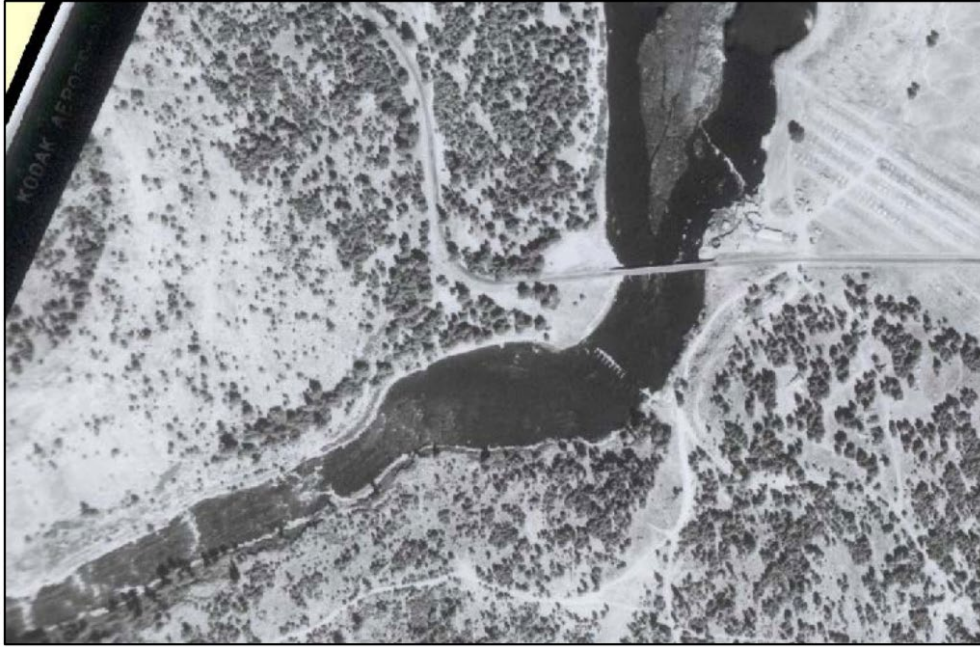
Figure D-3. Historic Aerial Photograph of J.C. Boyle Reservoir Area (1952) Prior to Dam Construction

There is little evidence of bedform development, and most in-channel sediment visible in historical photographs is boulder- or cobble-sized. Two (2)-year and 100-year flood extents were estimated to be narrow, demonstrating the confined nature of the Canyon Reach (KRRC, 2018).

Note: Highway 66 bridge crosses the Klamath River in this location. Flow is top to bottom. Photograph is oriented north-up. Dam location is out of frame at the bottom left.

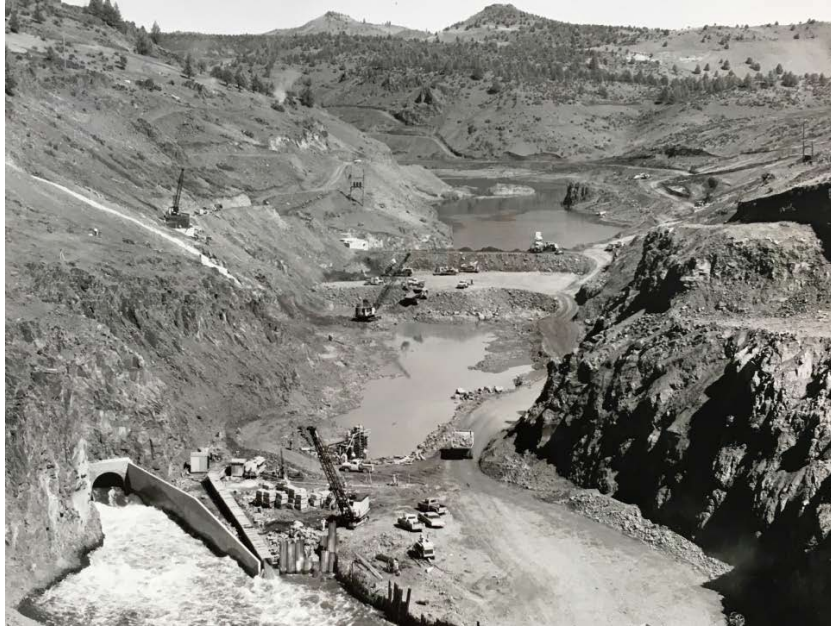
Figure D-10. View Looking Upstream at Site of Iron Gate Dam during Construction and Showing Reservoir Area

Note: Photo from initial Iron Gate Dam Construction, shows Cofferdam and bypass tunnel.
