APPENDIX F1

ROADS, BRIDGES, AND CULVERTS

DESIGN DETAILS

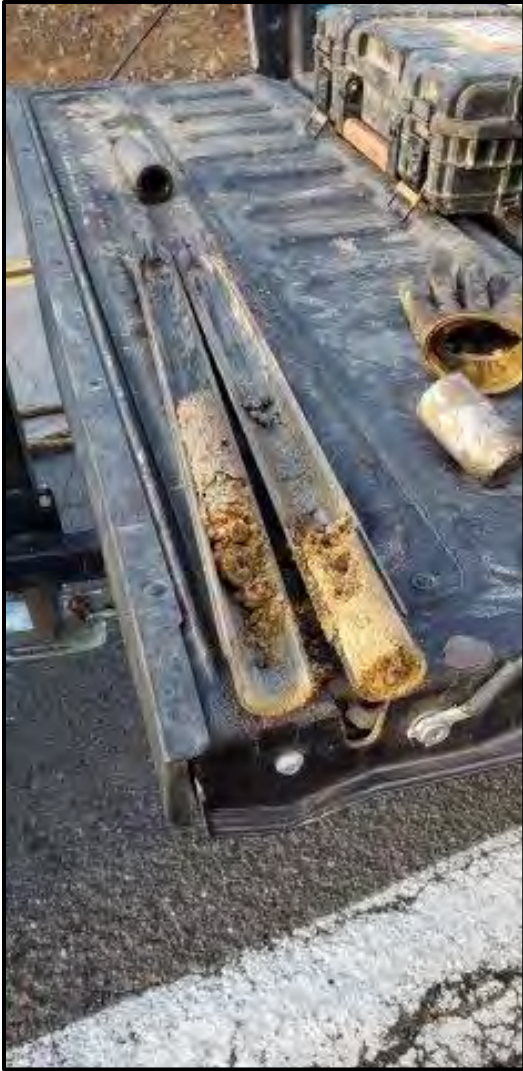
Photographs 1. Road Core RC-CR-001 (STA 180+60.0) SPT sample taken from 0-1.5' bgs.

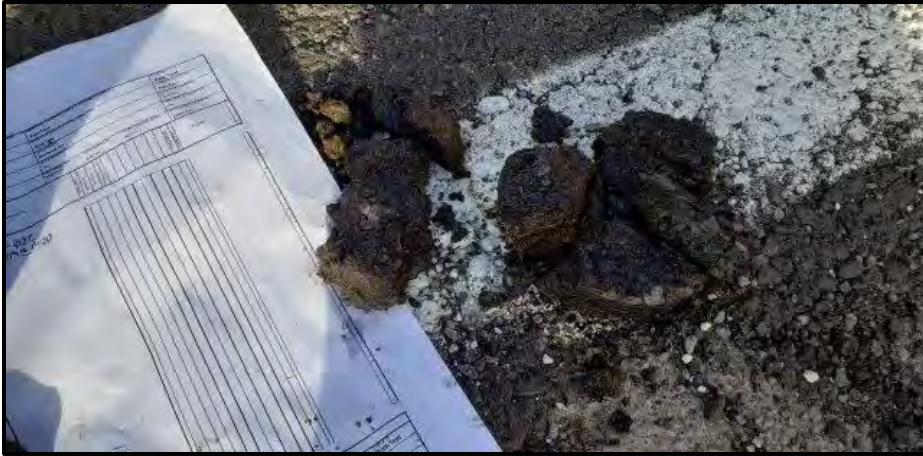
Photograph 2. Asphalt core sample at Road Core RC-CR-002 (STA 236+20.0).

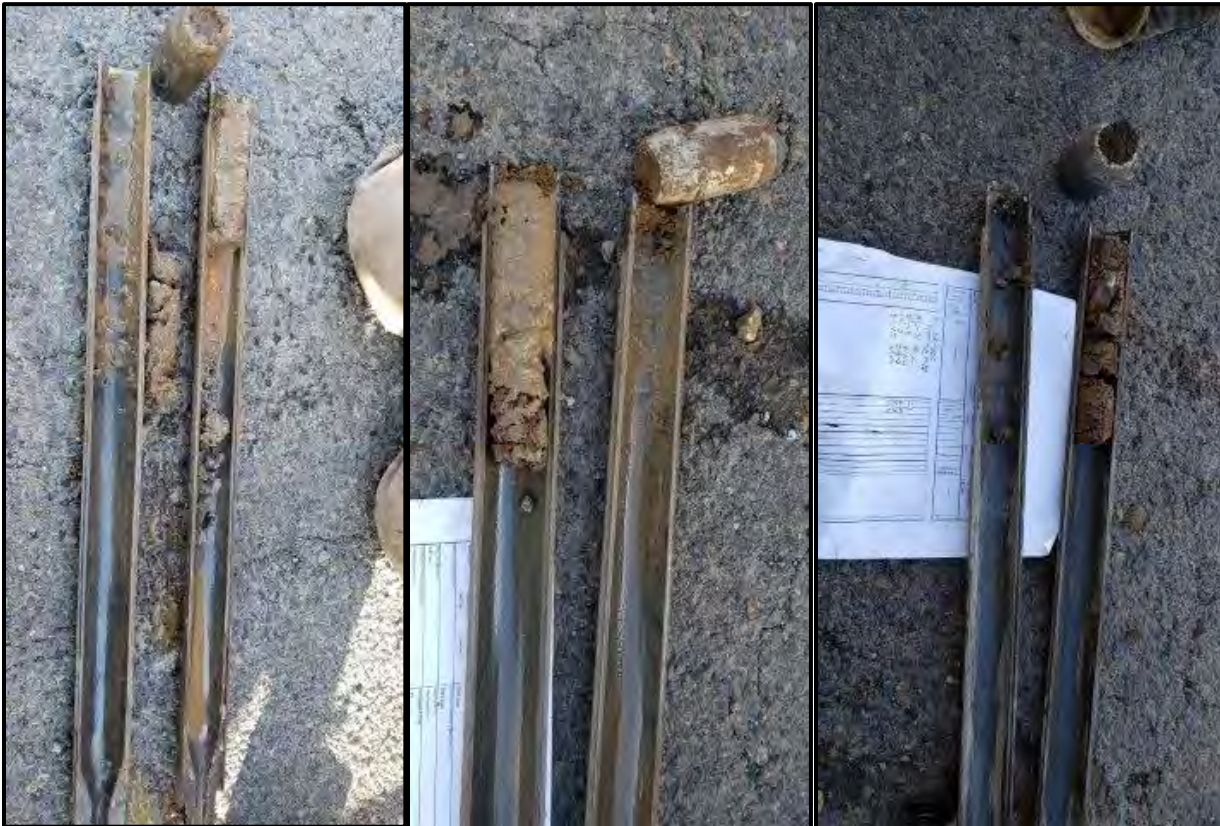
Photograph 3/4/5. SPT samples taken at 0-1.5' bgs -Left, 1.5-3' bgs -Middle, & 3-4.5' bgs -Right (CR-RC-002).

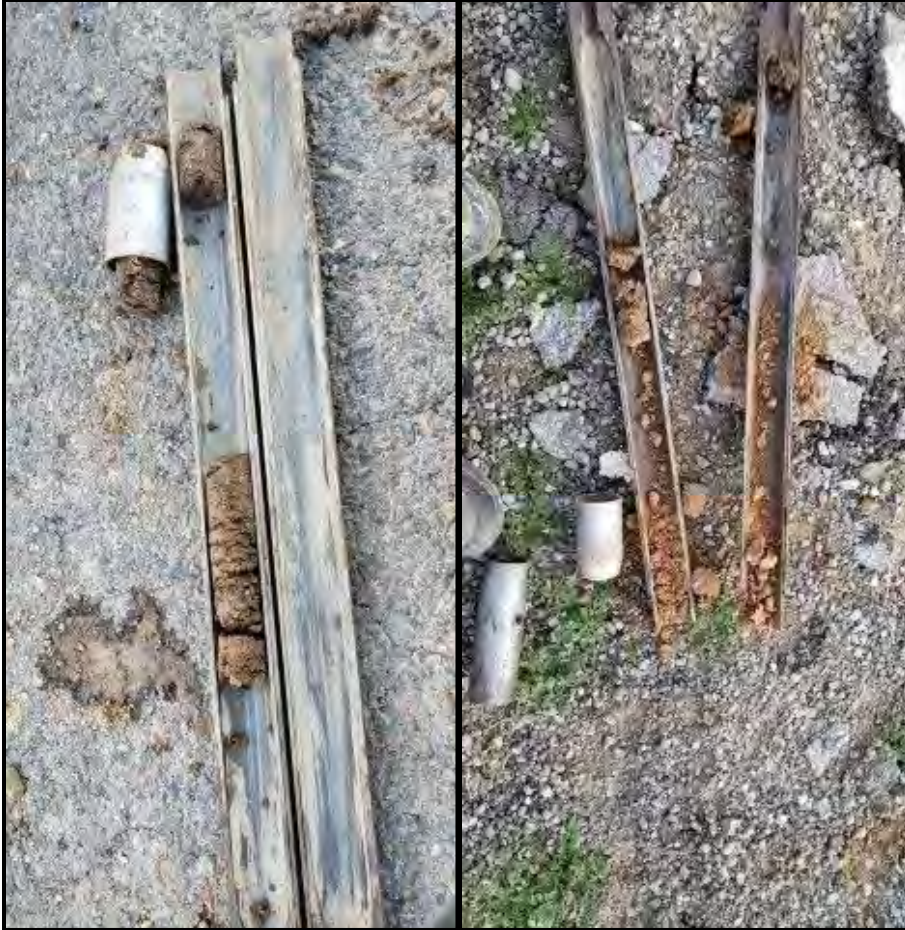
Photograph 6 & 7. SPT sample taken at 4.5-6.0' bgs-**Left**, & 6.5-6.584' bgs-**Right** (CR-RC-002).

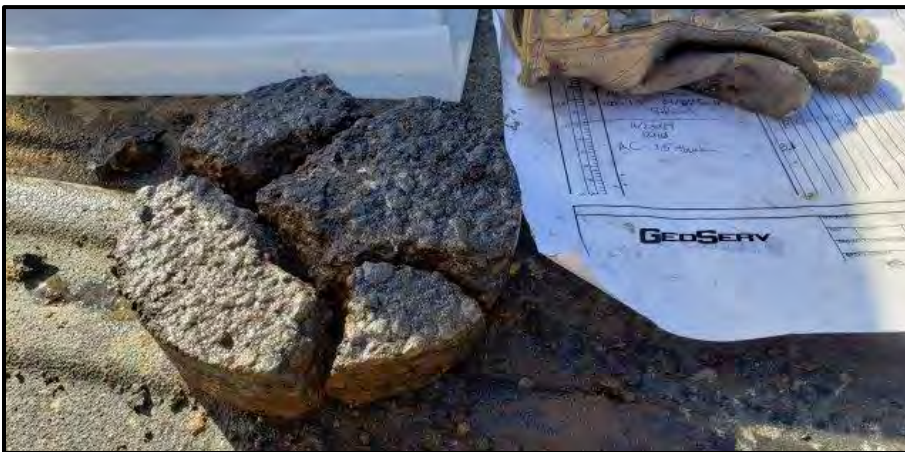
Photograph 7. Asphalt core sample at Road Core RC-CR-003 (**STA 220+57.0**).

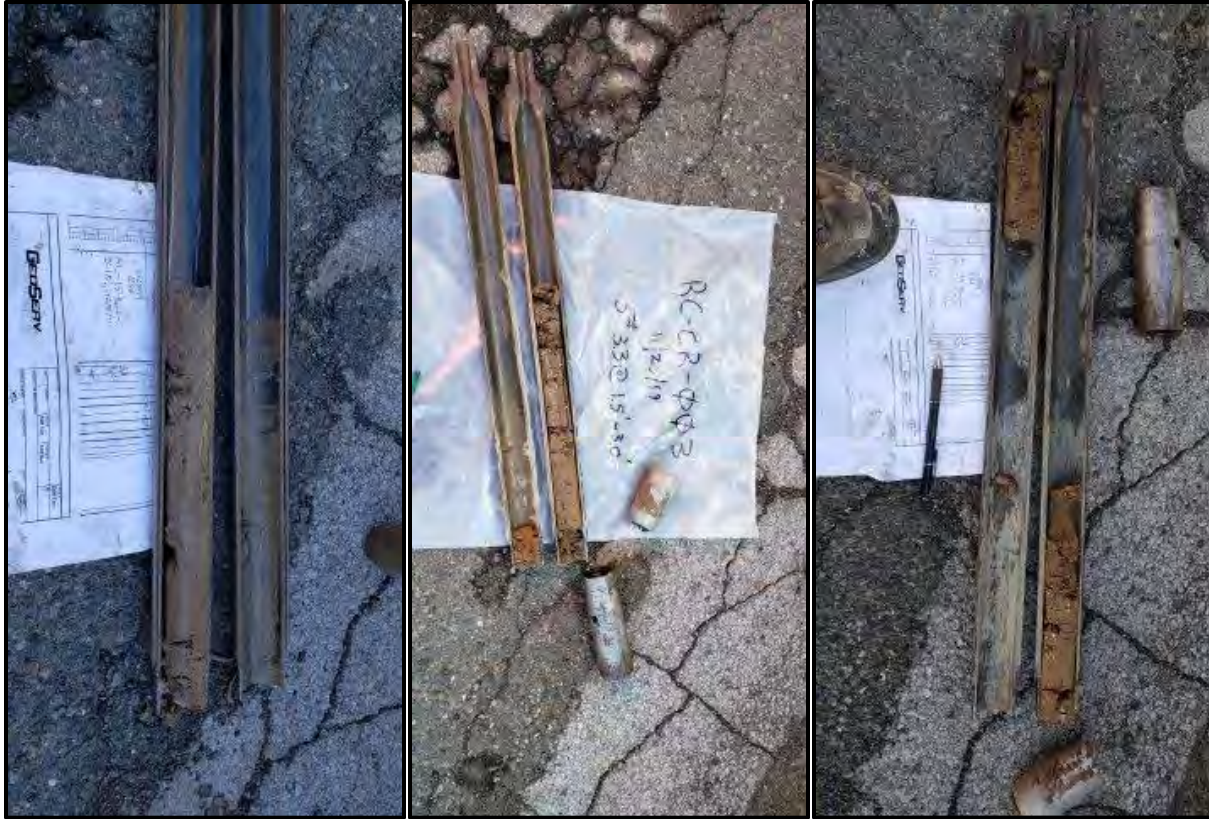
Photographs 8/9/10. SPT samples taken at 0-1.5' bgs-**Left**, 1.5'-3.0' bgs-**Middle**, & 3.0-4.5' bgs-**Right** (CR-RC-003).

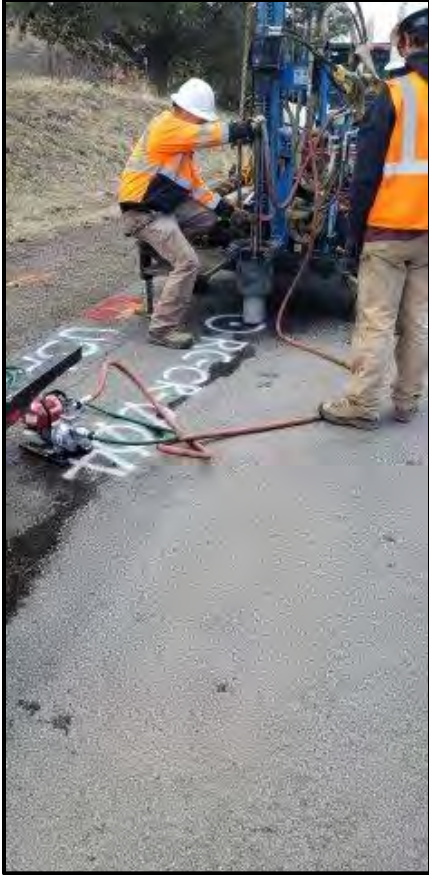
Photograph 11. Looking at asphalt coring at Road Core RC-CR-004 (STA 315+66.0).

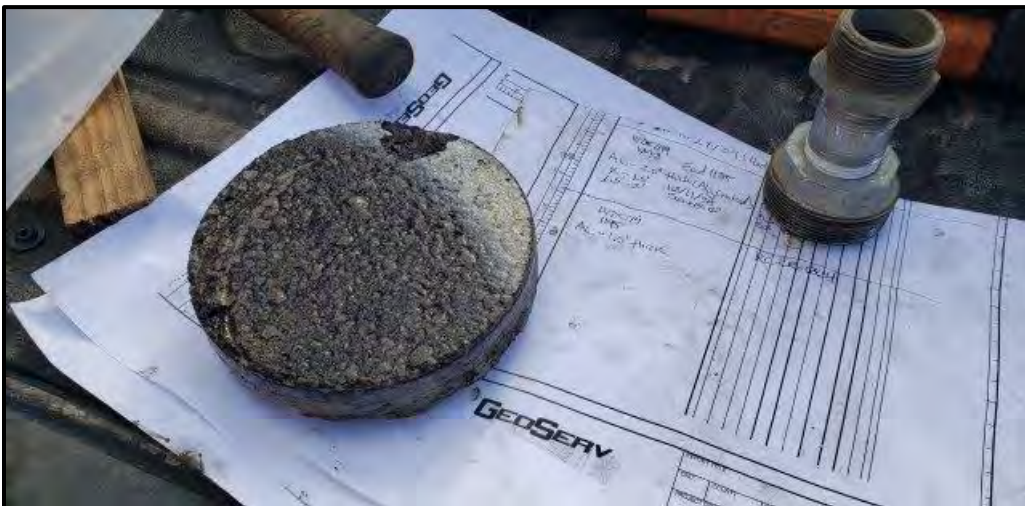
Photograph 12. Asphalt core sample at Road Core RC-CR-004.

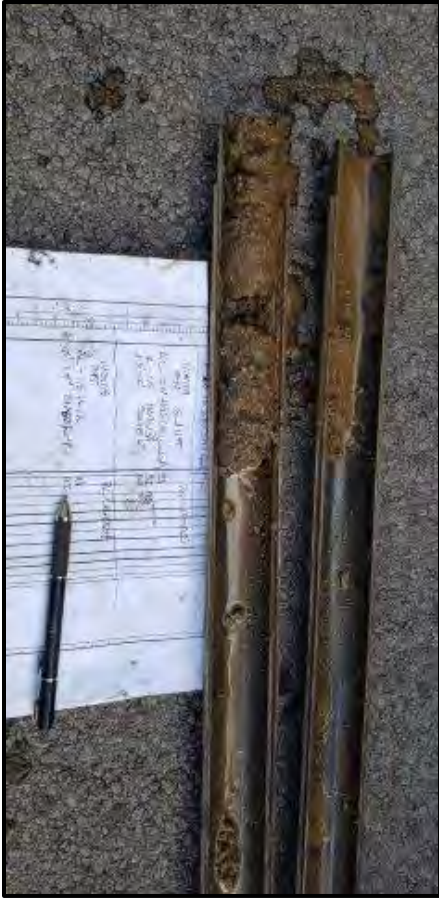
Photograph 13. SPT sample taken at 0-0.8' bgs (CR-RC-004).

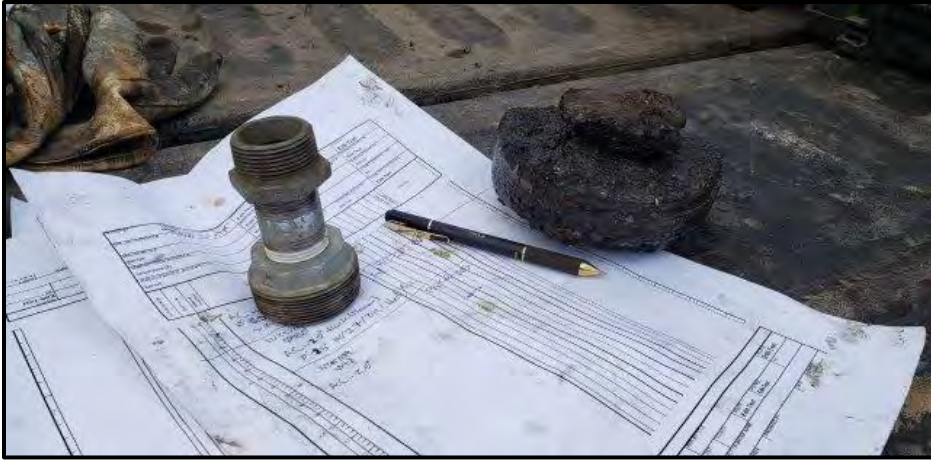
Photograph 14. Asphalt core sample at Road Core RC-CR-005 (STA 386+17.0).

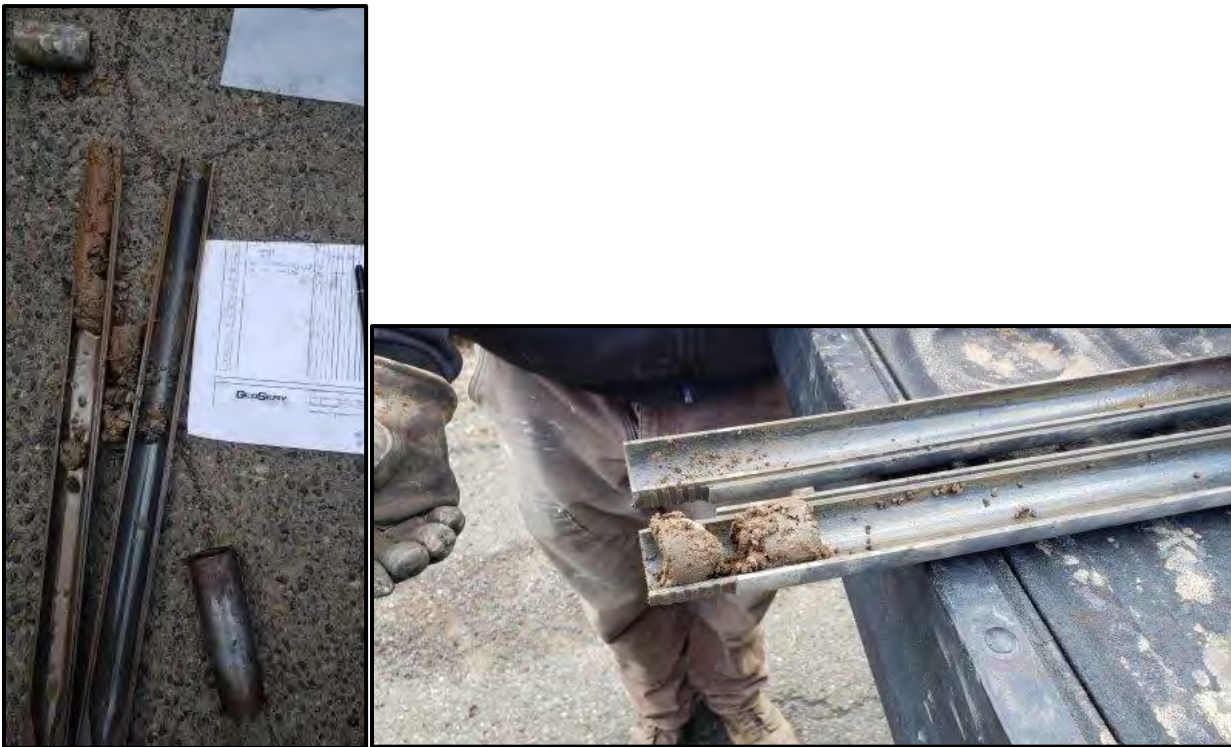
Photograph 15 & 16. SPT samples taken at 0-1.5' bgs -Left, & 1.5-1.958' bgs-Right (CR-RC-005)

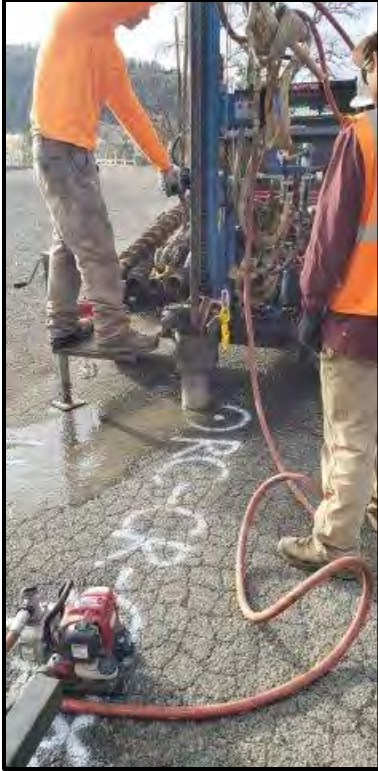
Photograph 17. Looking at asphalt coring at Road Core RC-CR-006 (STA 430+68.0).

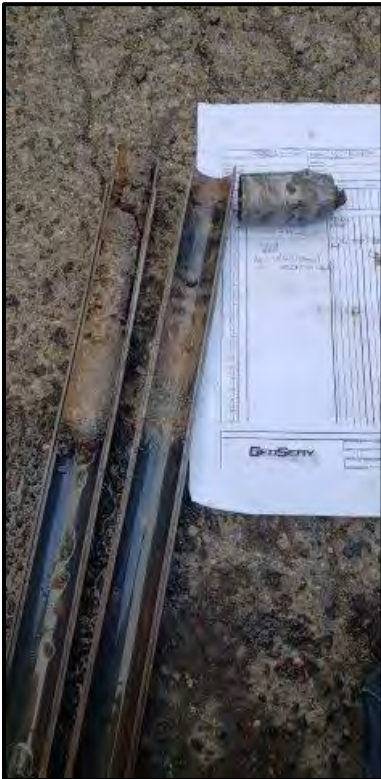
Photograph 18. SPT sample taken at 0-1.5' bgs (CR-RC-006)

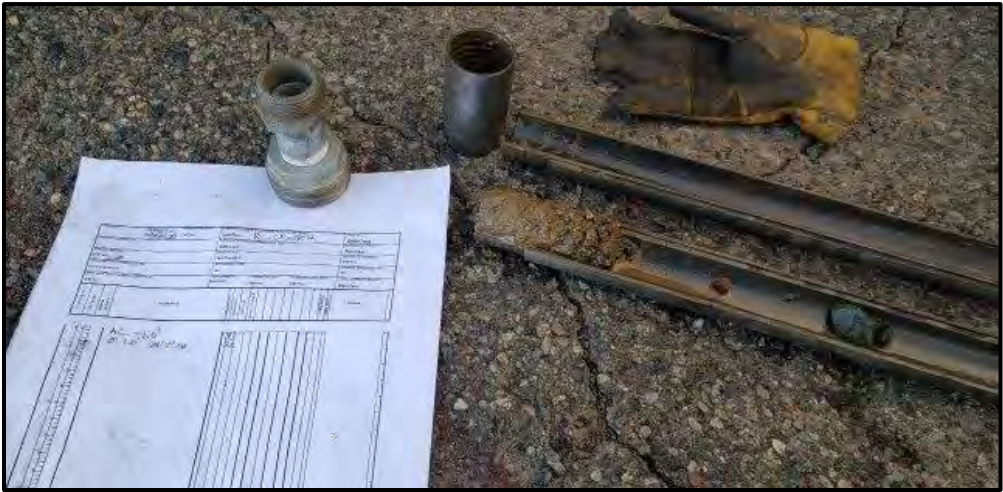
Photograph 20. SPT sample taken at 0-0.8' bgs (CR-RC-007)

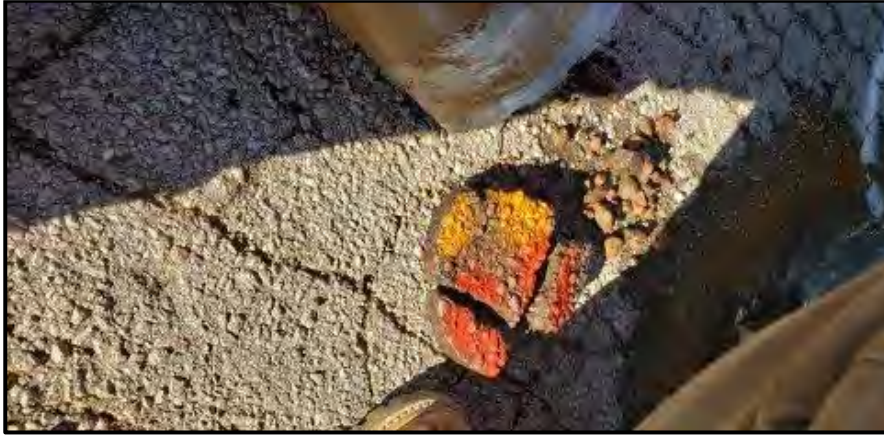
Photograph 21. Asphalt core sample at Road Core RC-CR-008. (507+44.0)

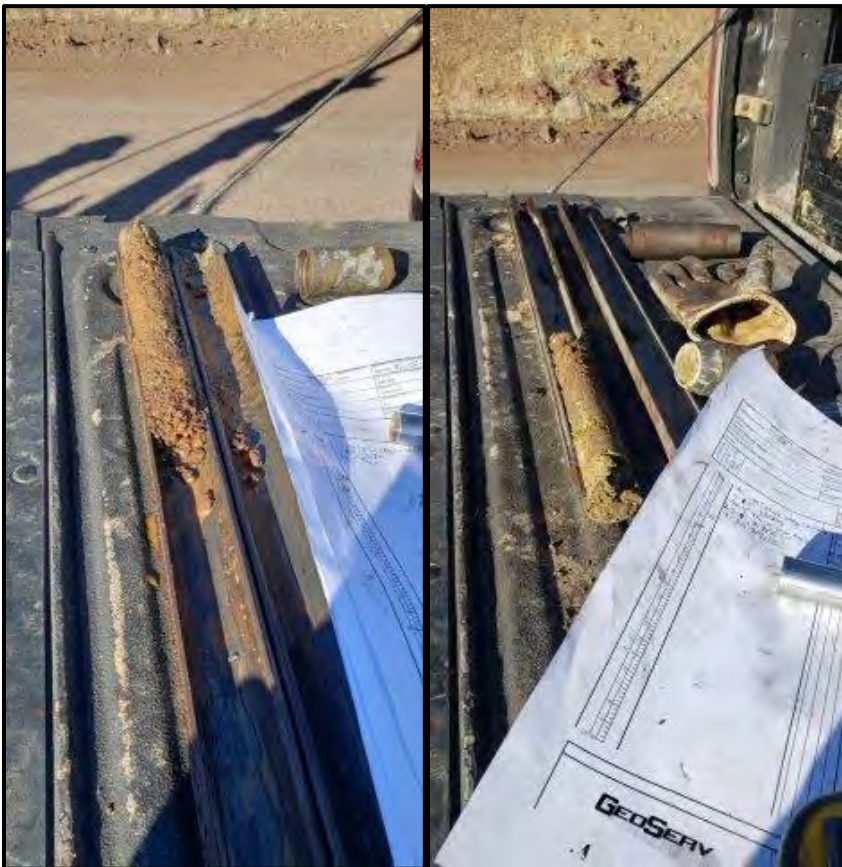
Photographs 22 & 23. SPT samples taken at 0-1.5' bgs-Left, & 2.5-4.0' bgs-Right (CR-RC-008)

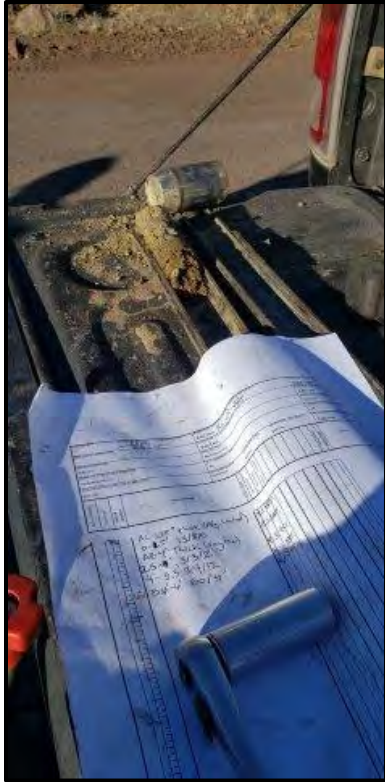
Photograph 24. SPT sample taken at 4.0-5.5' bgs (CR-RC-008)

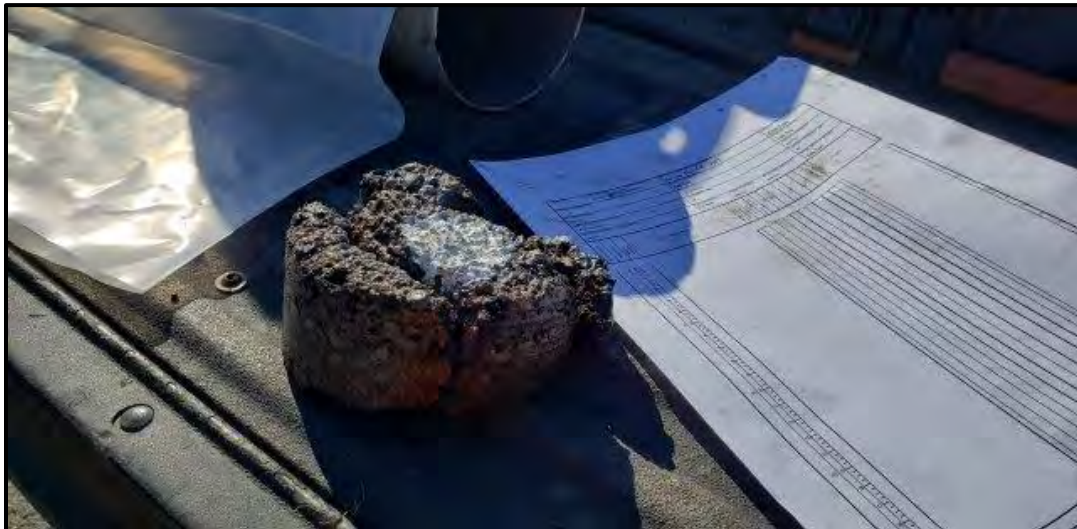
Photograph 25. Asphalt core sample at Road Core RC-CR-009 (STA 552+05).

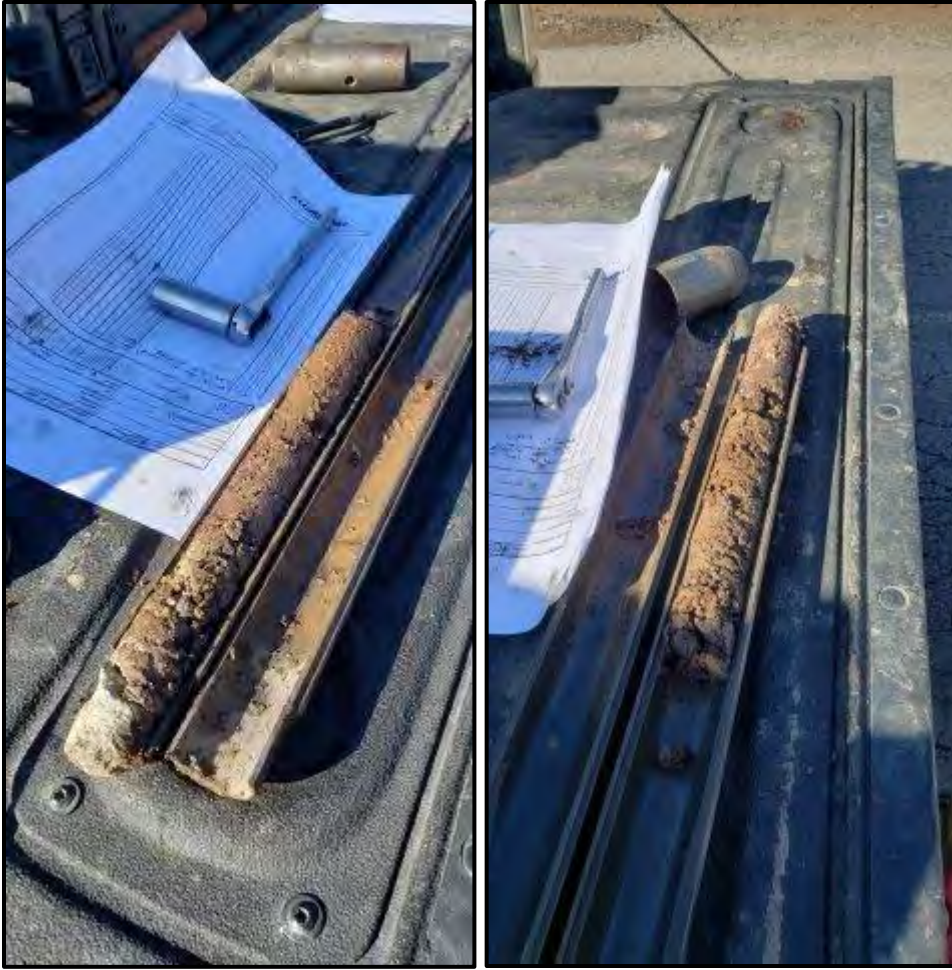
Photograph 26 & 27. SPT samples taken at 0-1.5' bgs -Left, & 1.5-3.0' bgs -Right (CR-RC-009)

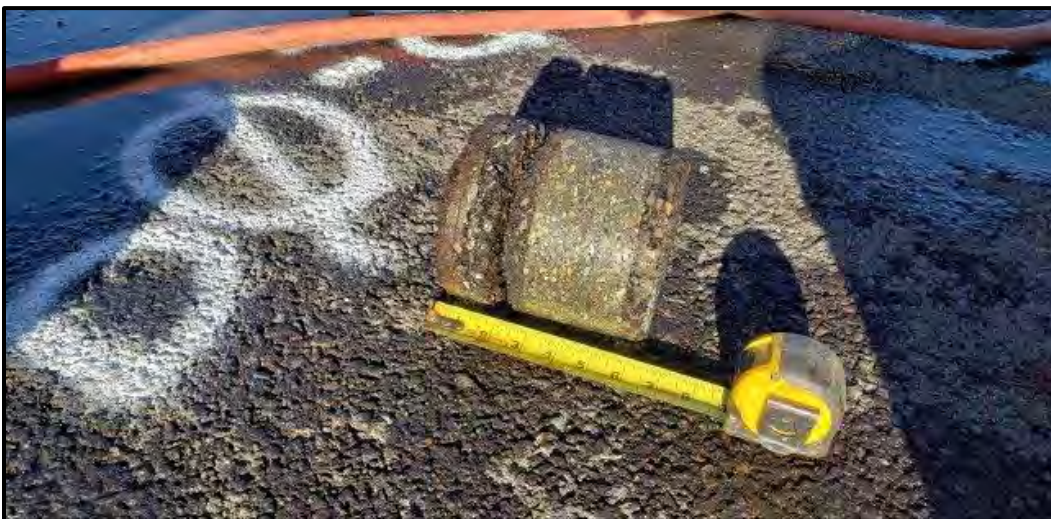
Photograph 28. Asphalt core sample at Road Core RC-CR-09A, (STA-739+58.0).

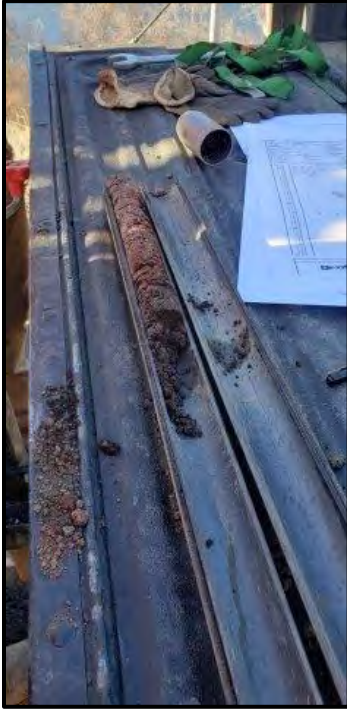
Photograph 29. Looking at SPT sample taken from 0.5-2.5' bgs (RC-CR-09A).

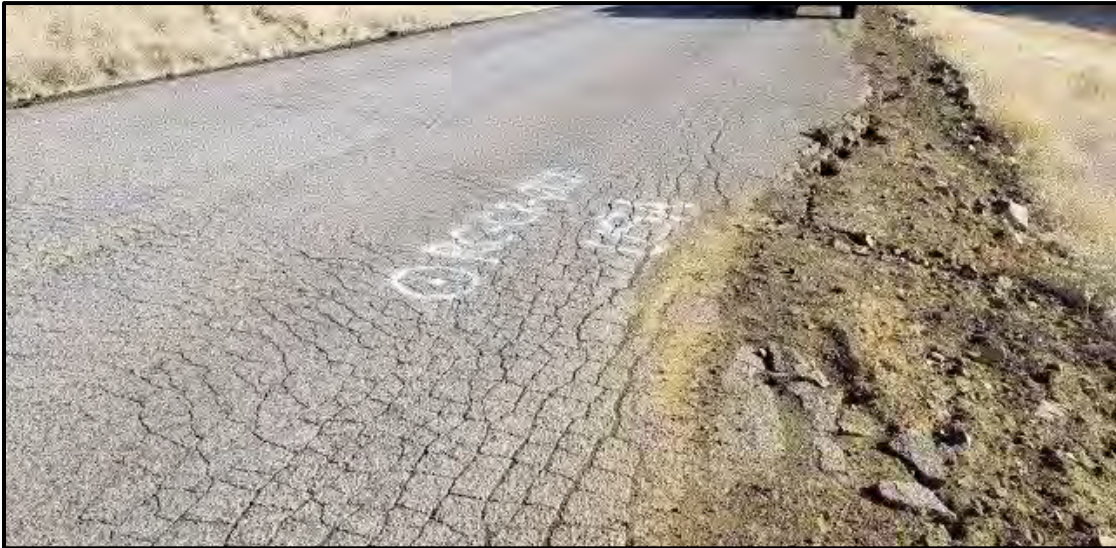
Photograph 30. Looking at Road Core location RC-CR-010 (STA 739+58.0).

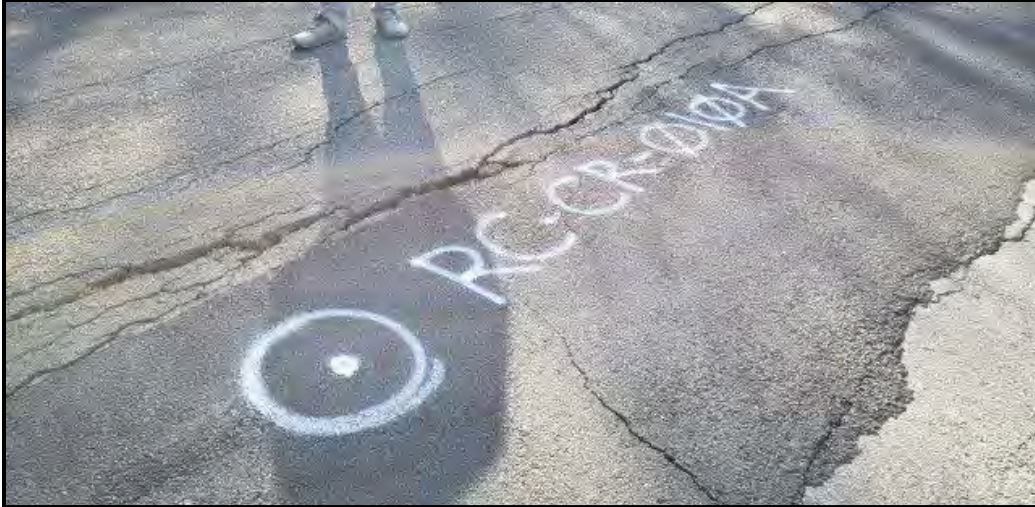
Photograph 31. Looking at Road Core location RC-CR-010A (STA 831+92.0).

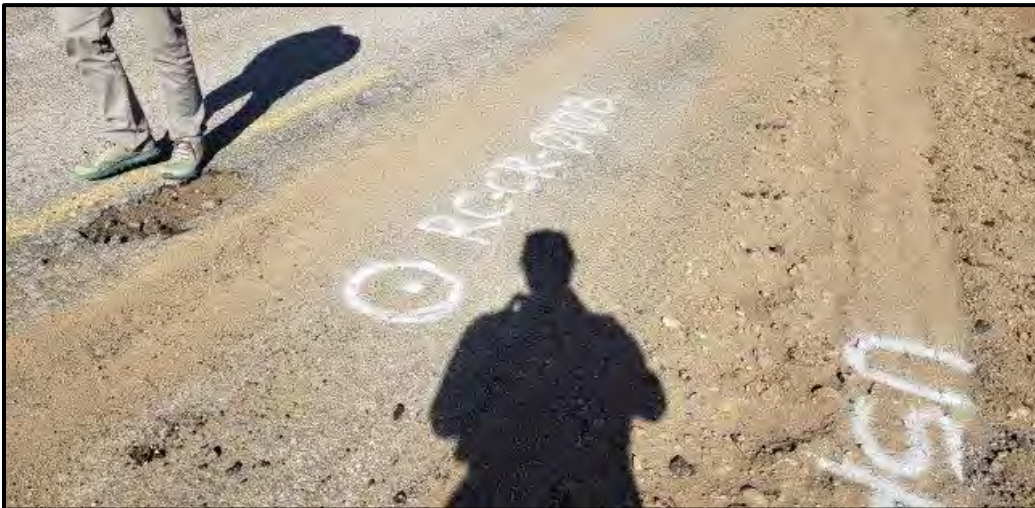
Photograph 32. Looking at Road Core location RC-CR-010B (STA 753+85).

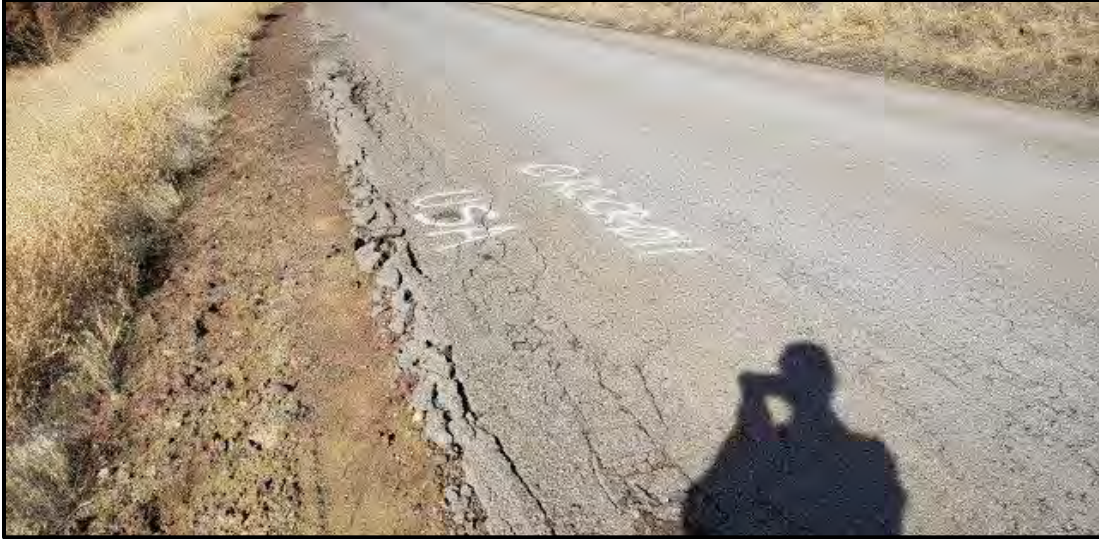
Photograph 33. Looking at Road Core location RC-CR-011 (STA 861+30.0).

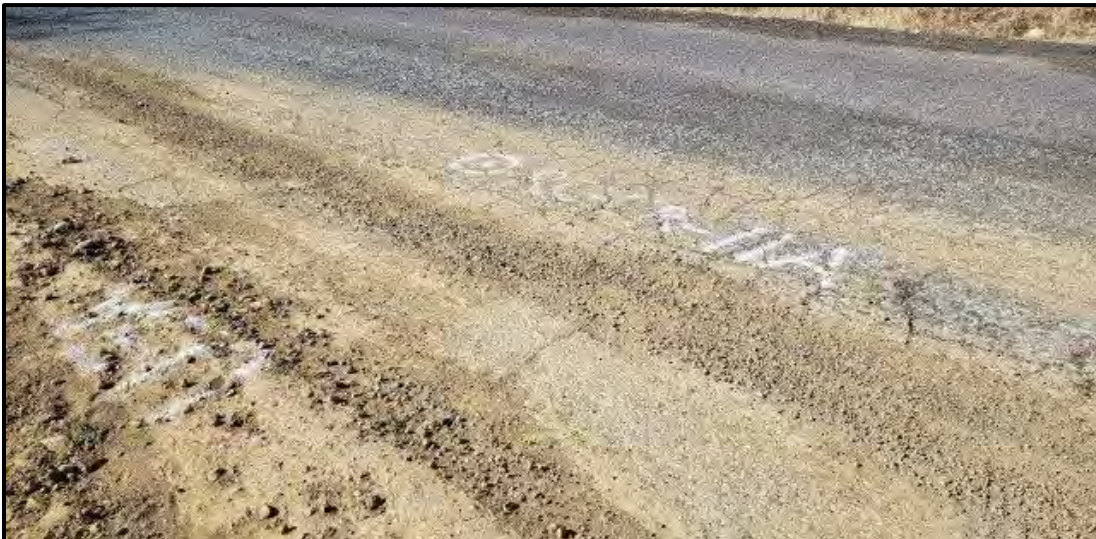
Photograph 34. Looking at Road Core location RC-CR-011A (STA 918+36.0).

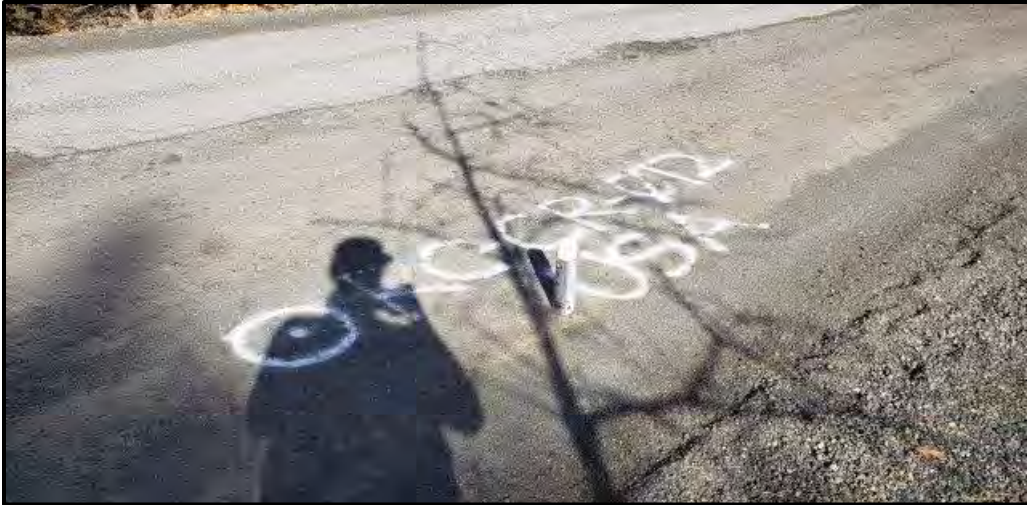
Photograph 35. Looking at Road Core location RC-CR-012 (STA 960+49.0).

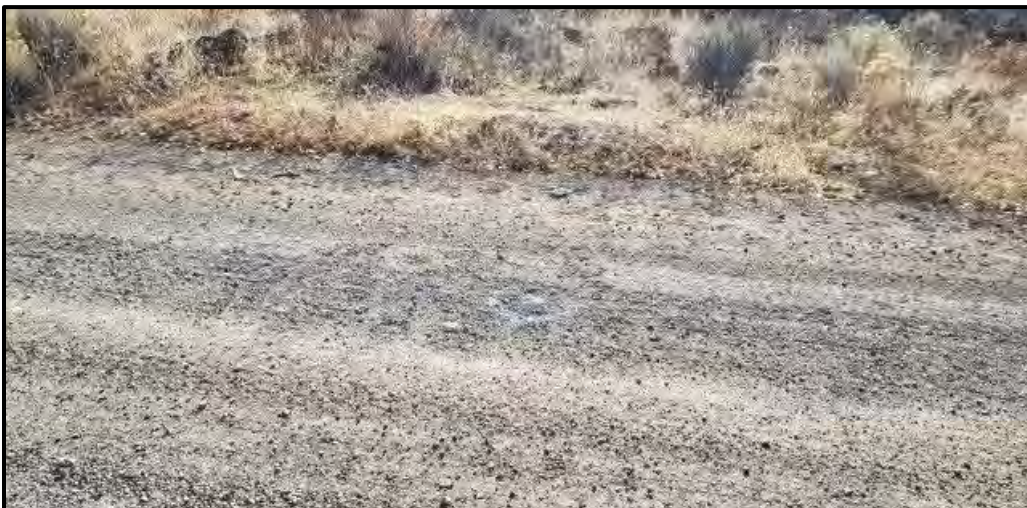
Photograph 36. Looking at Road Core location RC-CR-013 (STA 1019+33).

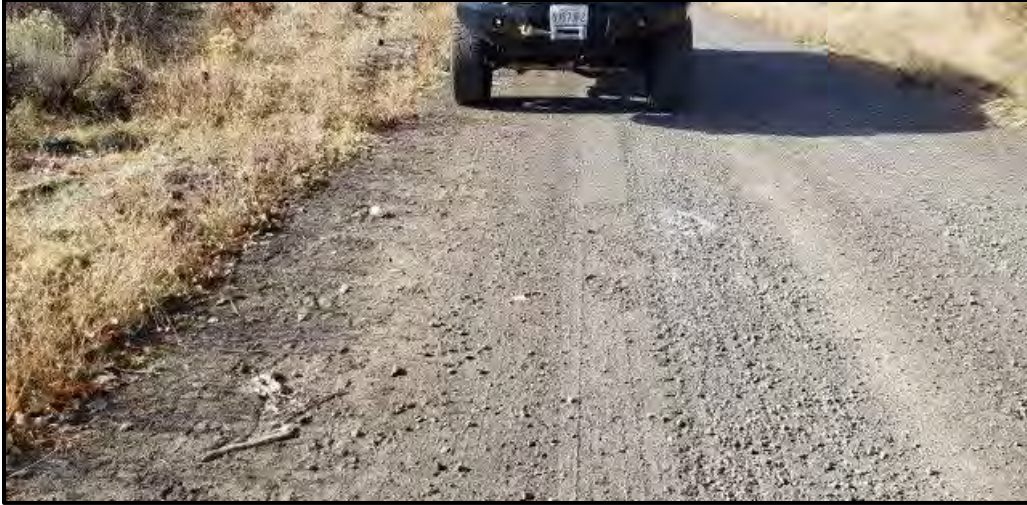
Photograph 37. Looking at Road Core location RC-CR-013 (STA 1059+30).

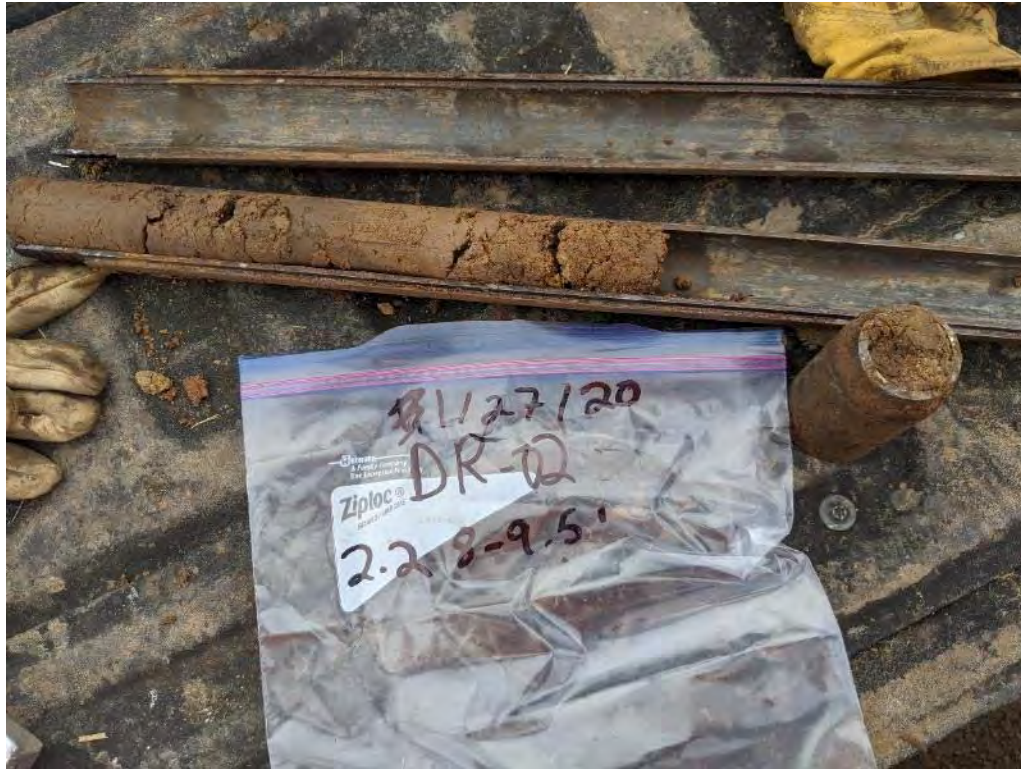
Copco Road at Dry Creek Bridge Photo 1 – BH-DR02 Sample 2.2 from 8-9.5 ft bgs.

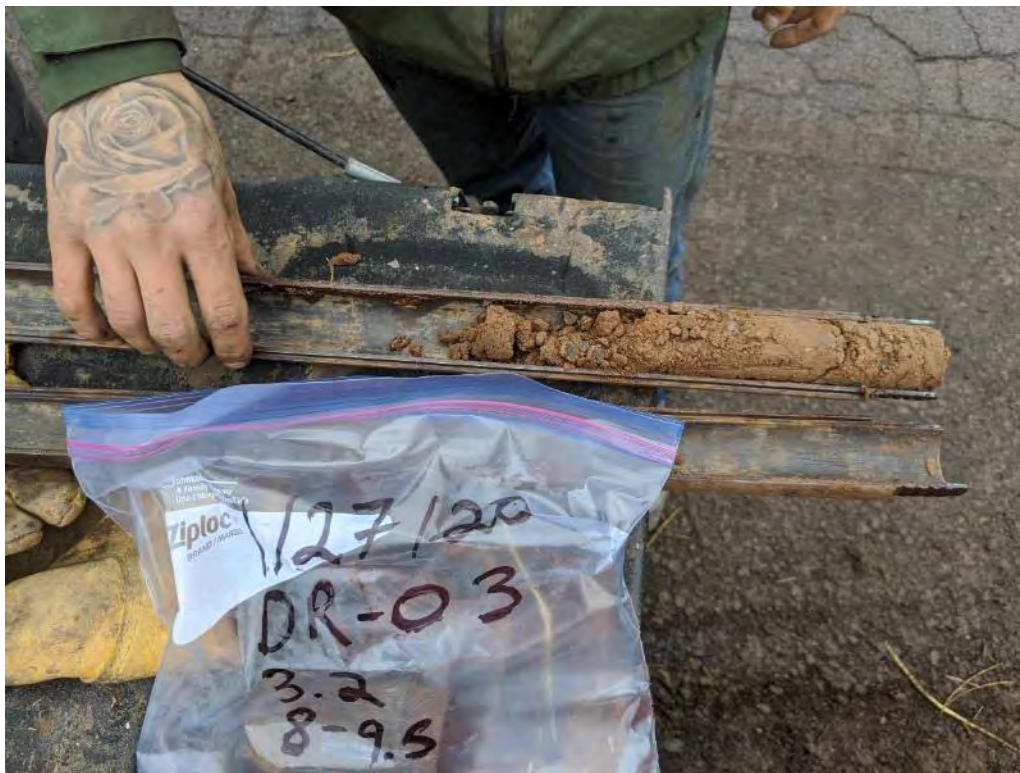
Copco Road at Dry Creek Bridge Photo 2 – BH-DR03 Sample 3.2 from 8-9.5 ft bgs.

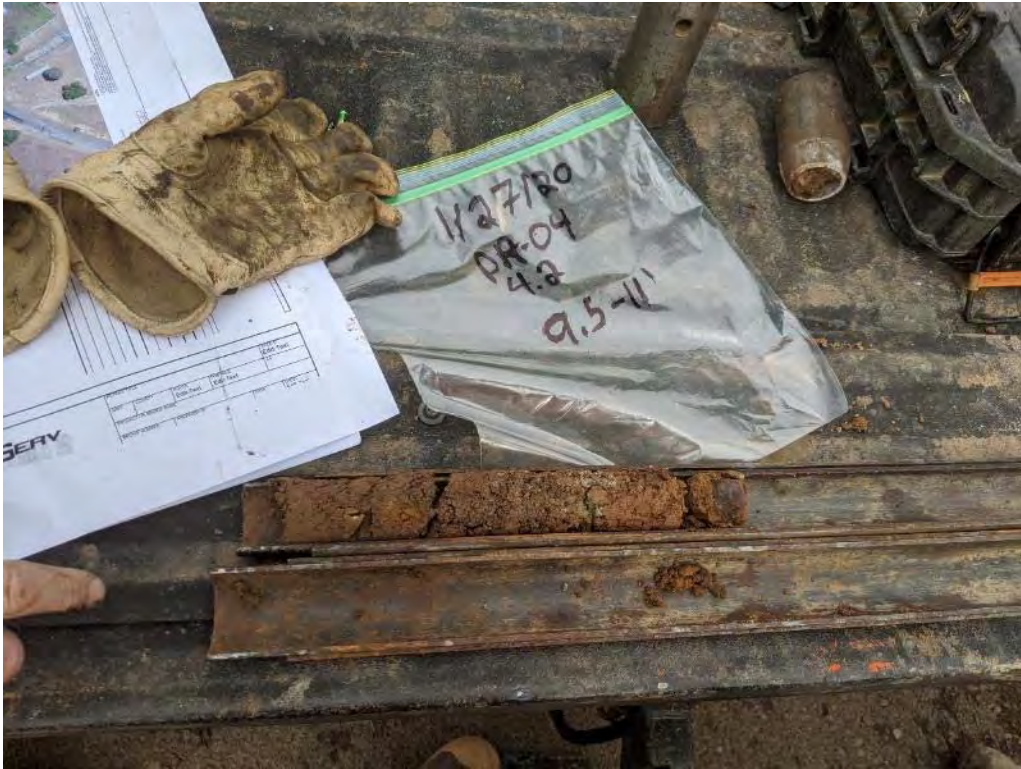
Copco Road at Dry Creek Bridge Photo 3 – BH-DR04 Sample 4.2 from 9.5-11 ft bgs.

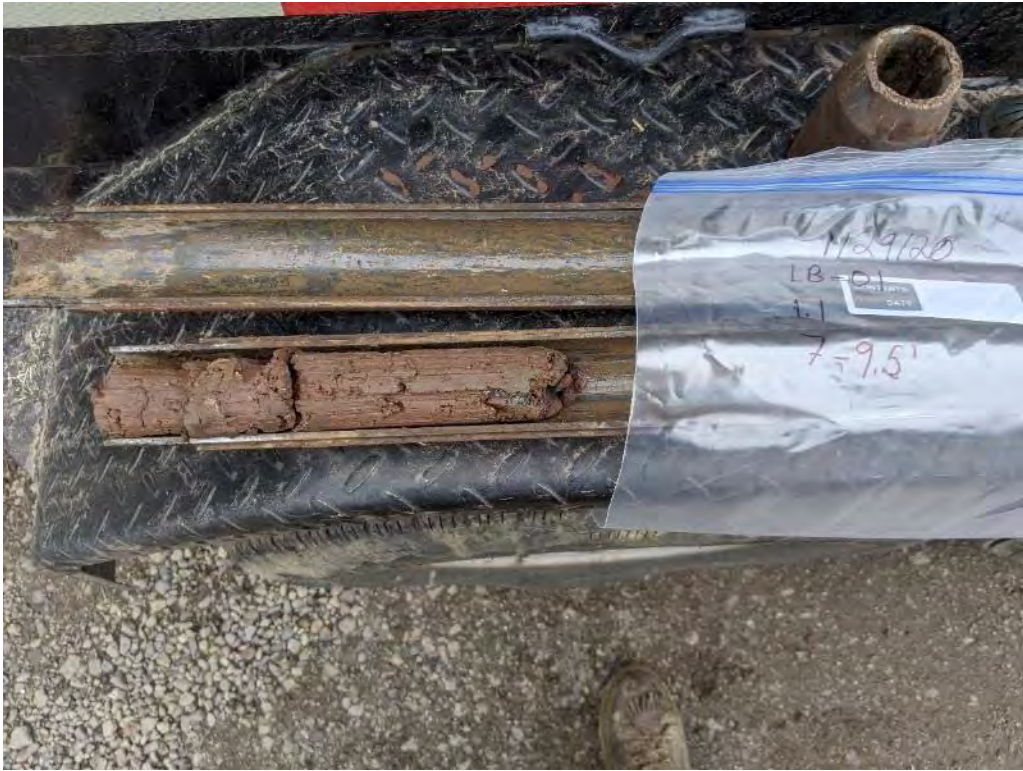
Lakeview Road Bridge Photo 1 – BH-AB01 Sample 1.1 from 7-9.5 ft bgs.

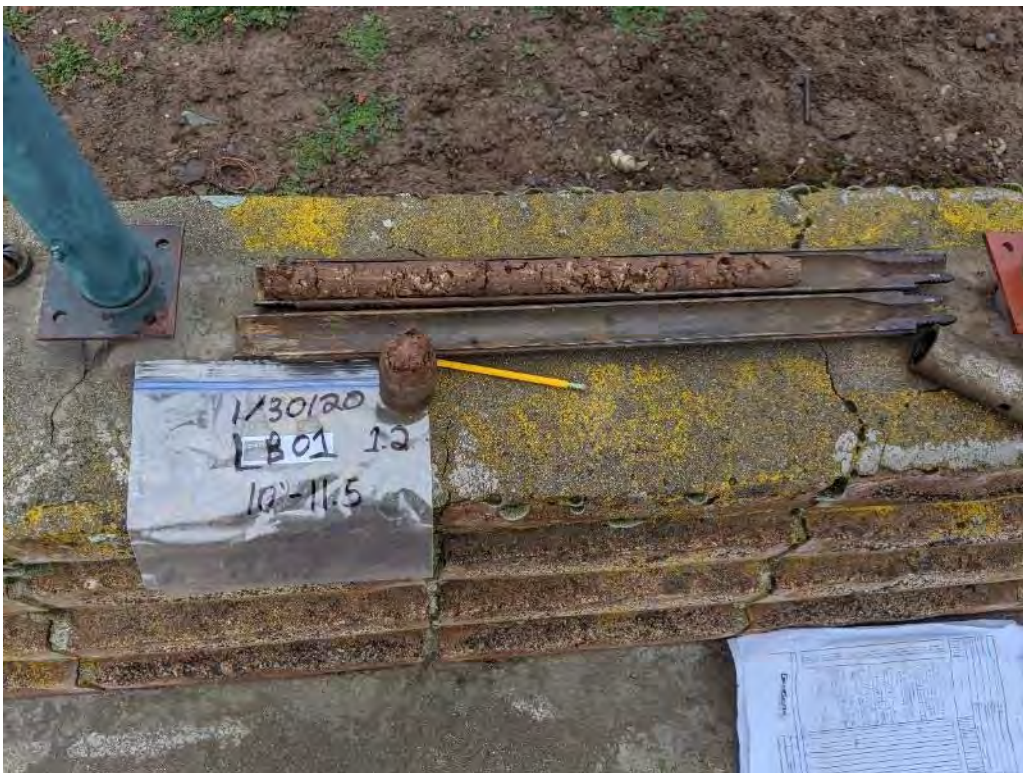
Lakeview Road Bridge Photo 2 – BH-AB01 Sample 1.2 from 10-11.5 ft bgs.

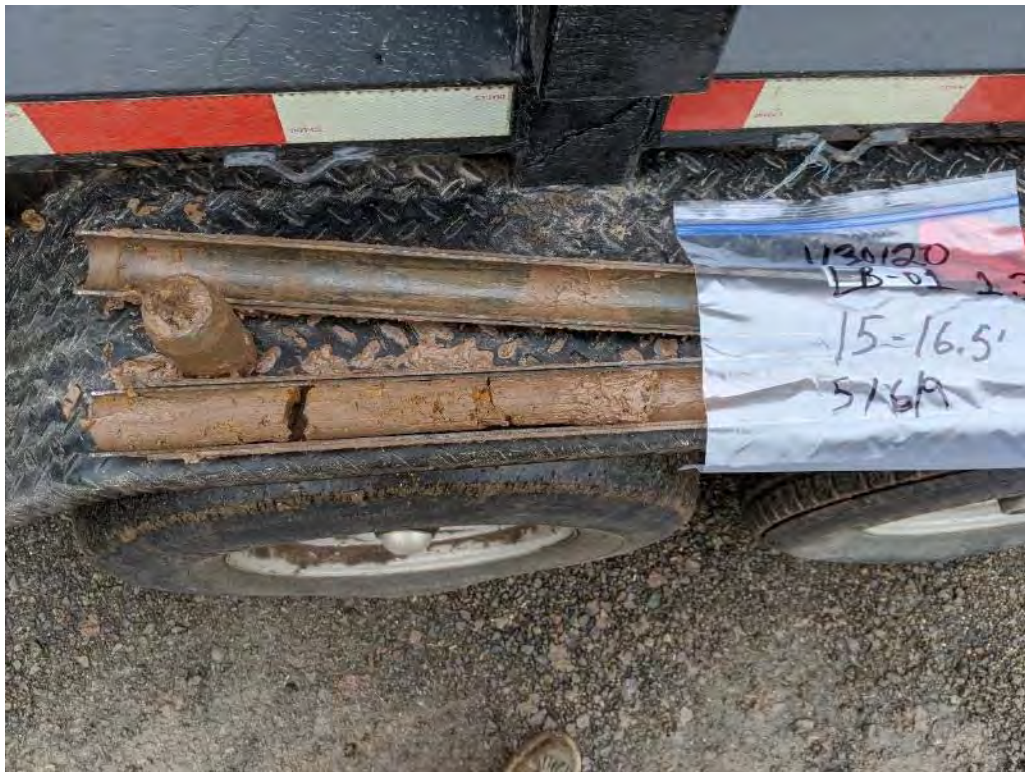
Lakeview Road Bridge Photo 3 – BH-AB01 Sample 1.3 from 15-16.5 ft bgs.

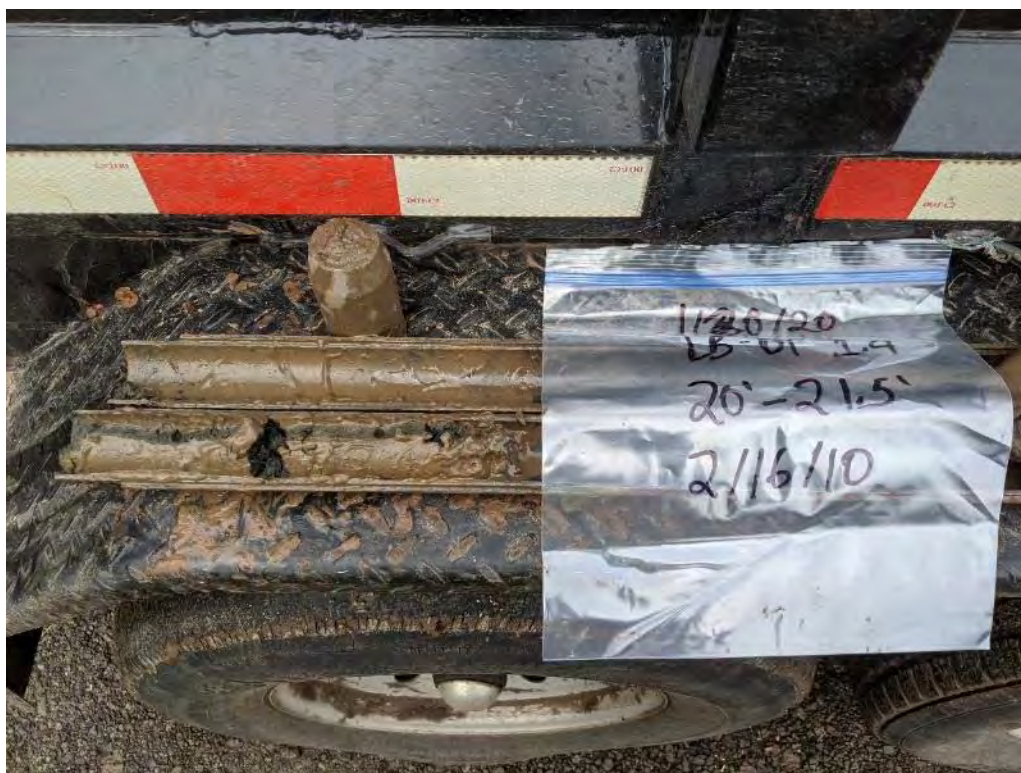
Lakeview Road Bridge Photo 4 – BH-AB01 Sample 1.4 from 20-21.5 ft bgs.

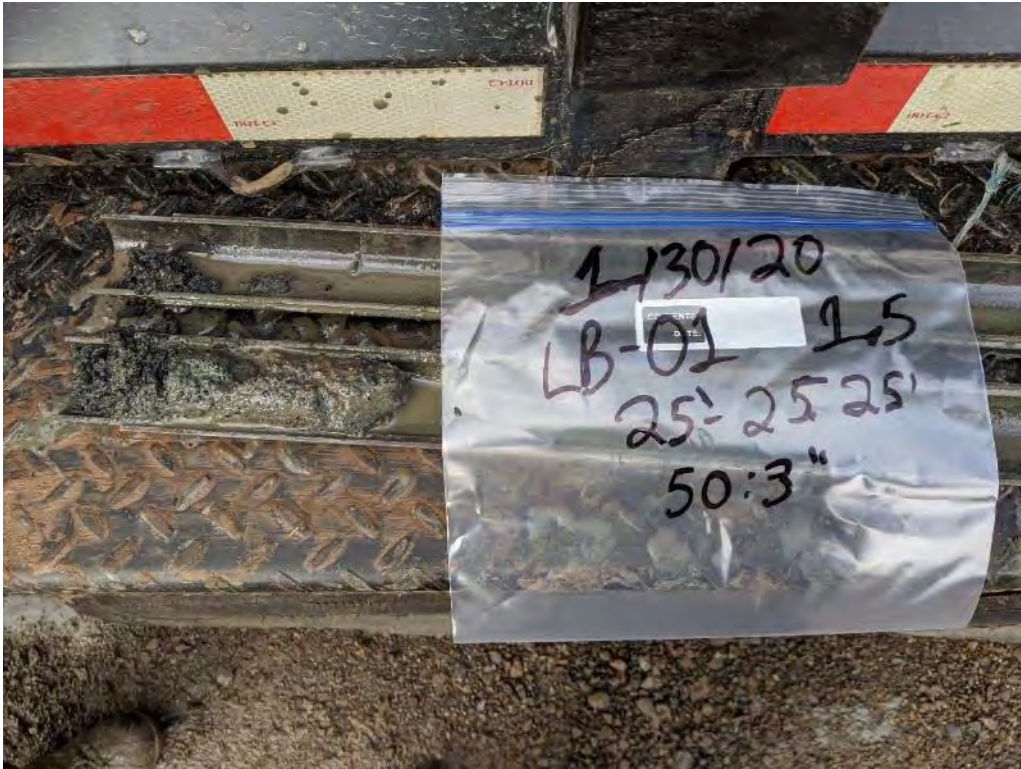
Lakeview Road Bridge Photo 5 – BH-AB01 Sample 1.5 from 25-25.25 ft bgs.
