APPENDIX F1

ROADS, BRIDGES, AND CULVERTS

DESIGN DETAILS

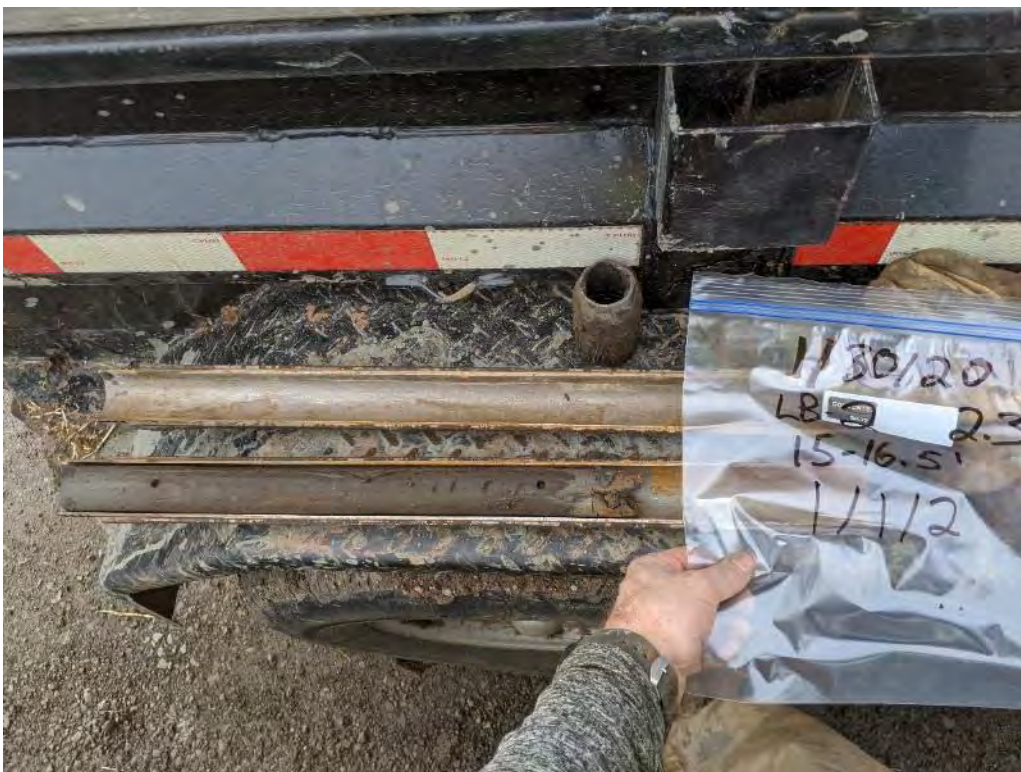
Lakeview Road Bridge Photo 6 – BH-AB02 Sample 2.3 from 15-16.5 ft bgs.

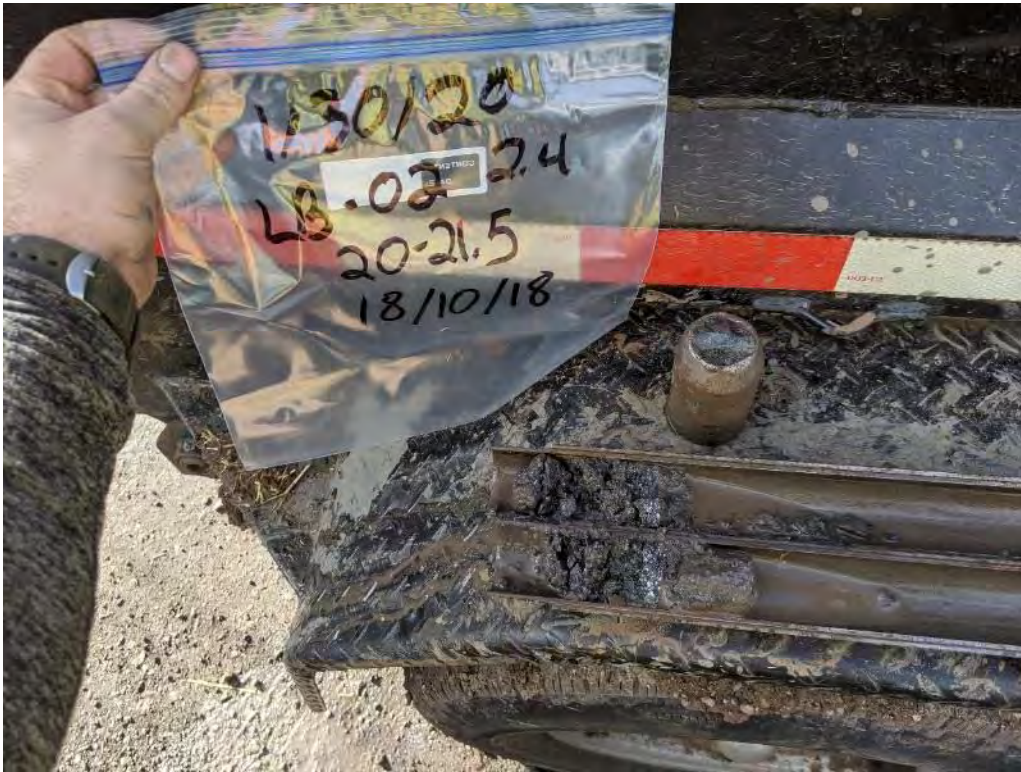
Lakeview Road Bridge Photo 7 – BH-AB2 Sample 2.4 from 20-21.5 ft bgs.

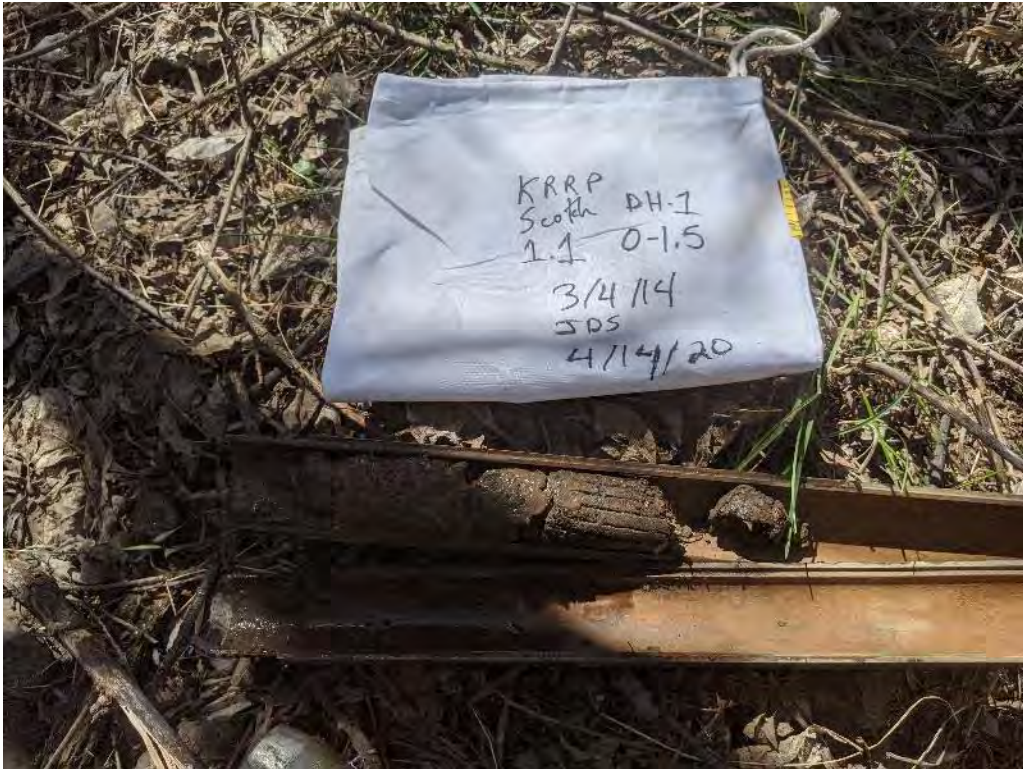
Scotch Creek Culvert Photo 1 – BH-SC01 Sample 1.1 from 0-1.5 ft bgs. #

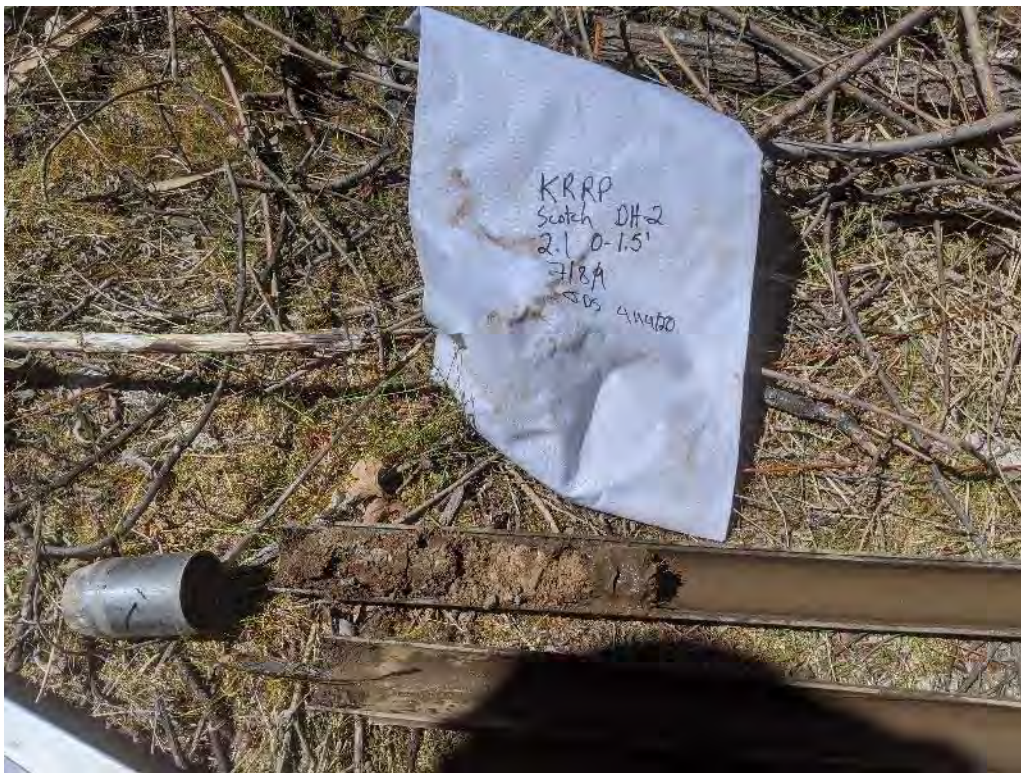
Scotch Creek Culvert Photo 2 – BH-SC02 Sample 2.1 from 0-1.5 ft bgs. #

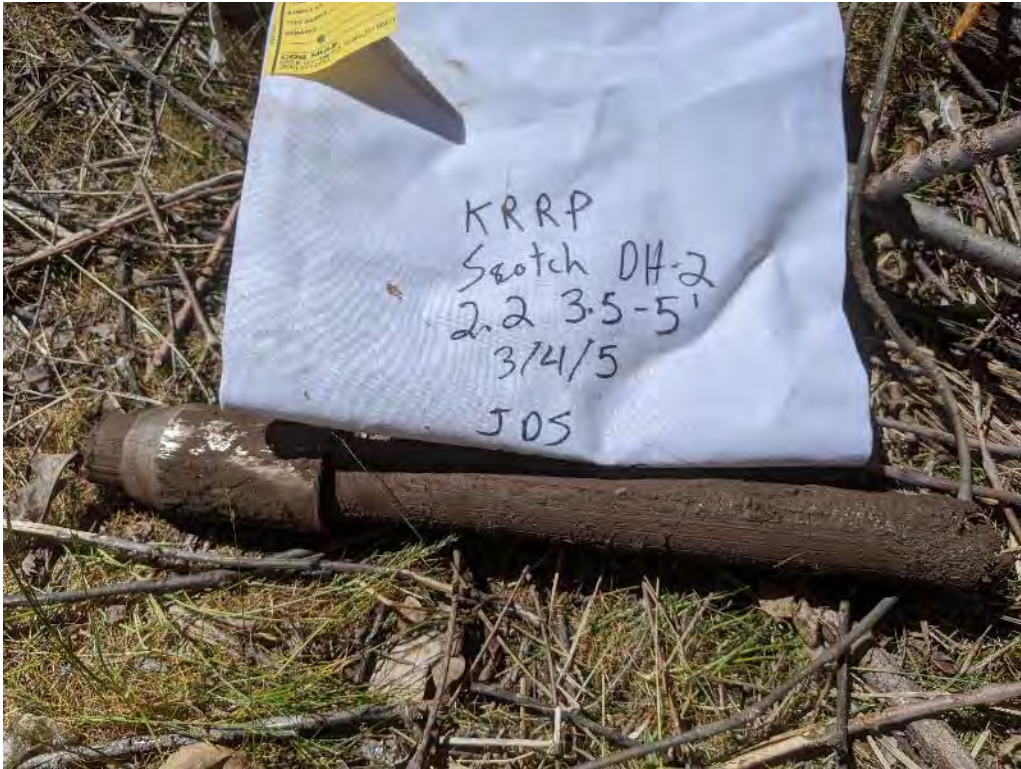
Scotch Creek Culvert Photo 3 – BH-SC02 Sample 2.2 from 3.5-5 ft bgs.

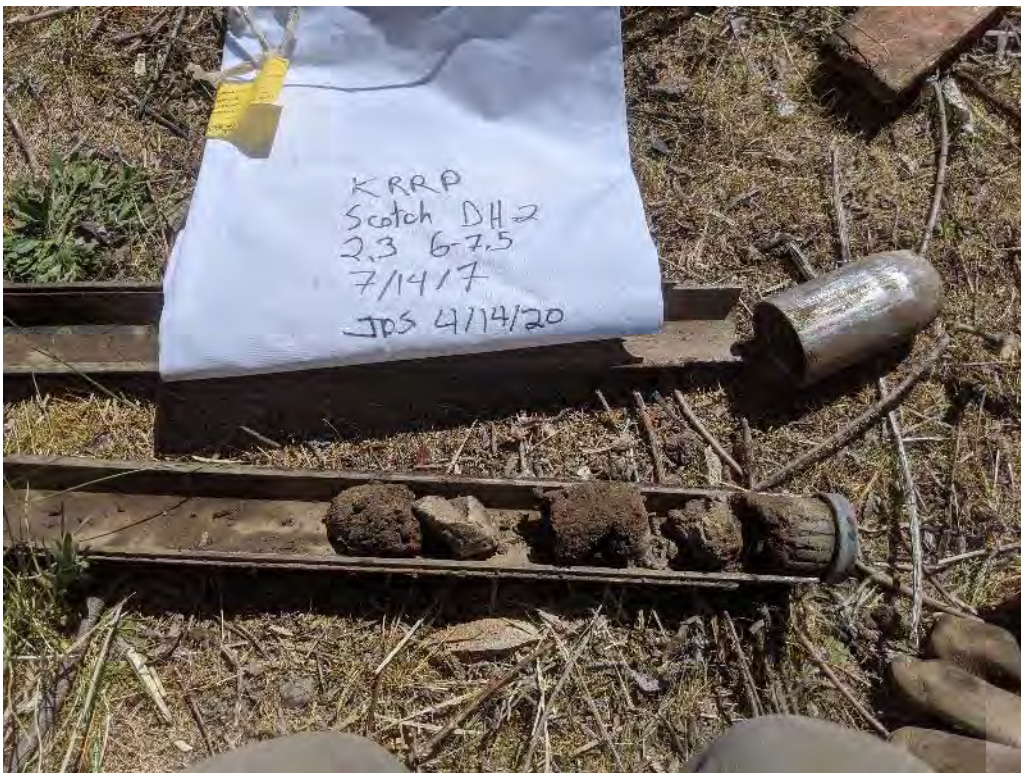
Scotch Creek Culvert Photo 4 – BH-SC02 Sample 2.3 from 6-7.5 ft bgs.

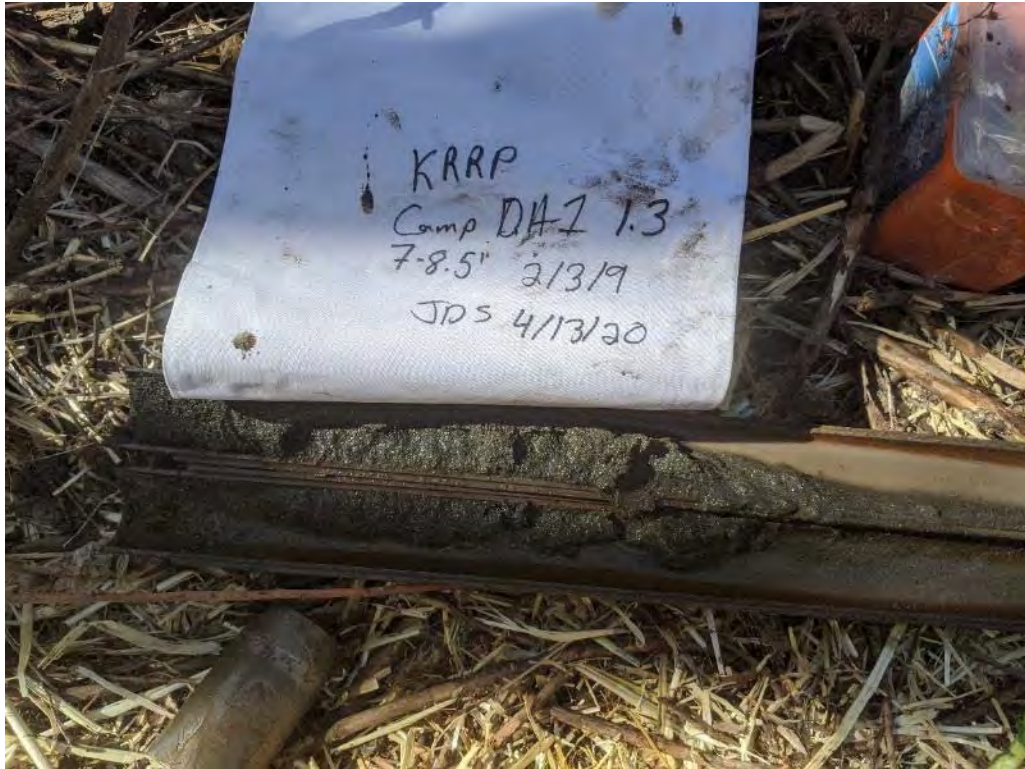
Camp Creek Culvert Photo 1 – BH-CC01 Sample 1.3 from 7-8.5 ft bgs. #

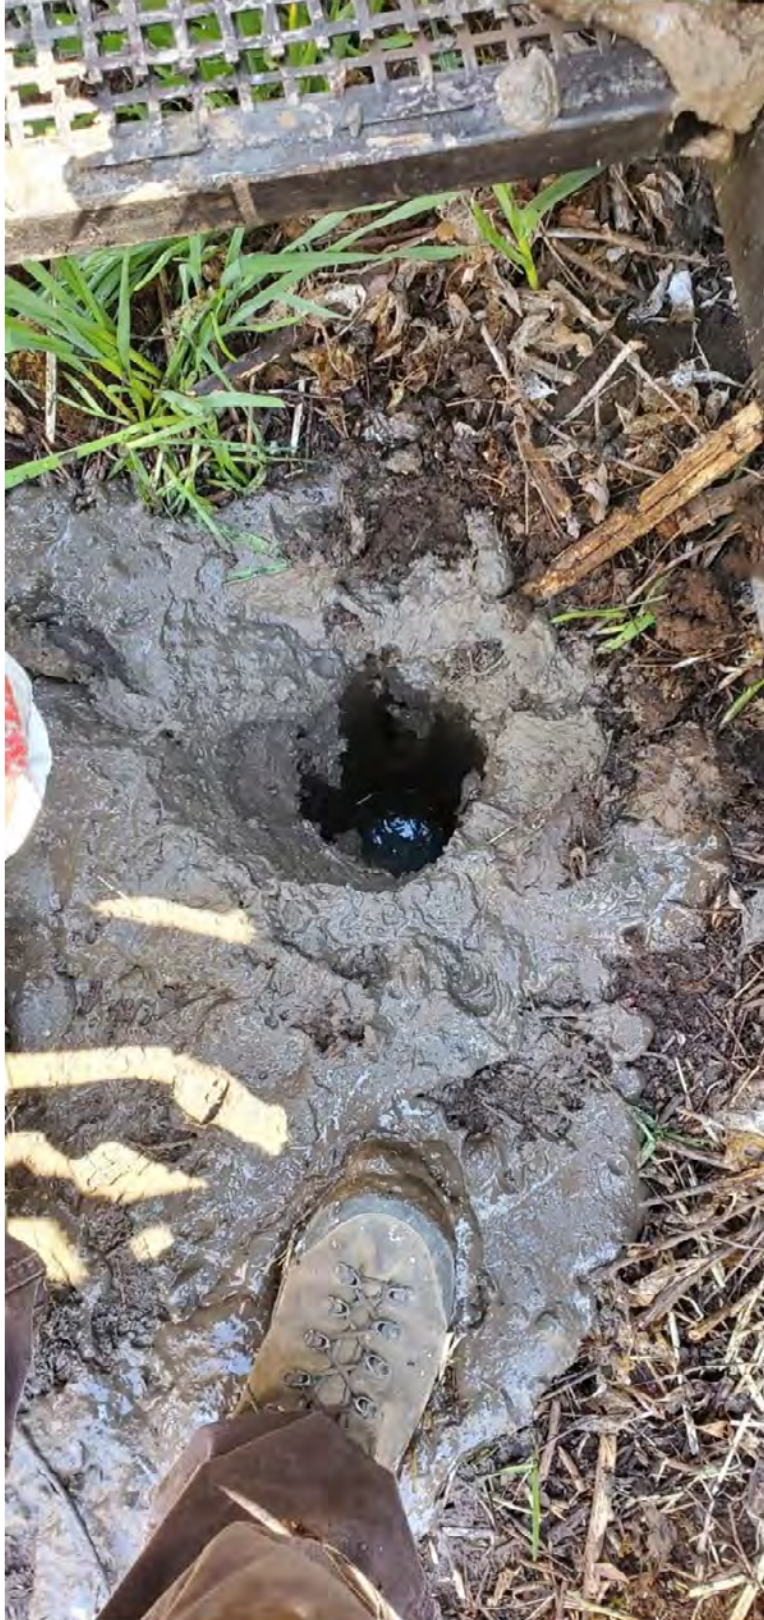
sediment deposited in Camp Creek delta on top of the original stream channel (Figure 4). The upper layer of alluvial material is loose and liquefiable given that during drilling sand flowed up into the auger. Groundwater was encountered in both boreholes between 3' and 4' bgs. The groundwater was perched above the stream with the surface water in the stream 2' to 3' lower than the water level measured in the boreholes.

Camp Creek Culvert Photo 3 – BH-CC01 immediately after drilling completion, ground water present in borehole.

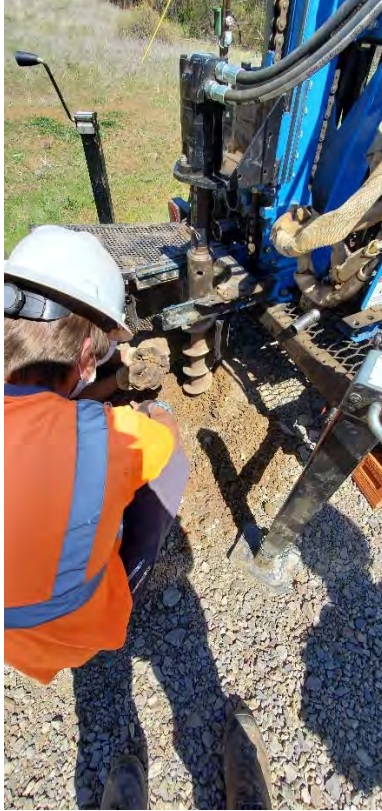
Fall Creek at Daggett Road Photo 3 – BH-DG04 bulk sample at 5 ft bgs. #

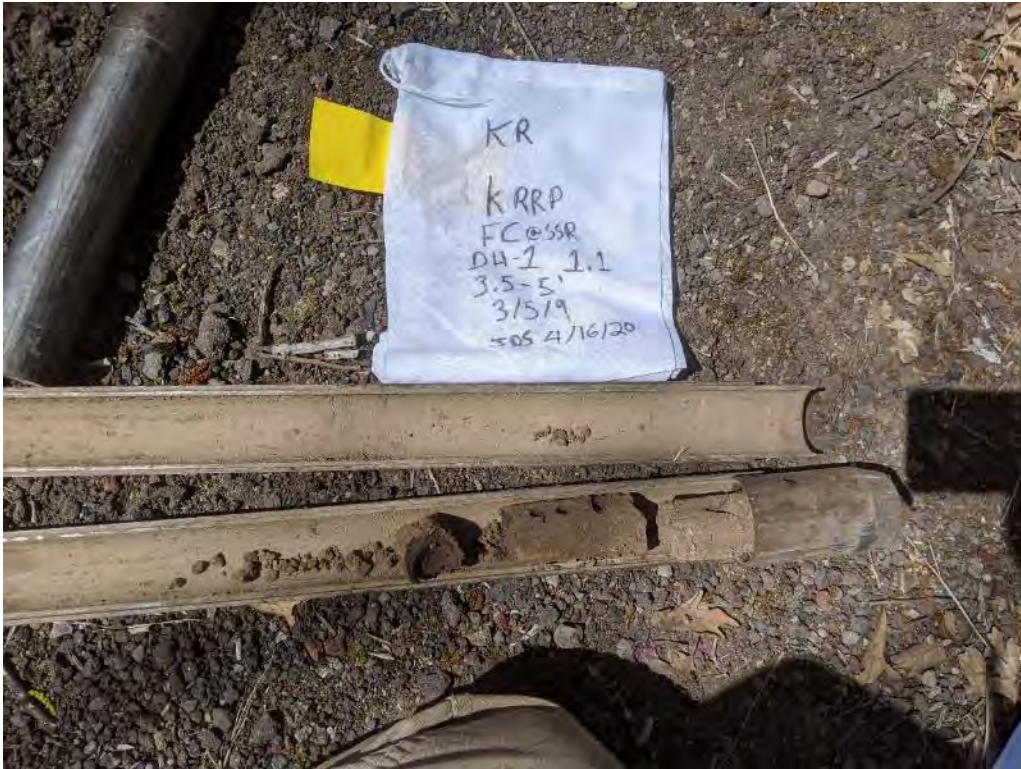
Fall Creek at Substation Road Photo 1 – BH-DG02 Sample 1.1 from 3.5-5 ft bgs. #

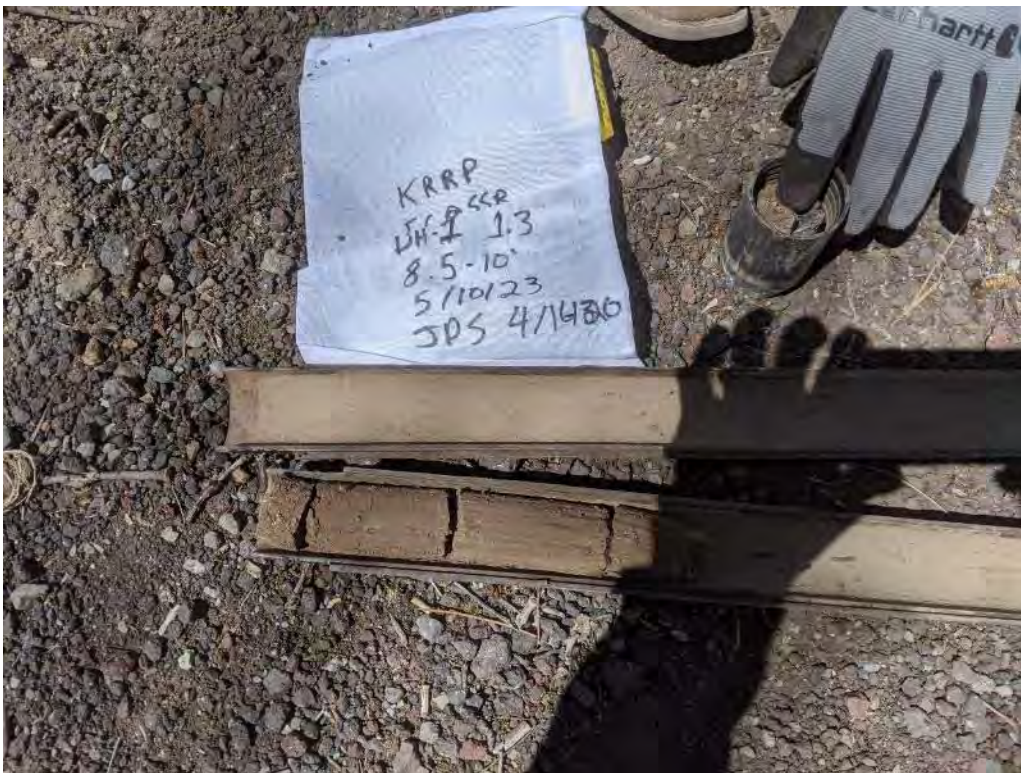
Fall Creek at Substation Road Photo 2 – BH-DG02 Sample 1.3 from 8.5-10 ft bgs.

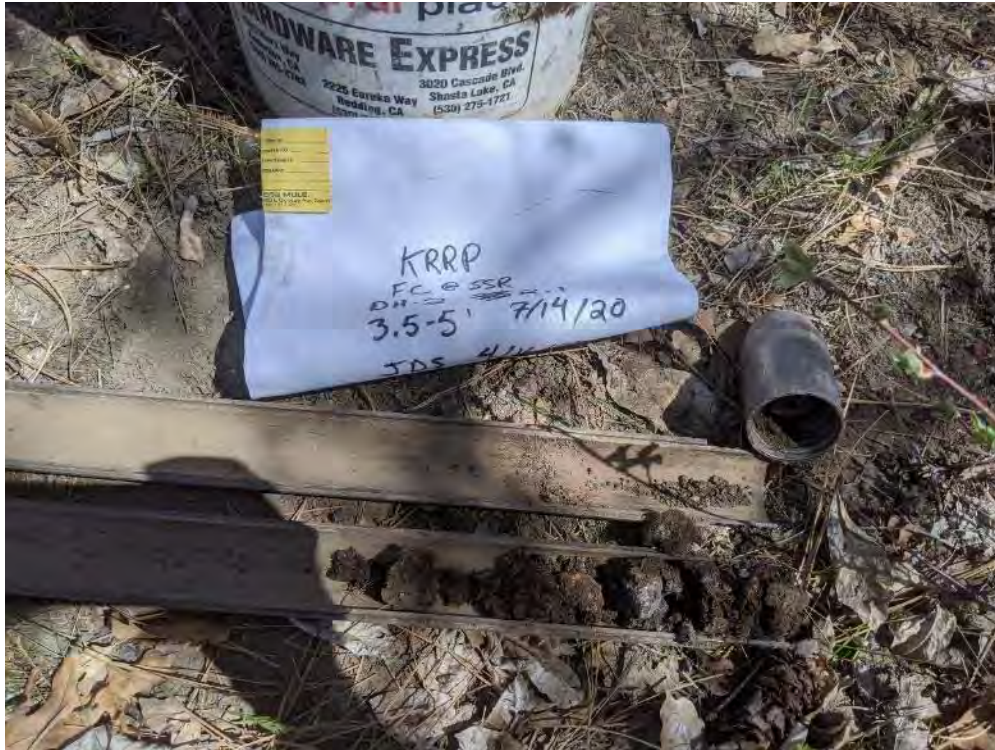
Fall Creek at Substation Road Photo 3 – BH-DG01 Sample 2.1 from 3.5-5 ft bgs.
