APPENDIX G4

Test Pit Photographs

ROCK SLOPE HAZARDS

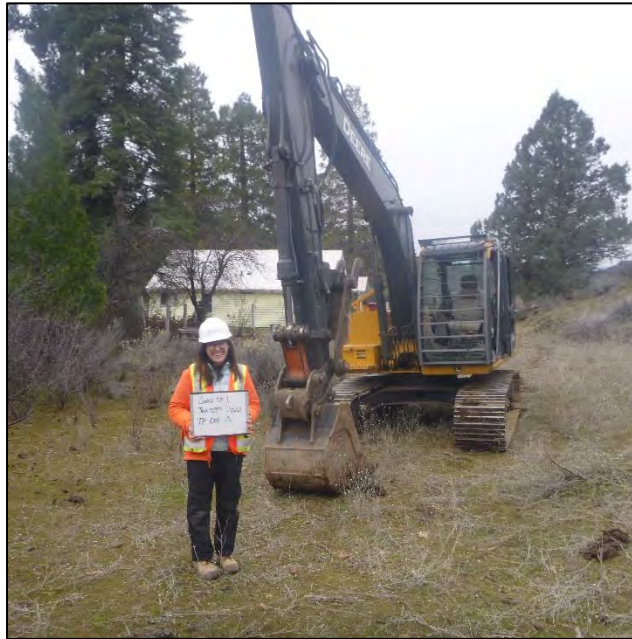
PHOTO 1 – TP-CO1-A site pre-excavation

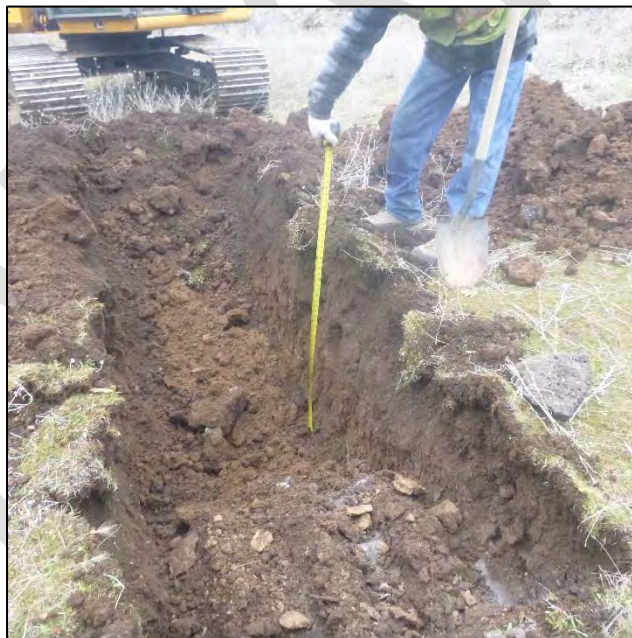
PHOTO 2 – TP-CO1-A pit excavated to depth 3.8 ft

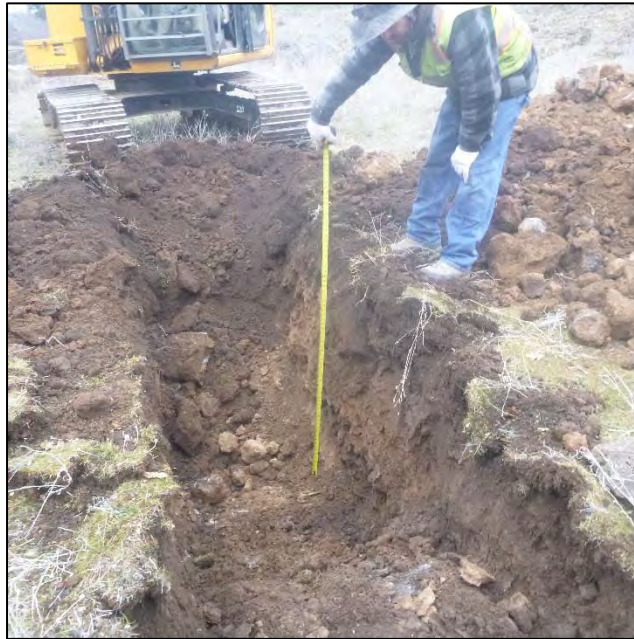
PHOTO 3 – TP-CO1-A pit excavated to depth 4.3 ft

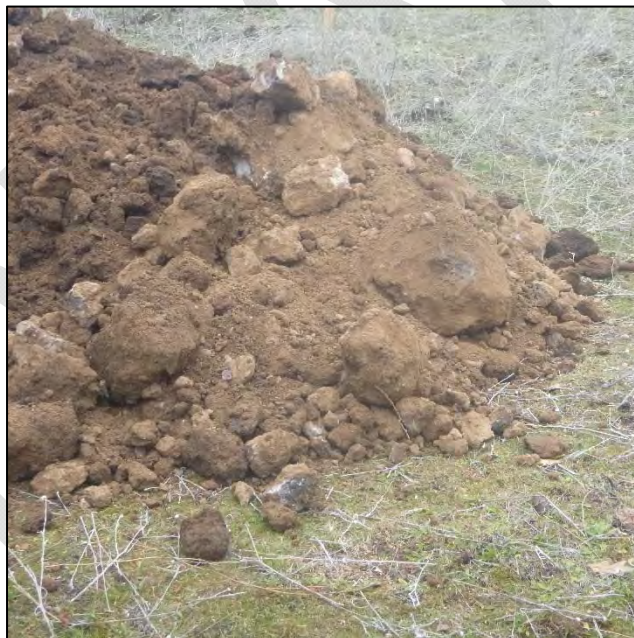
PHOTO 4 – TP-CO1-A spoils from excavation to depth 4.3 ft

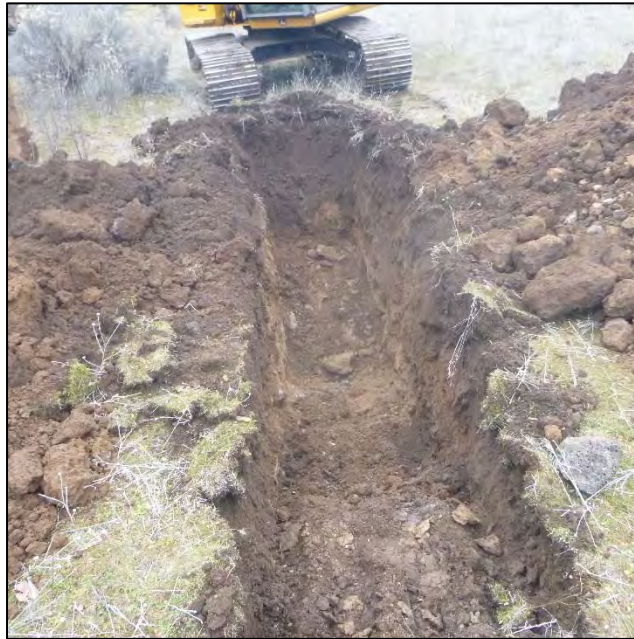
PHOTO 5 – TP-CO1-A pit excavated to final depth 6.1 ft

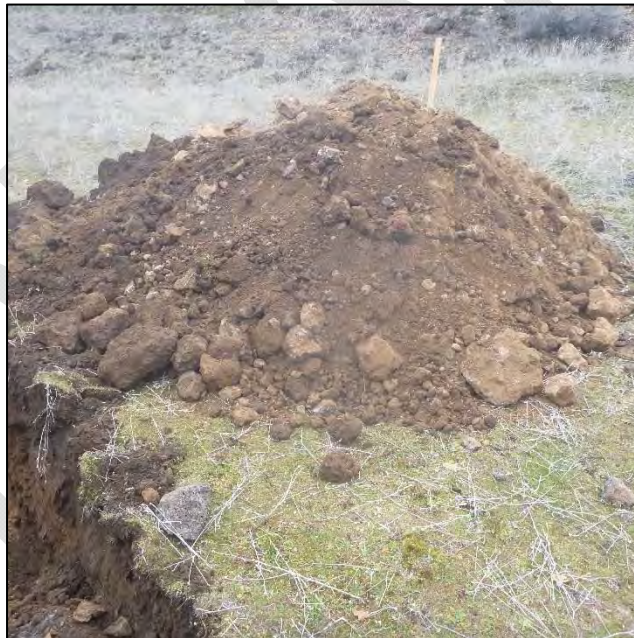
PHOTO 6 – TP-CO1-A spoils from excavation

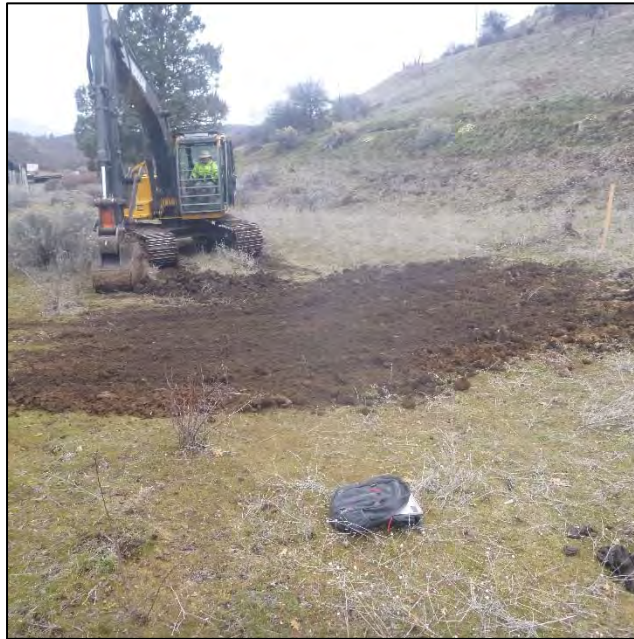
PHOTO 7 – TP-CO1-A site post-excitation

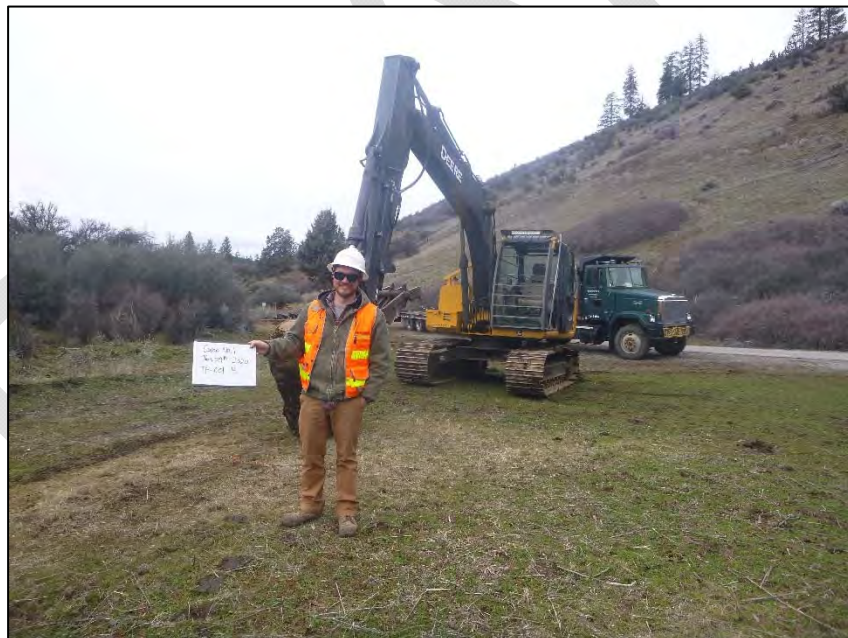
PHOTO 8 – TP-CO1-B site pre-excitation

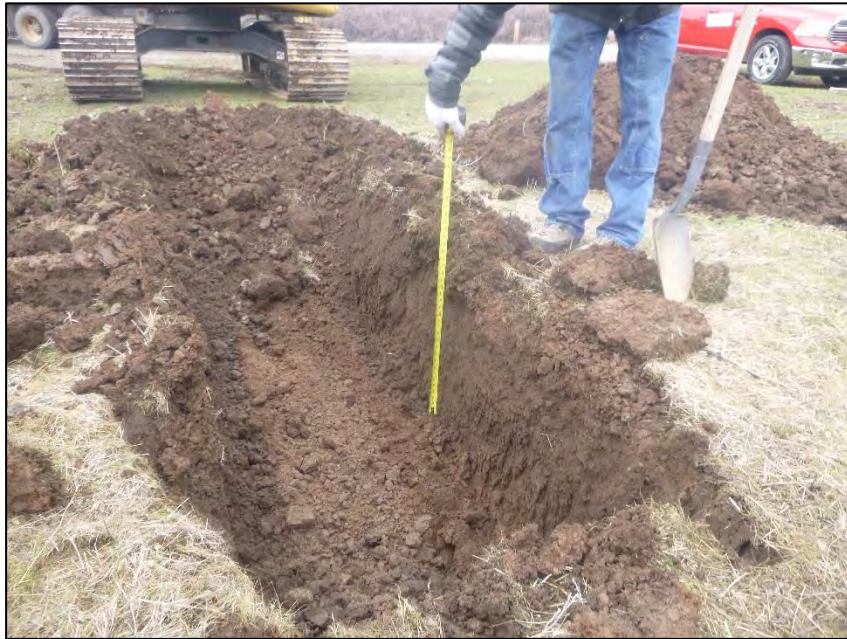
PHOTO 9 – TP-CO1-B excavated to depth 2.0 ft

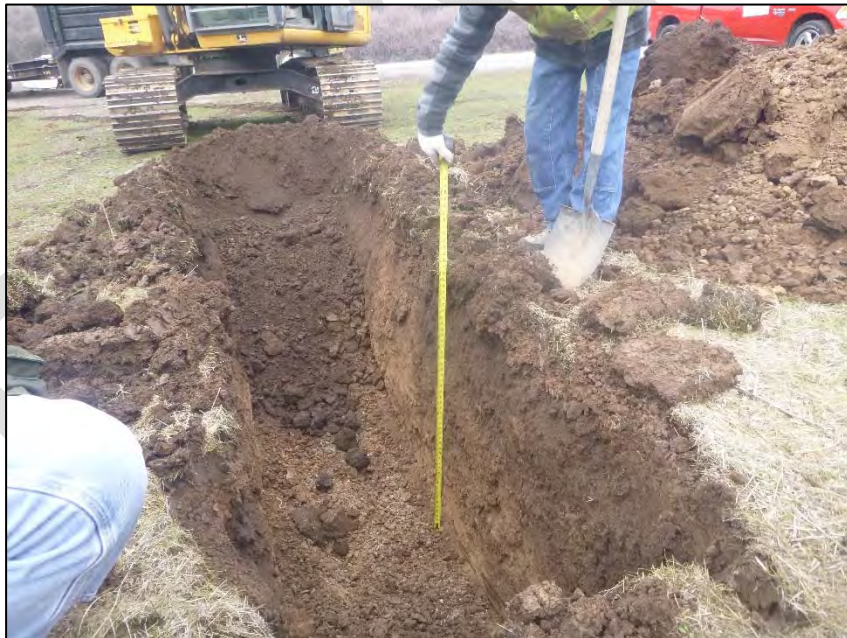
PHOTO 10 – TP-CO1-B excavated to depth 4.0 ft

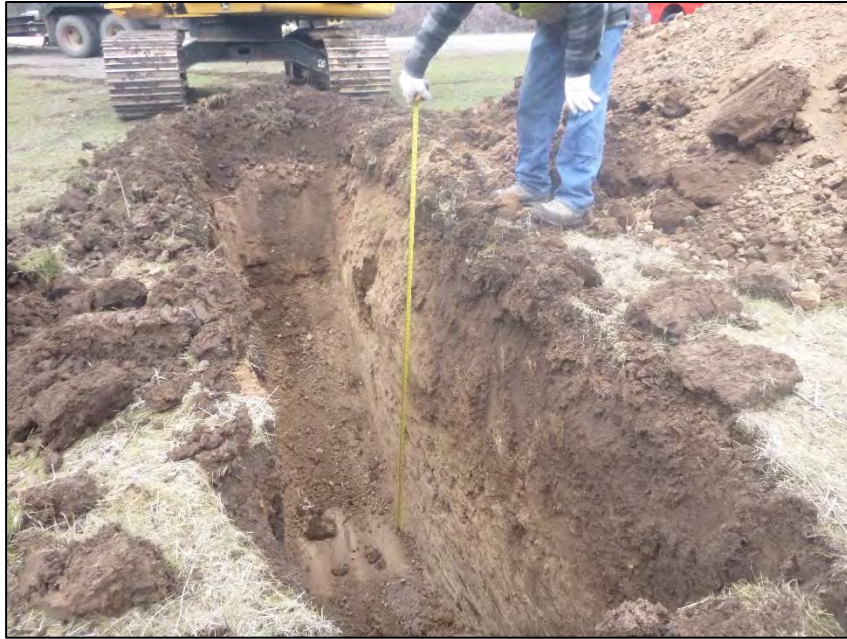
PHOTO 11 – TP-CO1-B excavated to depth 6.9 ft

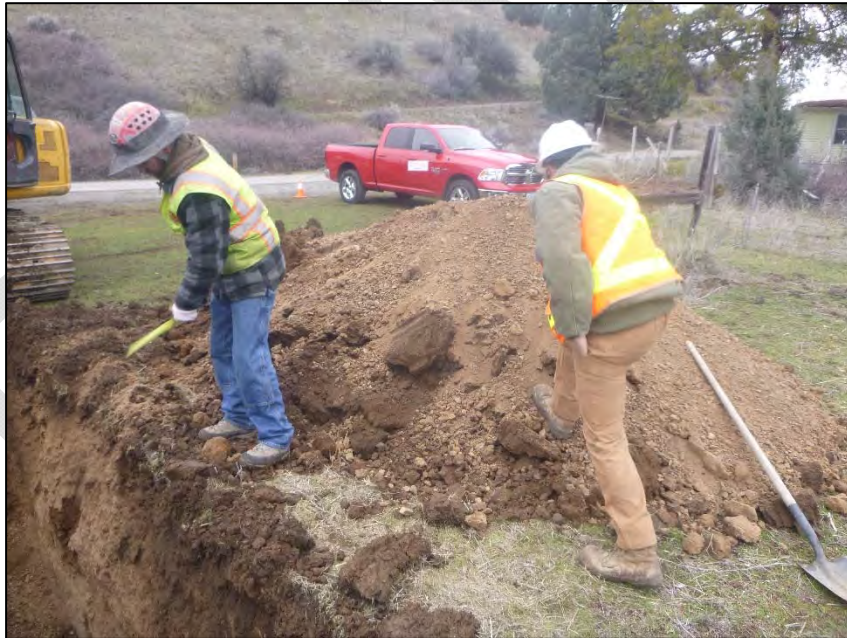
PHOTO 12 – TP-CO1-B spoils from excavation to depth 6.9 ft

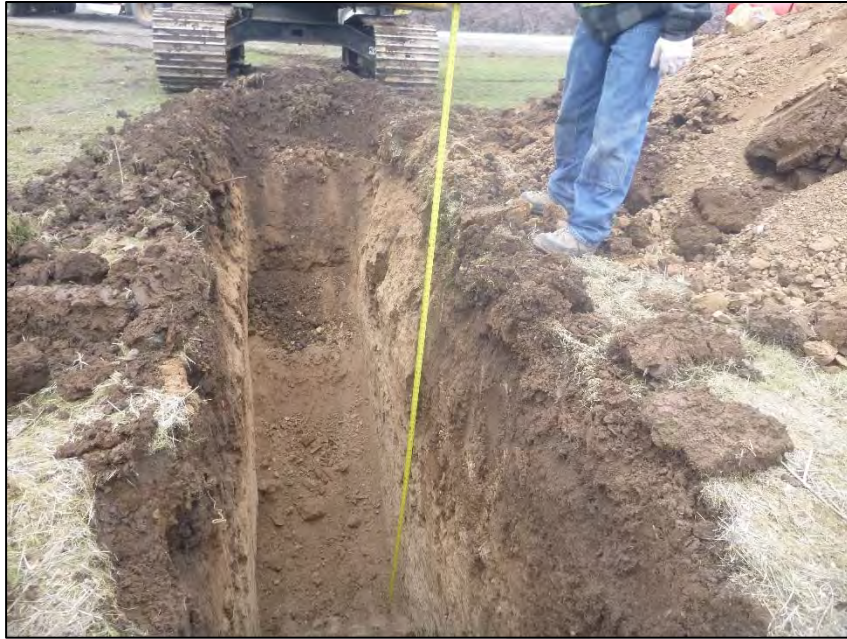
PHOTO 13 – TP-CO1-B pit excavated to final depth 7.7 ft

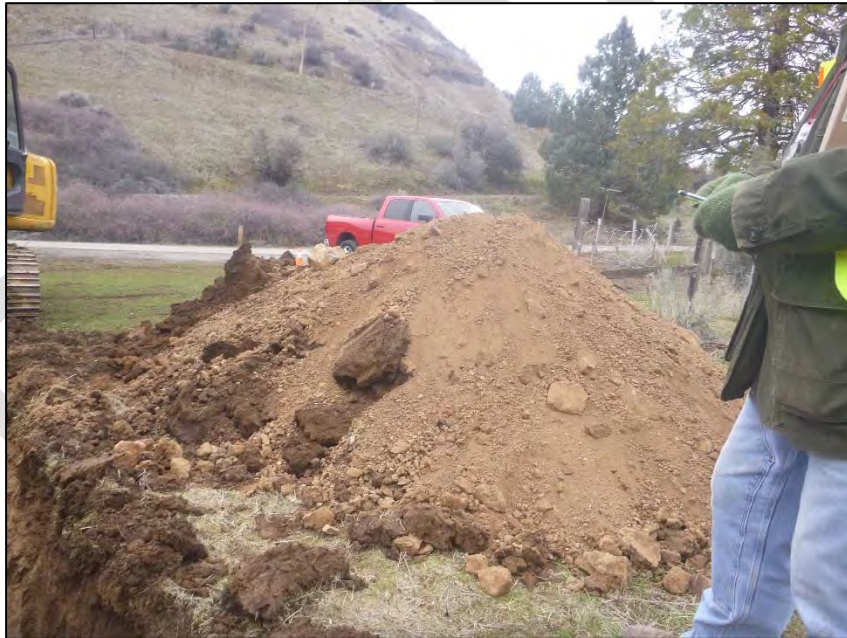
PHOTO 14 – TP-CO1-B spoils from excavation

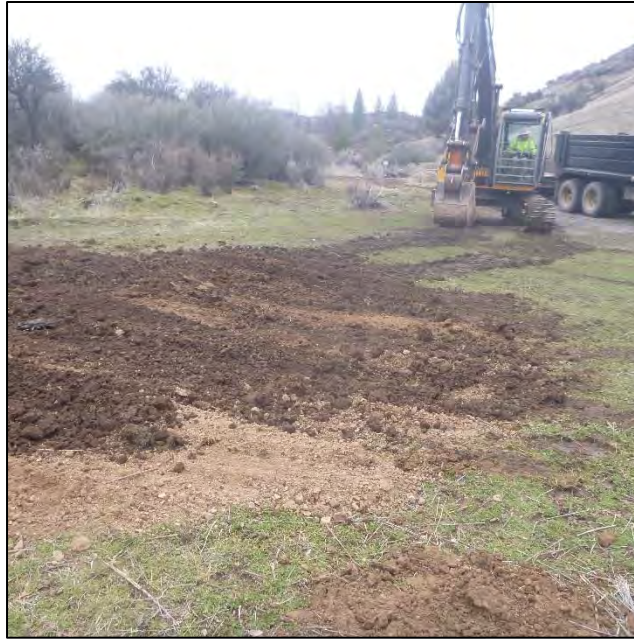
PHOTO 15 – TP-CO1-B site post-excitation

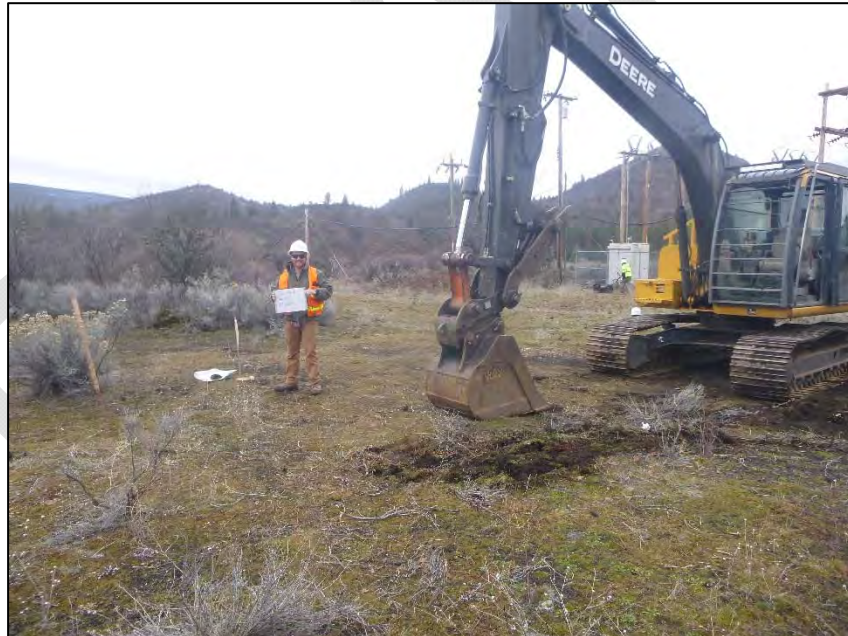
PHOTO 16 – TP-CO1-C site pre-excitation

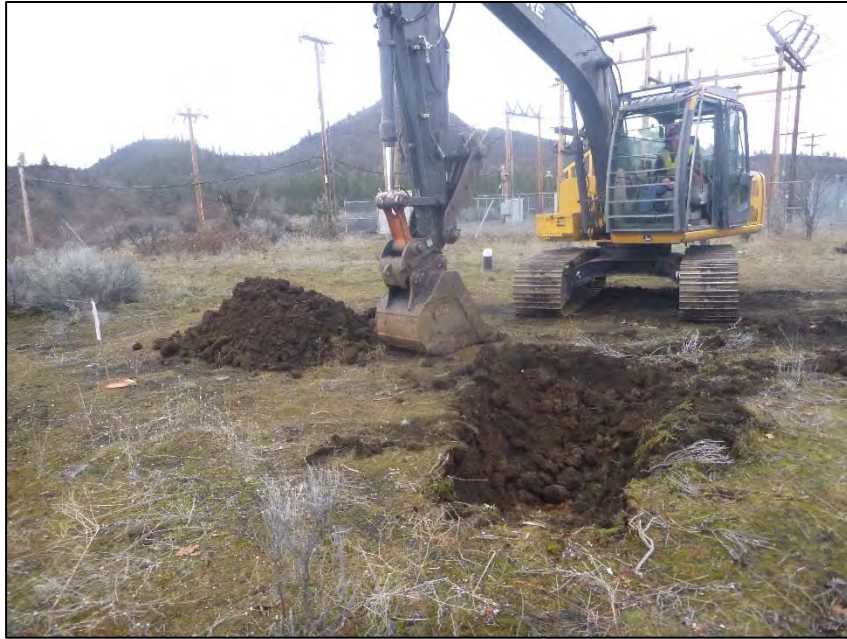
PHOTO 17 – TP-CO1-C pit excavated to depth 2.3 ft

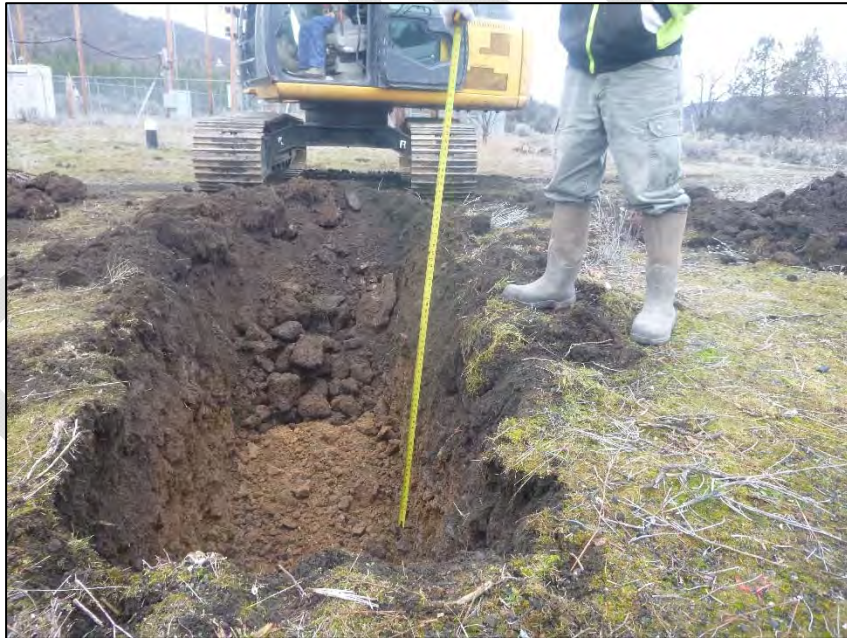
PHOTO 18 – TP-CO1-C pit excavated to depth 3.3 ft

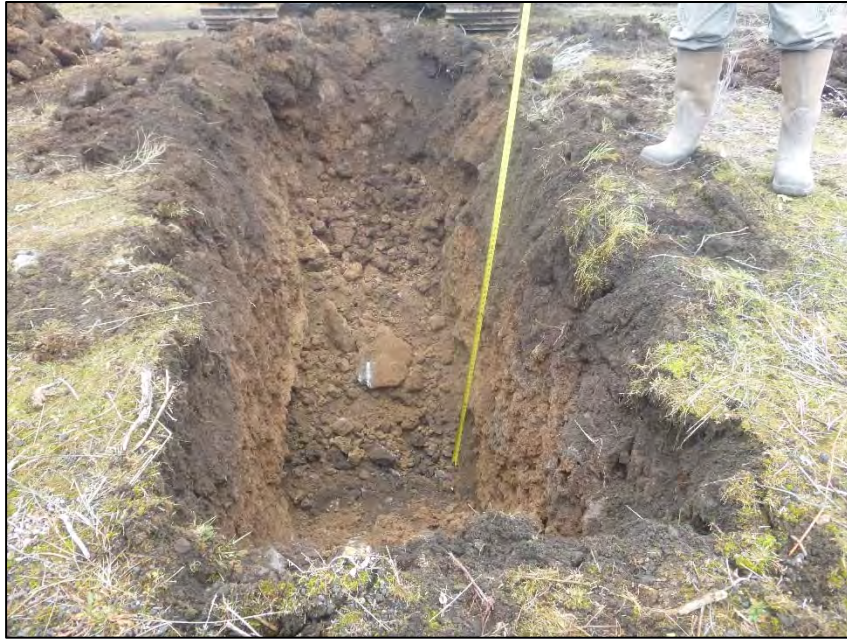
PHOTO 19 – TP-CO1-C pit excavated to depth 5.3 ft

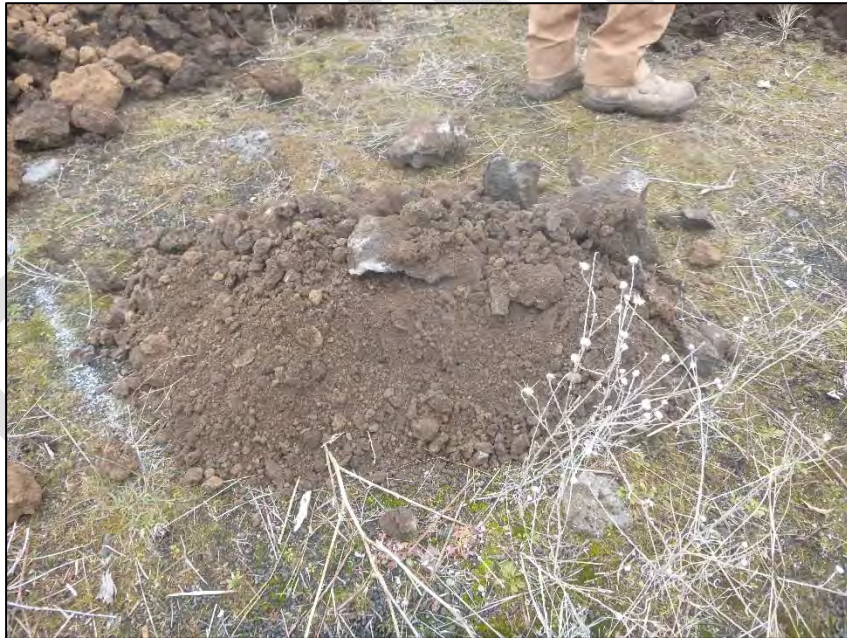
PHOTO 20 – TP-CO1-C spoils from excavation to depth 5.3 ft

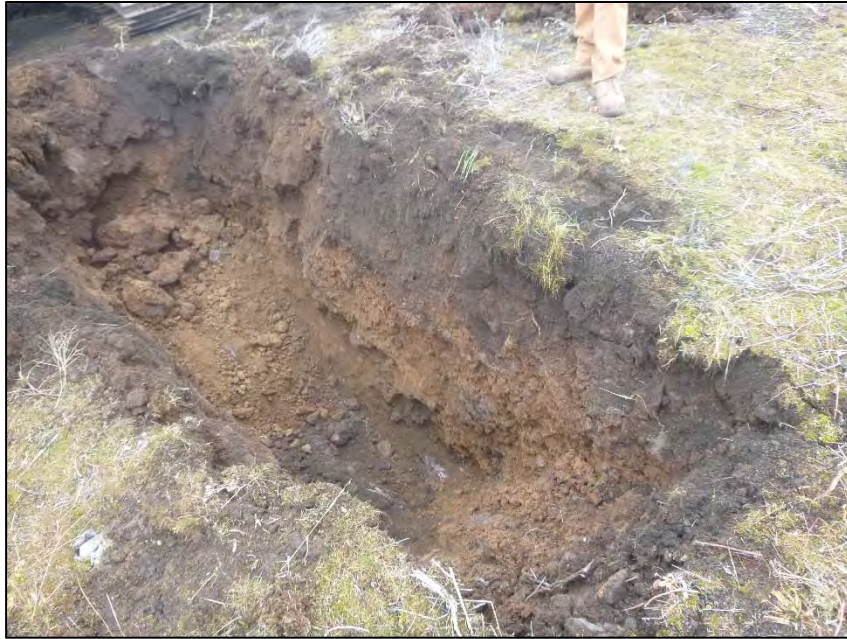
PHOTO 21 – TP-CO1-C pit excavated to final depth 5.5 ft

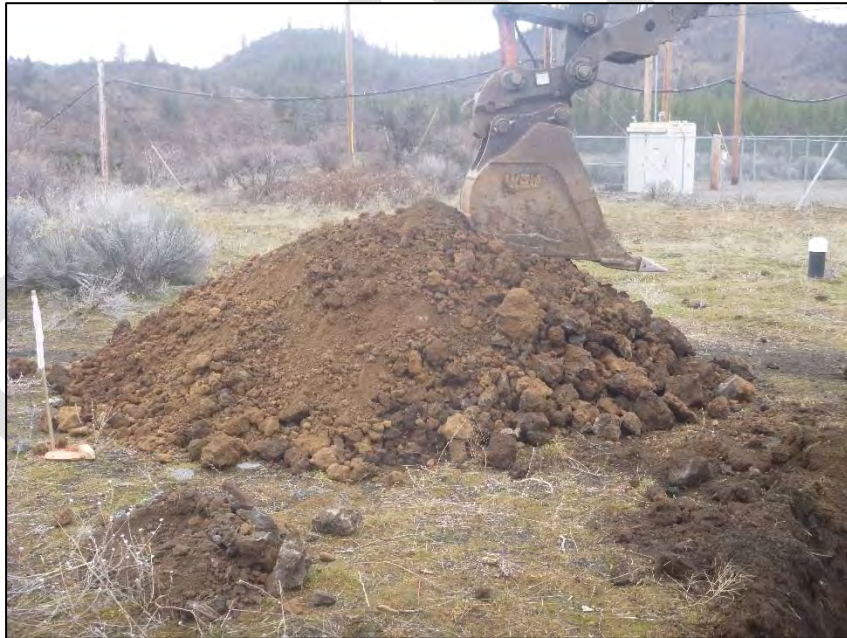
PHOTO 22 – TP-CO1-C spoils from excavation

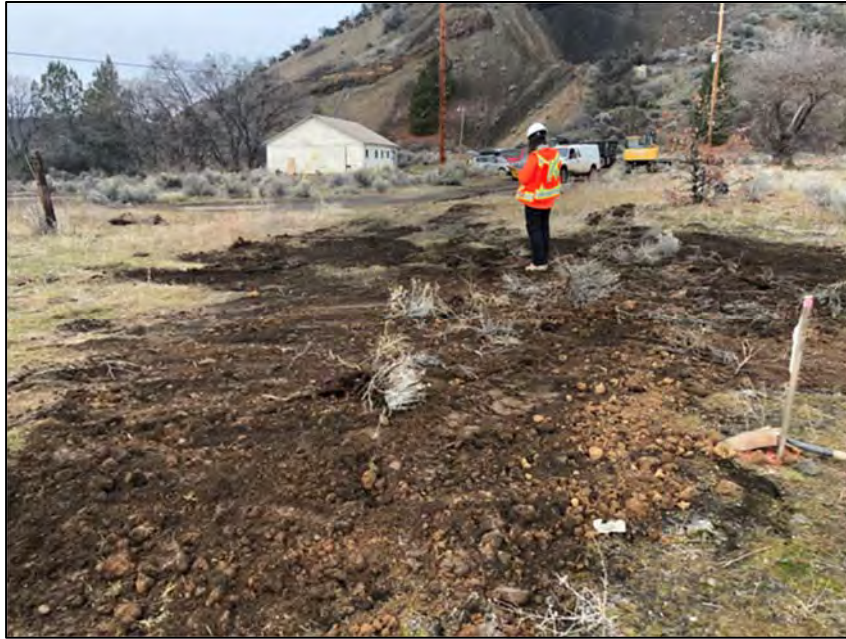
PHOTO 23 – TP-CO1-C site post-excavation

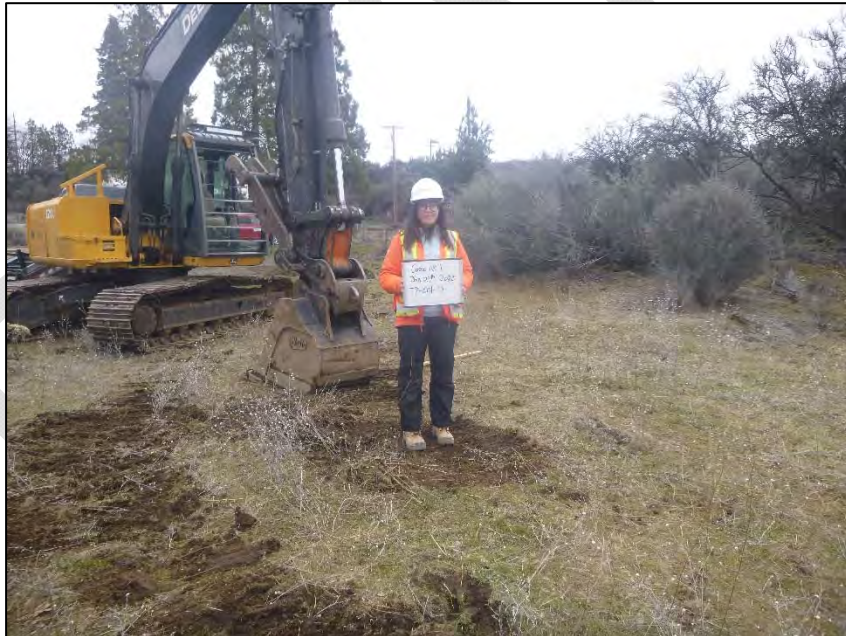
PHOTO 24 – TP-CO1-D site pre-excavation

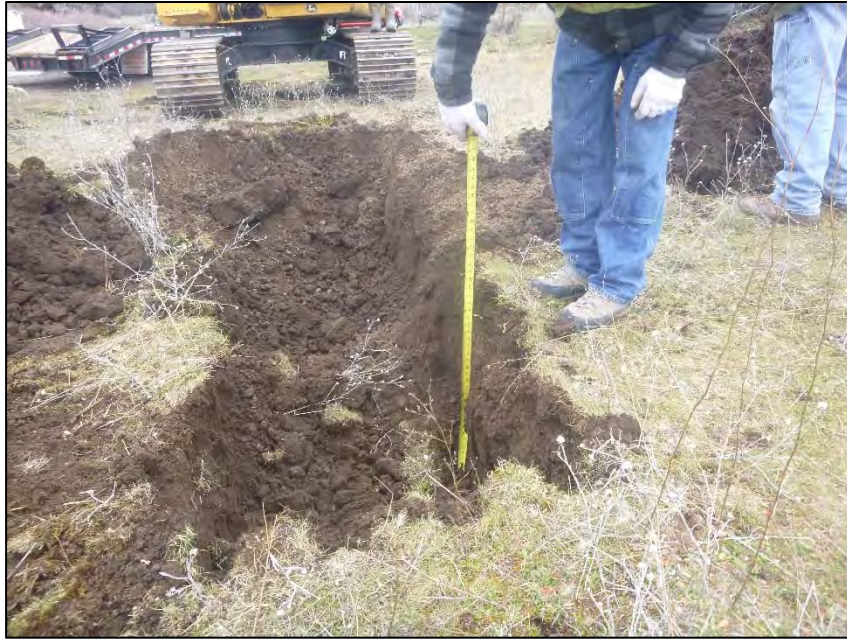
PHOTO 25 – TP-CO1-D pit excavated to depth 2.0 ft

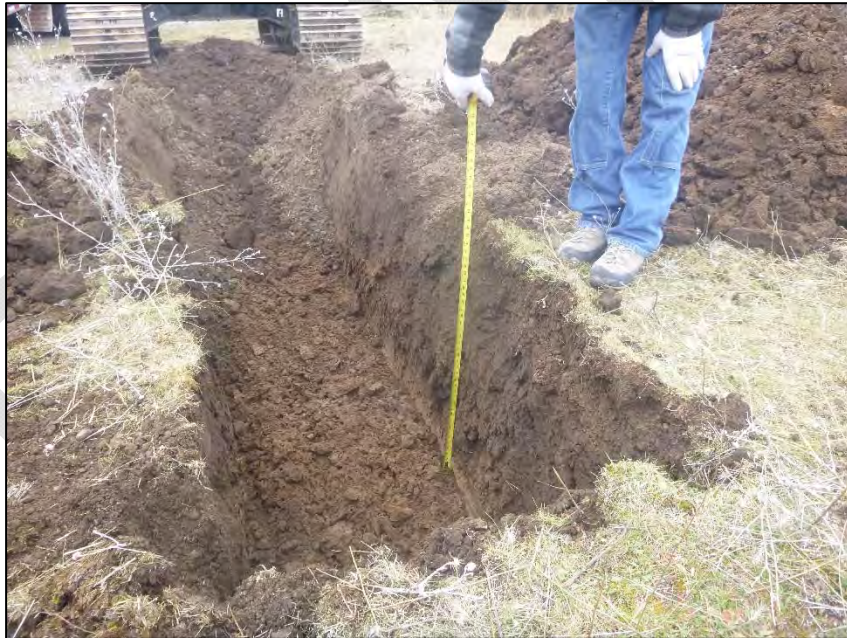
PHOTO 26 – TP-CO1-D pit excavated to depth 3.1 ft

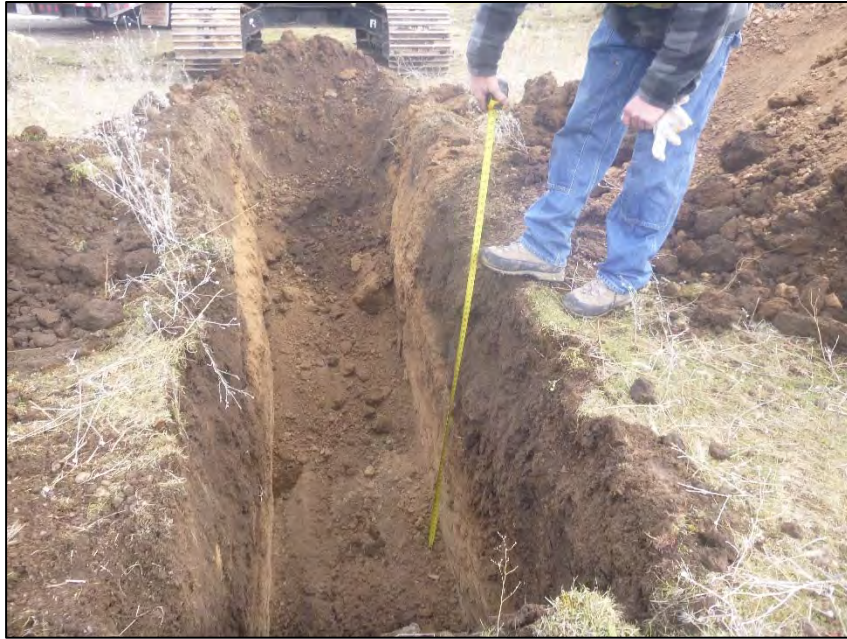
PHOTO 27 – TP-CO1-D pit excavated to depth 4.8 ft

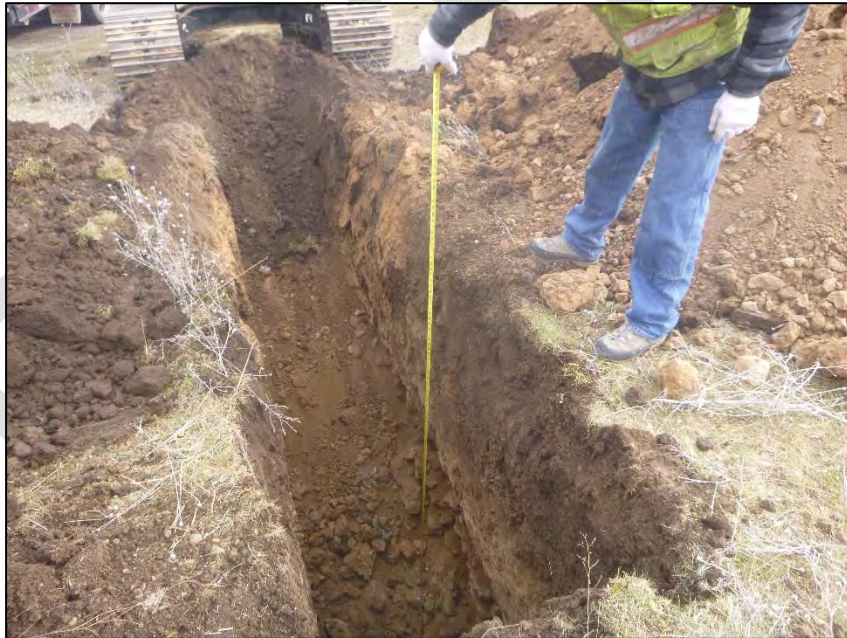
PHOTO 28 – TP-CO1-D pit excavated to depth 8.2 ft

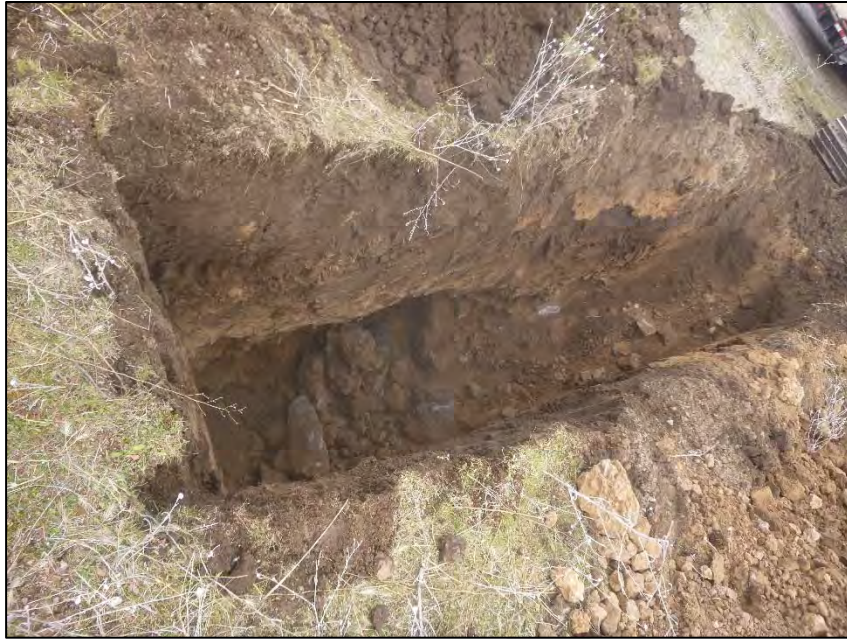
PHOTO 29 – TP-CO1-D pit excavated to final depth approximately 8.8 ft

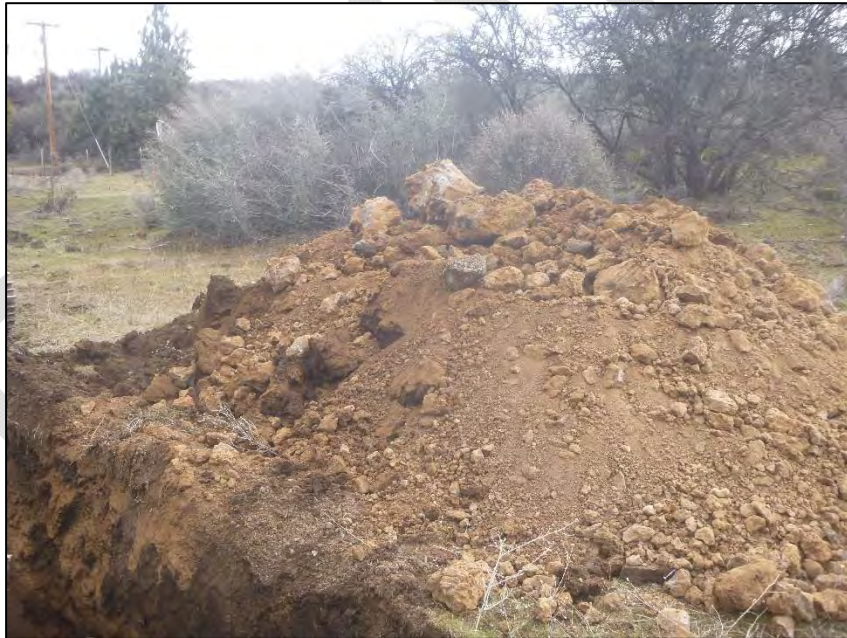
PHOTO 30 – TP-CO1-D spoils from excavation

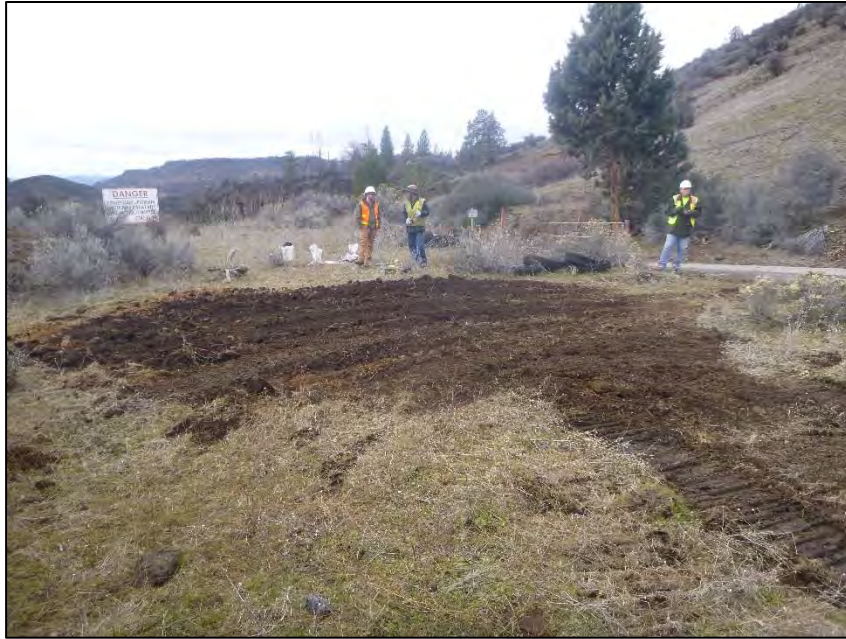
PHOTO 31 – TP-CO1-D site post-excitation

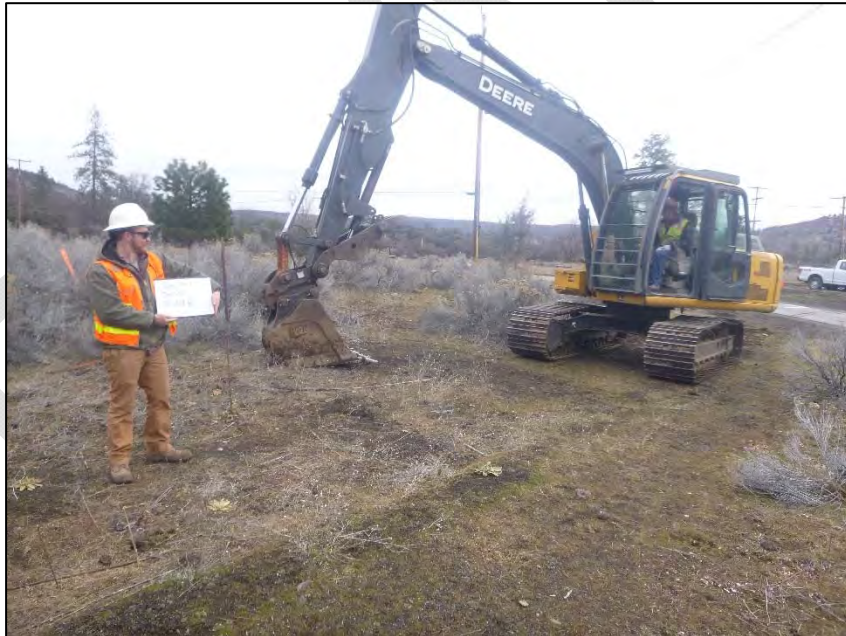
PHOTO 32 – TP-CO1-E site pre-excitation

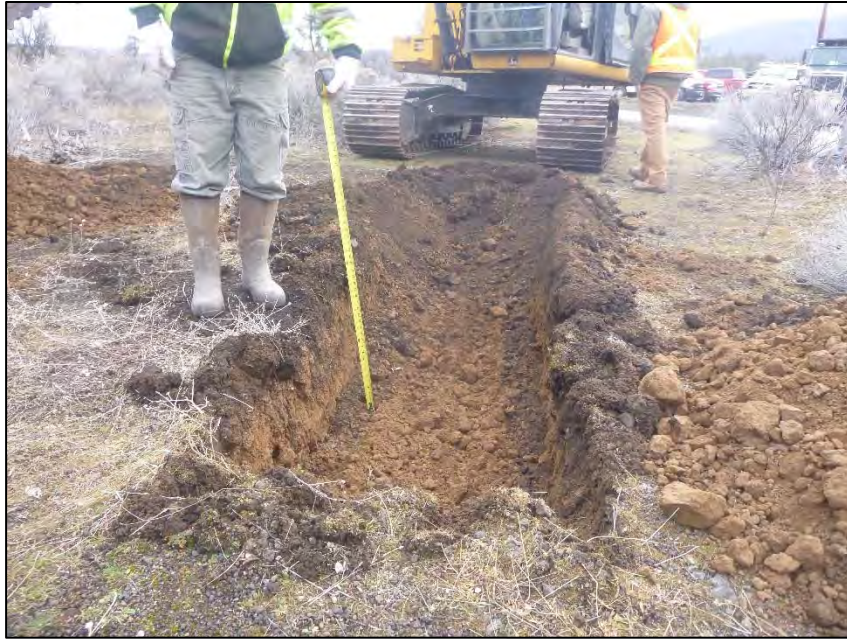
PHOTO 33 – TP-CO1-E pit excavated to depth 1.4 ft

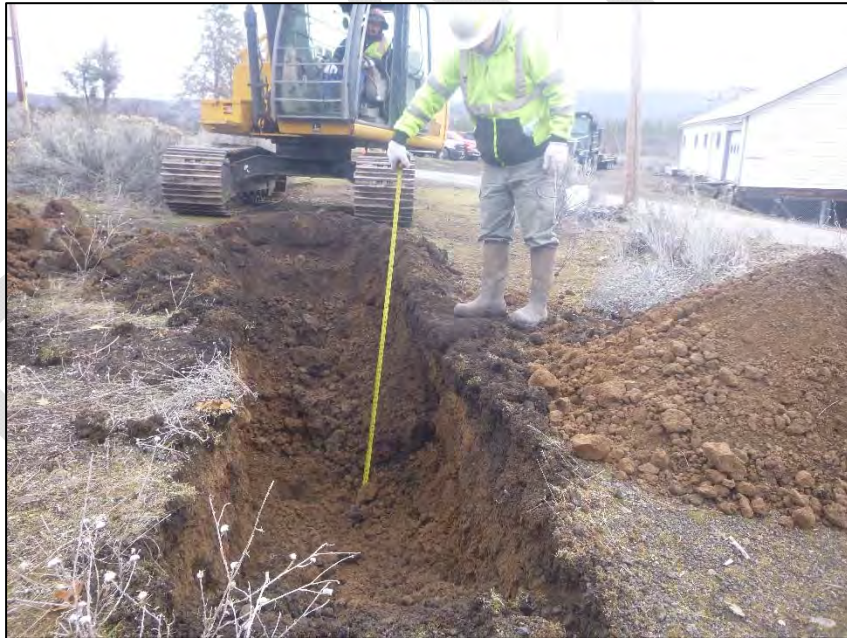
PHOTO 34 – TP-CO1-E pit excavated to depth 3.4 ft

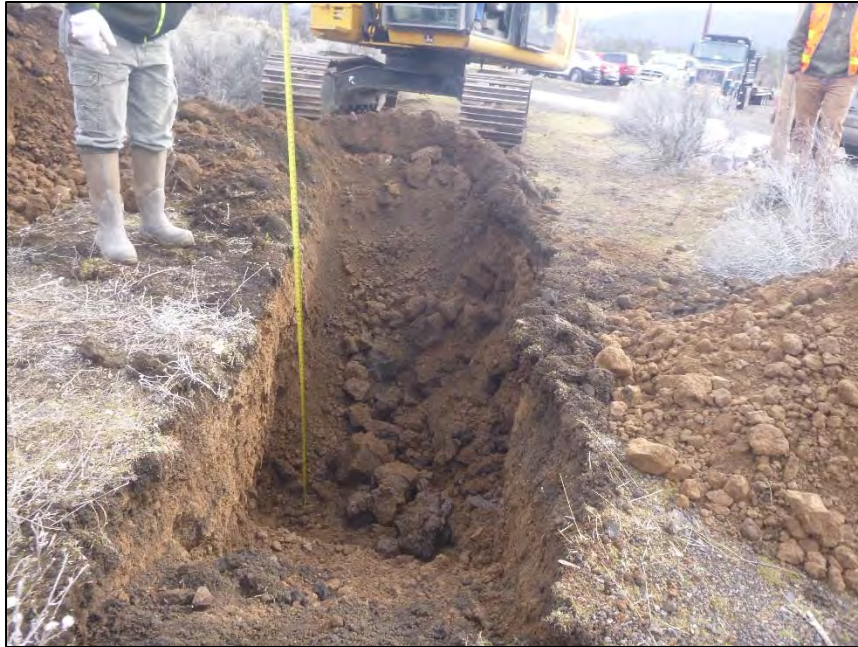
PHOTO 35 – TP-CO1-E pit excavated to depth 4.5 ft

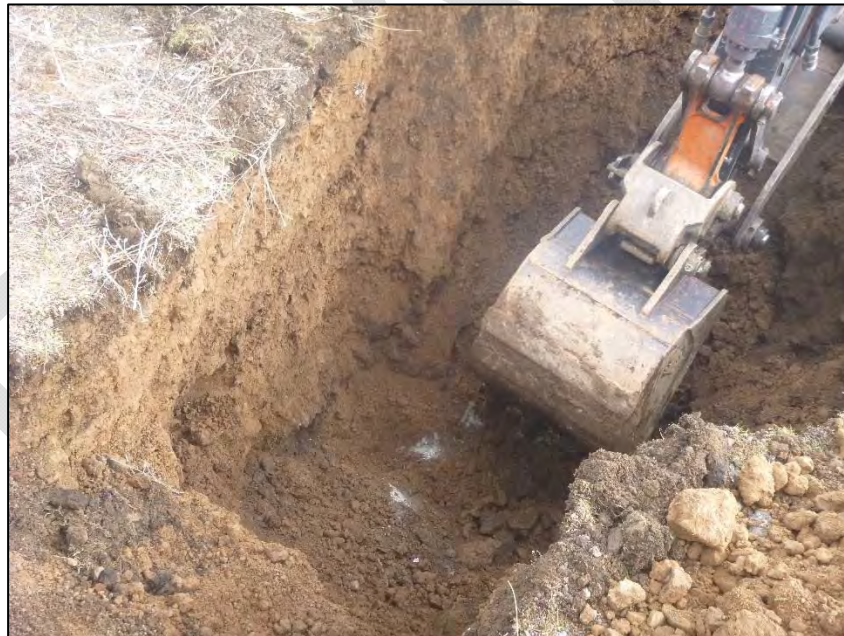
PHOTO 36 – TP-CO1-E pit excavated to final depth 8.0 ft

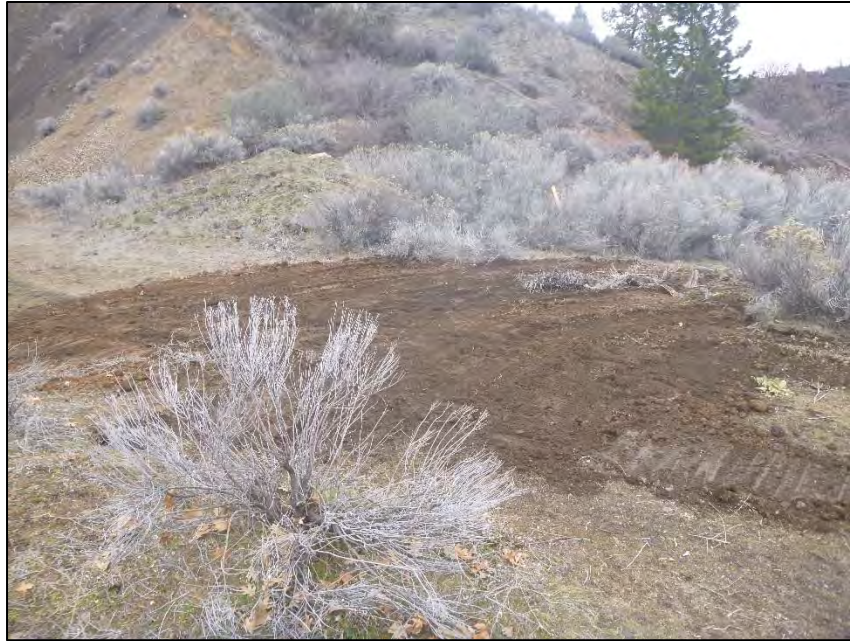
PHOTO 37 – TP-CO1-E site post-excitation

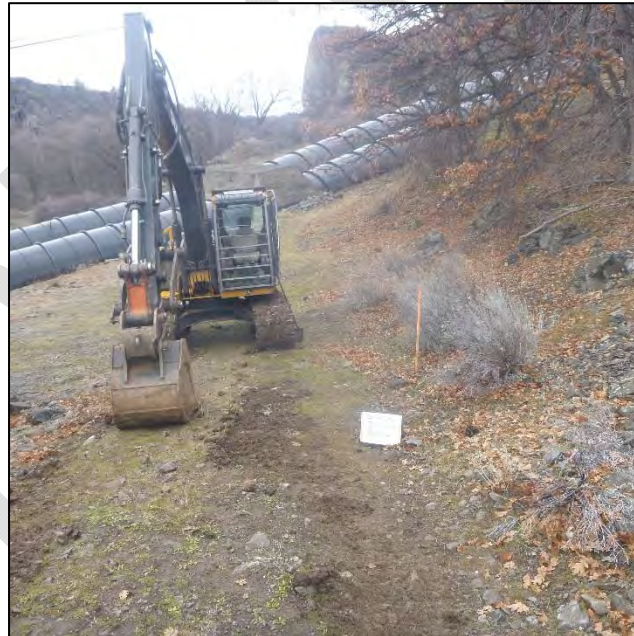
PHOTO 38 – TP-CO2-A site pre-excitation

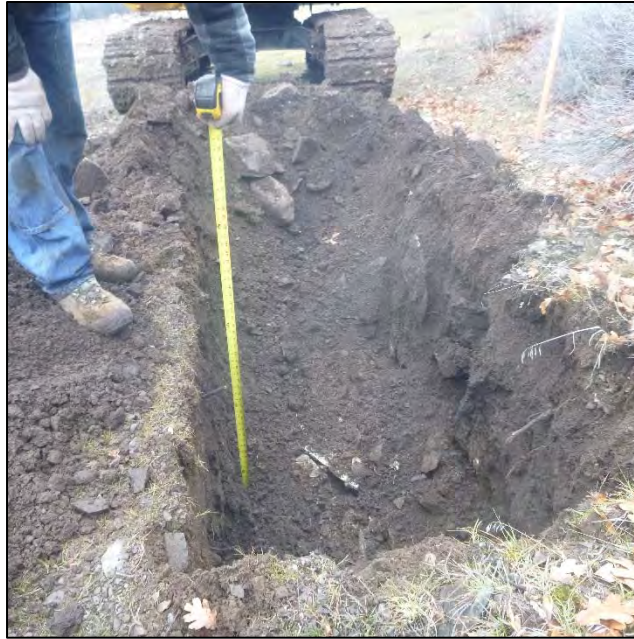
PHOTO 39 – TP-CO2-A pit excavated to depth 3.0 ft

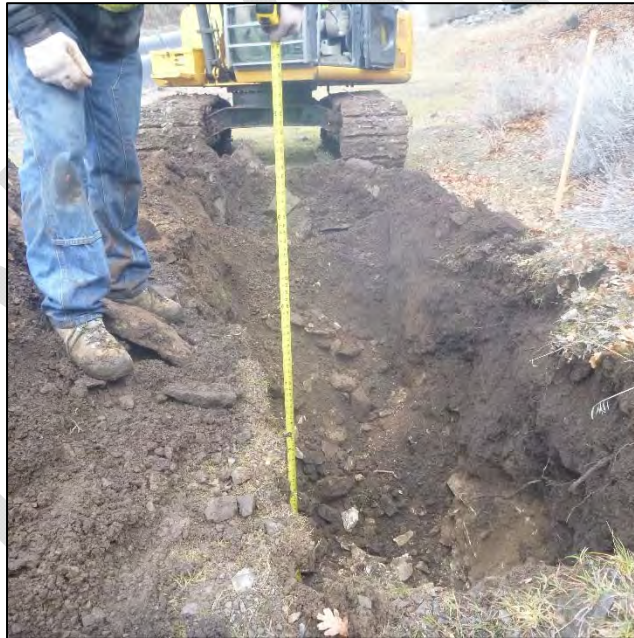
PHOTO 40 – TP-CO2-A spoils from depth 3.0 to 4.0 ft

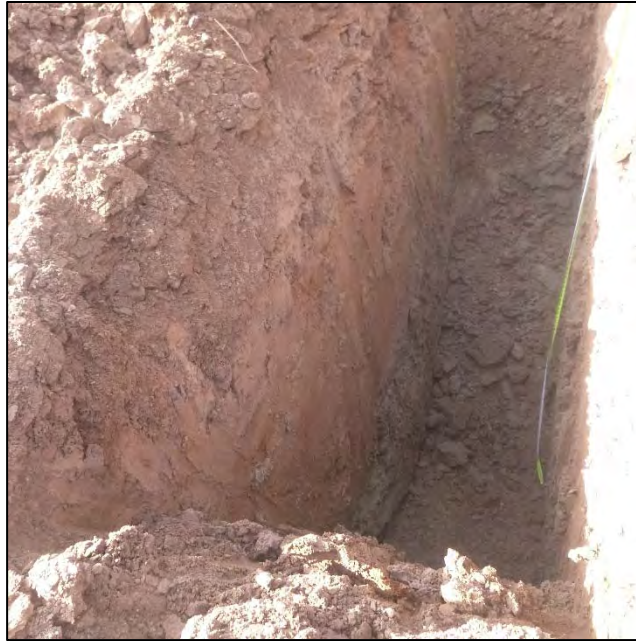
PHOTO 121 – TP-JCB-C pit excavated to depth 8.0 ft

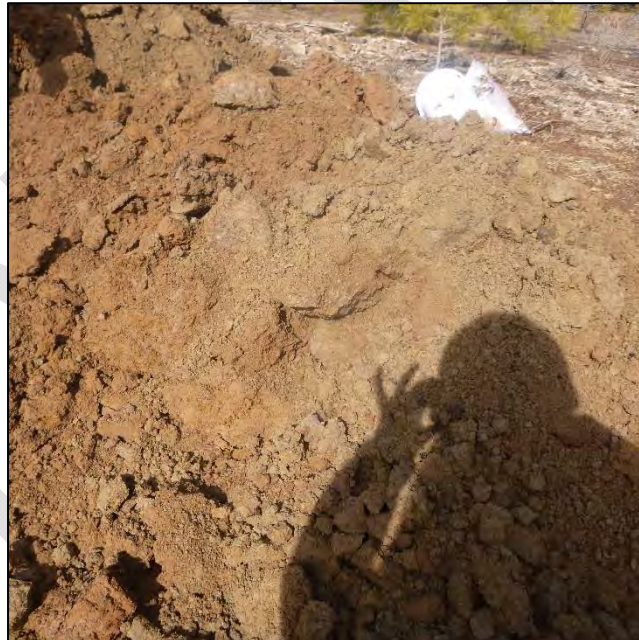
PHOTO 122 – TP-JCB-C spoils from depth 8.0 ft

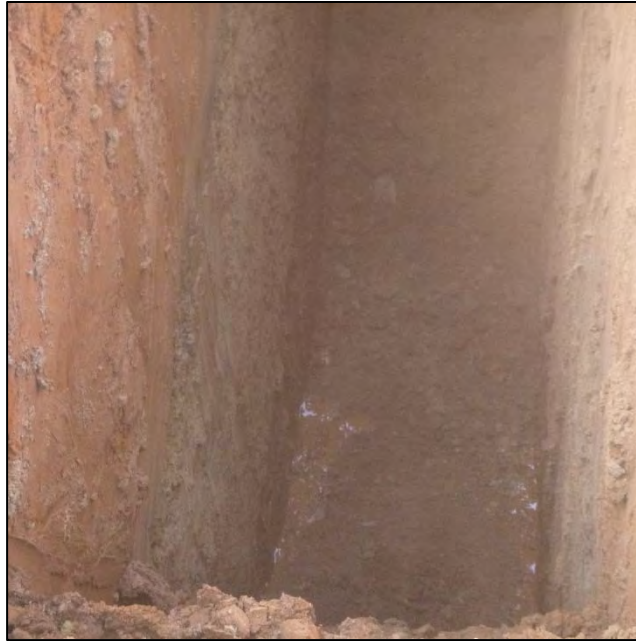
PHOTO 123 – TP-JCB-C pit excavated to depth 13.3 ft

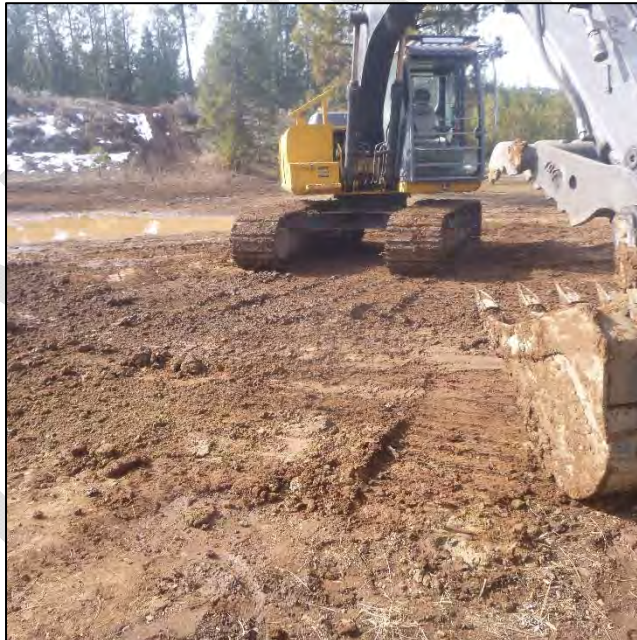
PHOTO 124 – TP-JCB-C site post-excavation

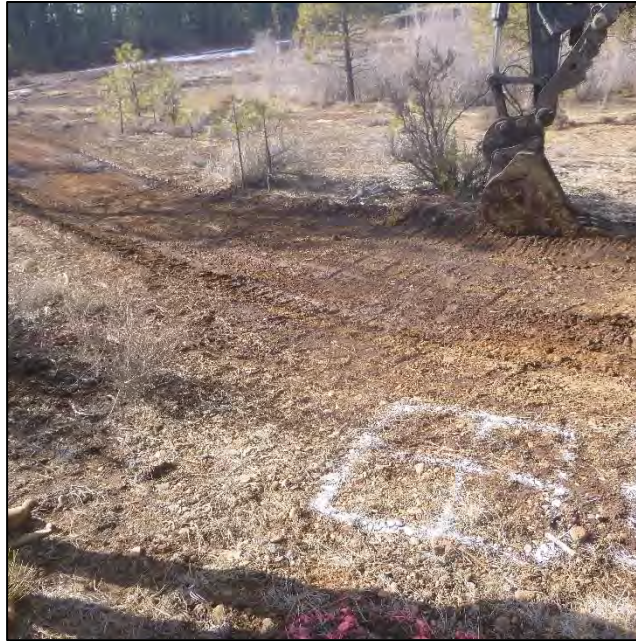
PHOTO 125 – TP-JCB-D site pre-excavation

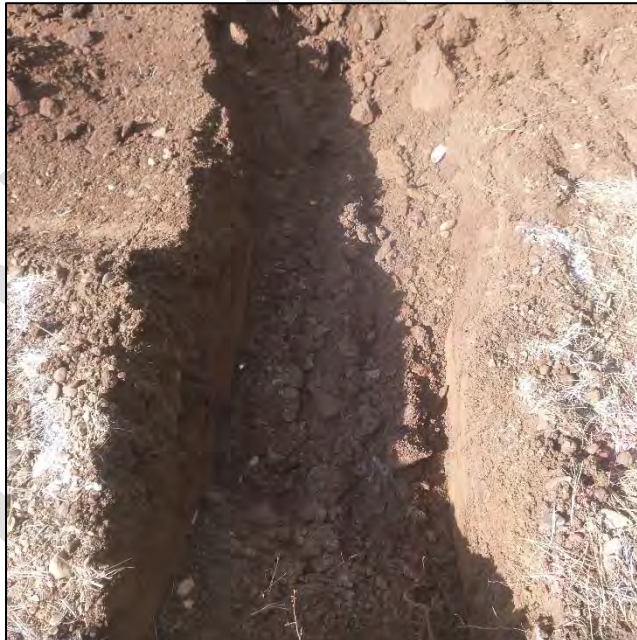
PHOTO 126 – TP-JCB-D pit excavated to depth 1.7 ft
