APPENDIX G4

Test Pit Photographs

ROCK SLOPE HAZARDS

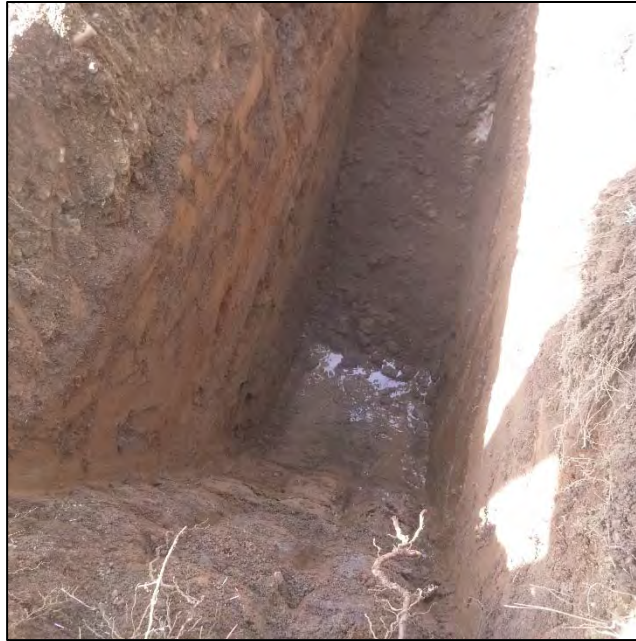
PHOTO 127 – TP-JCB-D pit excavated to depth 7.7 ft

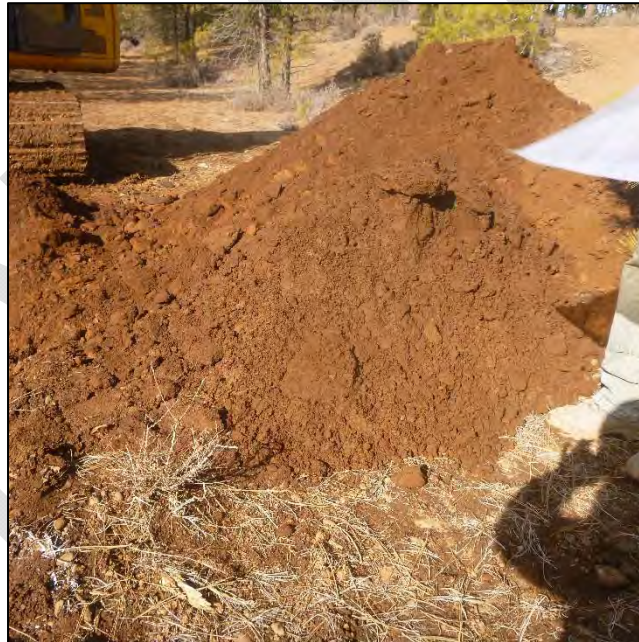
PHOTO 128 – TP-JCB-D spoils from depth 7.7 ft

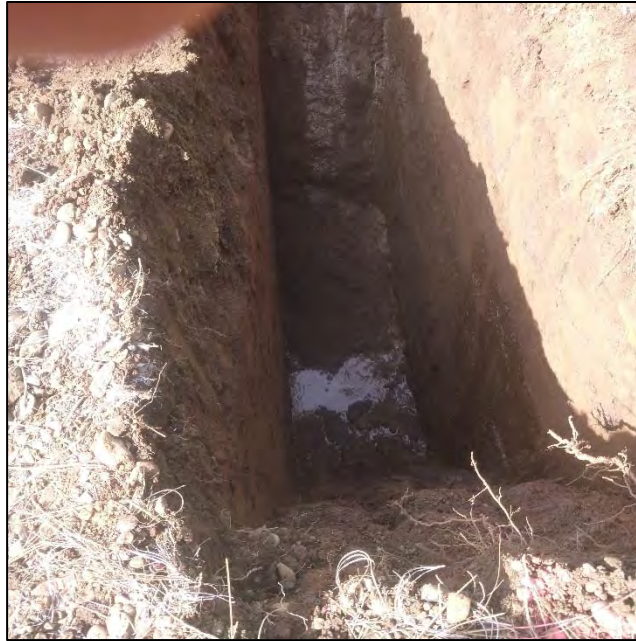
PHOTO 129 – TP-JCB-D pit excavated to depth 8.8 ft

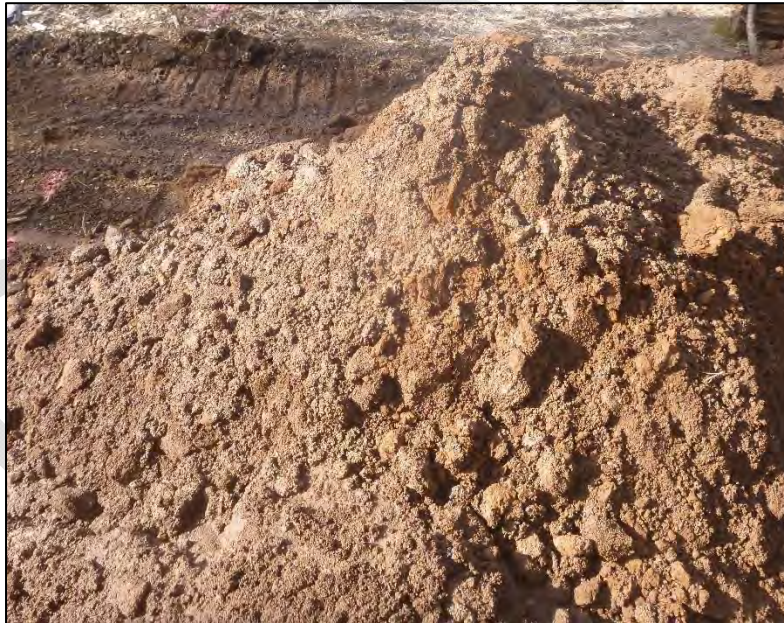
PHOTO 130 – TP-JCB-D spoils from depth 8.8 to 9.0 ft

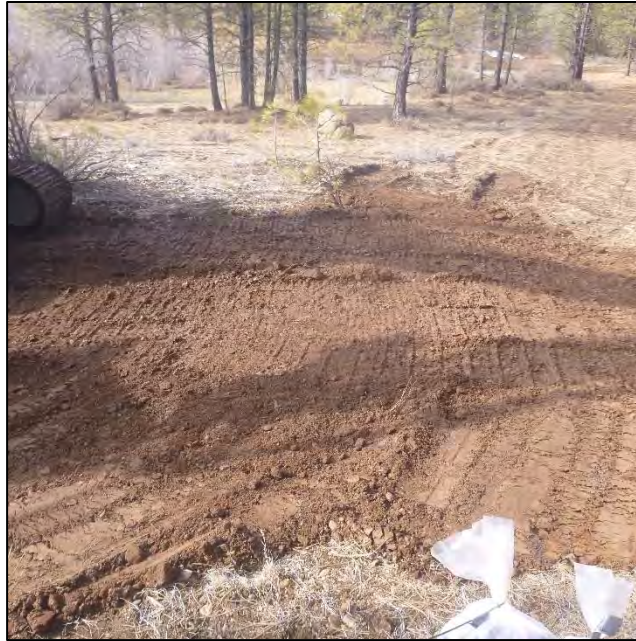
PHOTO 131 – TP-JCB-D site post-excitation

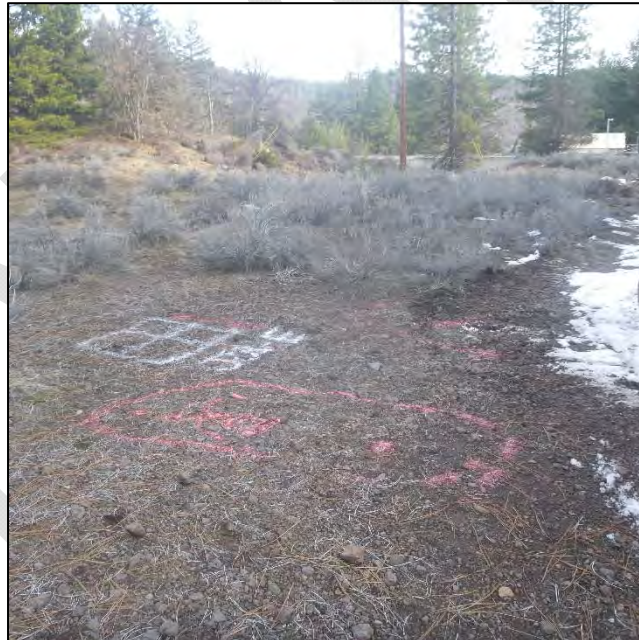
PHOTO 132 – TP-JCB-E site pre-excitation

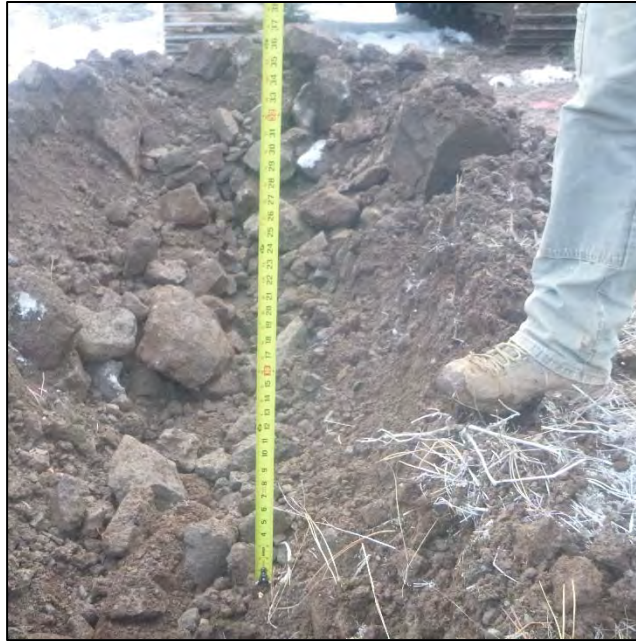
PHOTO 133 – TP-JCB-E pit excavated to depth 1.2 ft

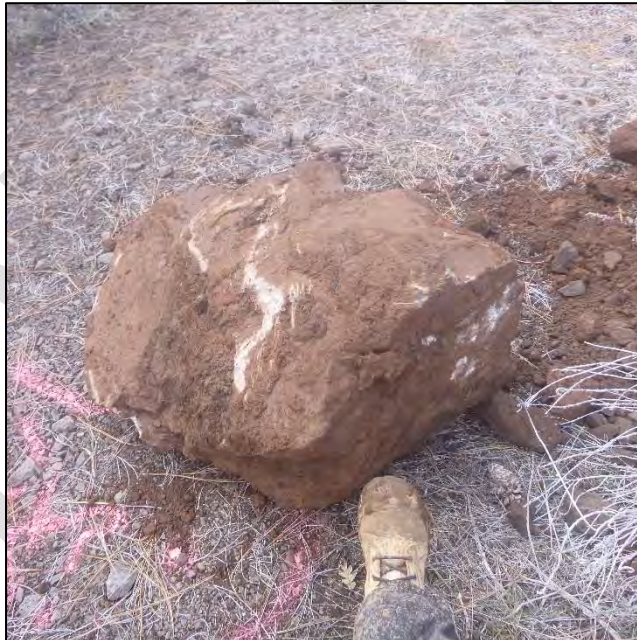
PHOTO 134 – TP-JCB-E boulder uncovered approximately 2.0 ft below surface

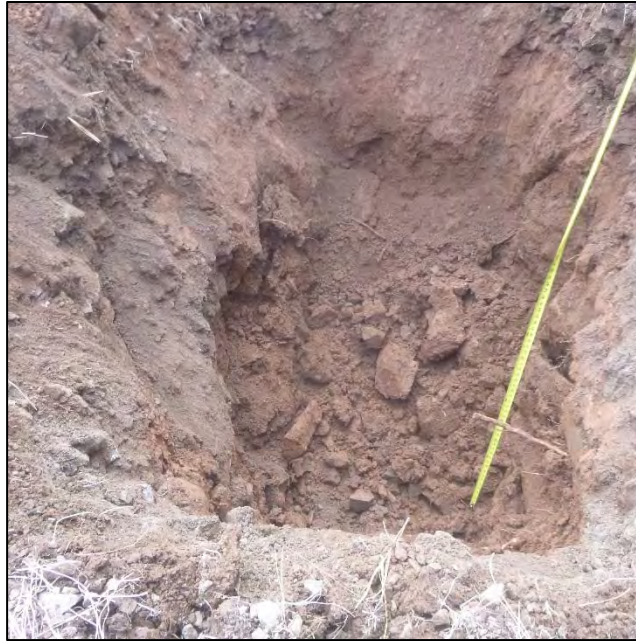
PHOTO 135 – TP-JCB- E pit excavated to depth 6.0 ft

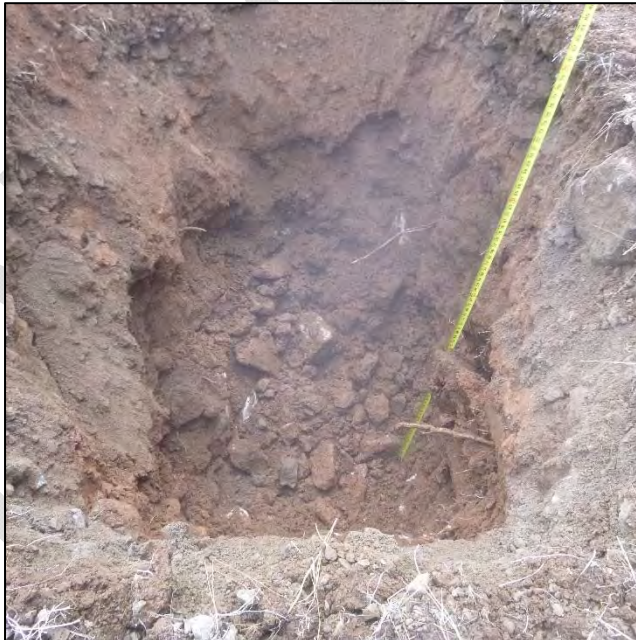
PHOTO 136 – TP-JCB-E pit excavated to 6.6 ft

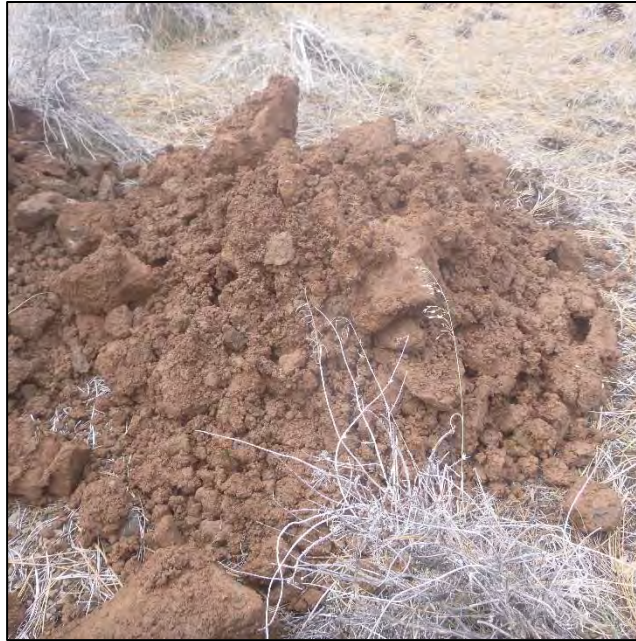
PHOTO 137 – TP-JCB-E spoils from depth 6.6 ft

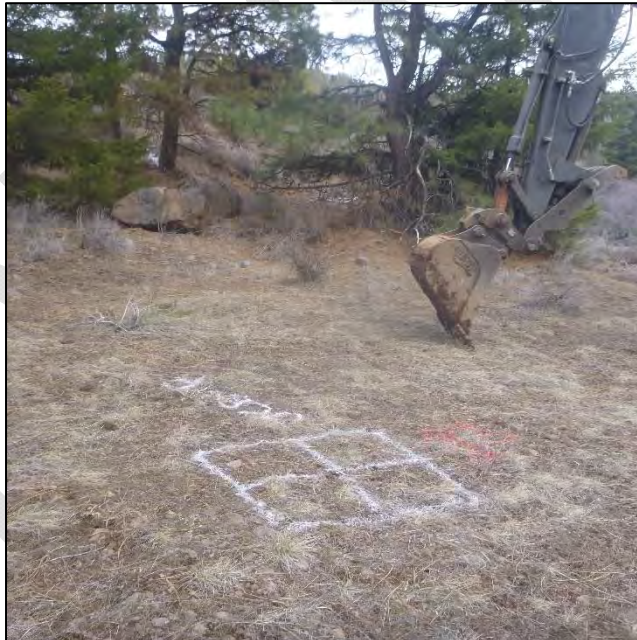
PHOTO 138 – TP-JCB-F site pre-excavation

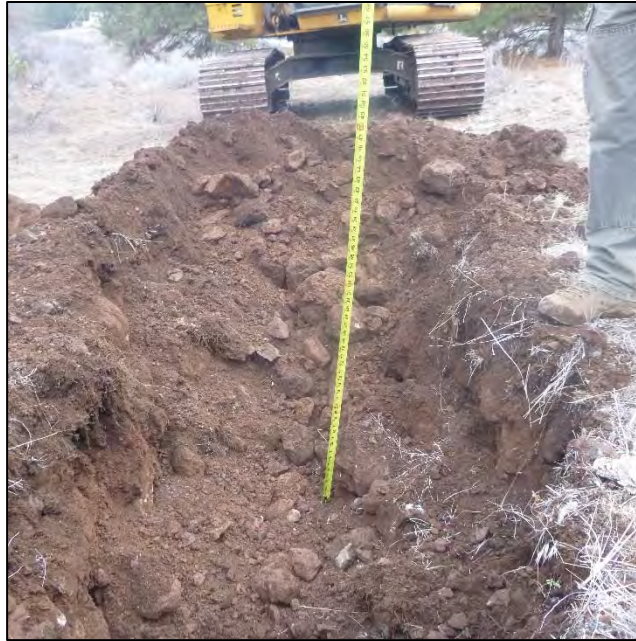
PHOTO 139 – TP-JCB-F pit excavated to depth 2.3 ft

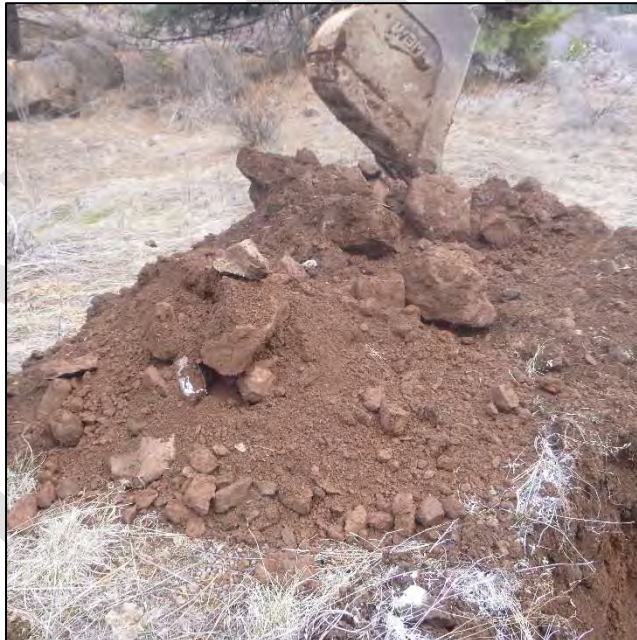
PHOTO 140 – TP-JCB-F spoils from depth 2.3 to 6.4 ft

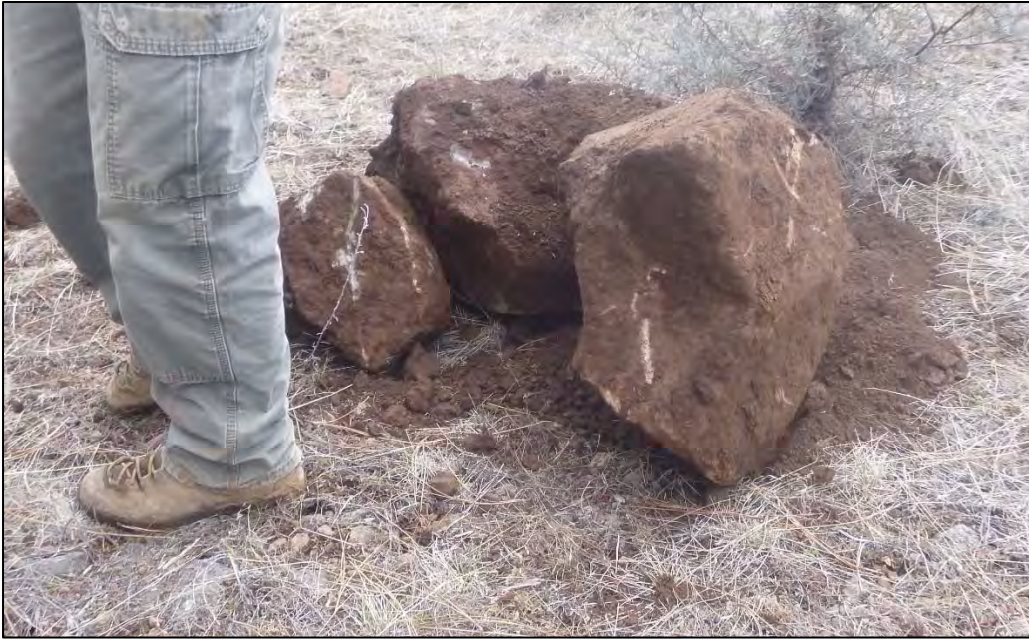
PHOTO 141 – TP-JCB-F boulders uncovered from depth 2.3 to 6.4 ft

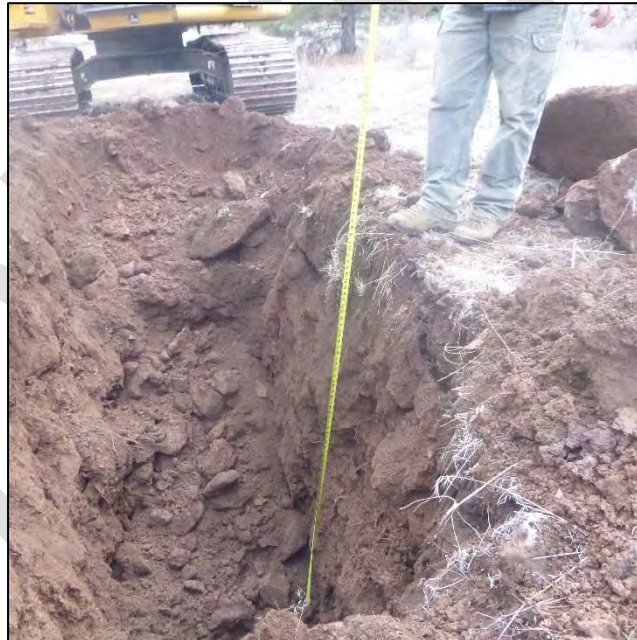
PHOTO 142 – TP-JCB-F pit excavated to 6.4 ft

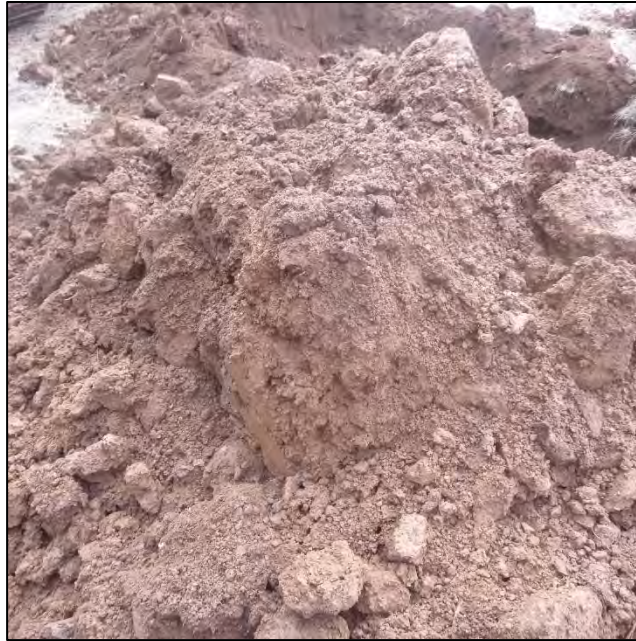
PHOTO 143 – TP-JCB-F spoils from depth 6.4 ft

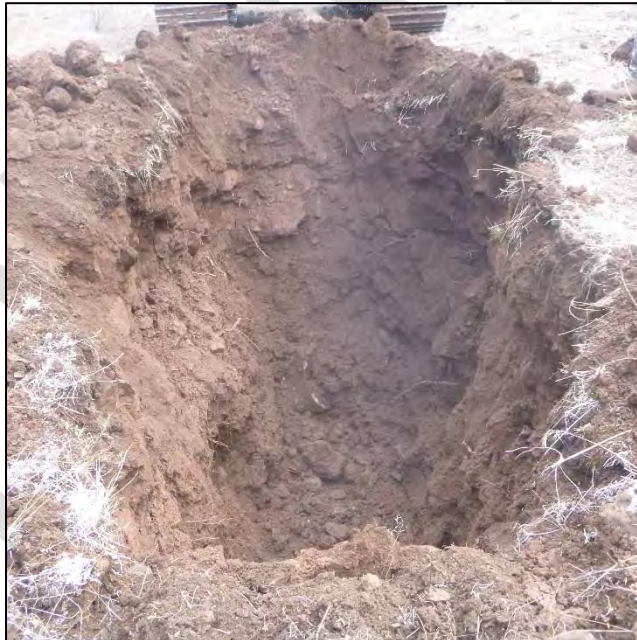
PHOTO 144 – TP-JCB-F pit excavated to depth 8.5 ft

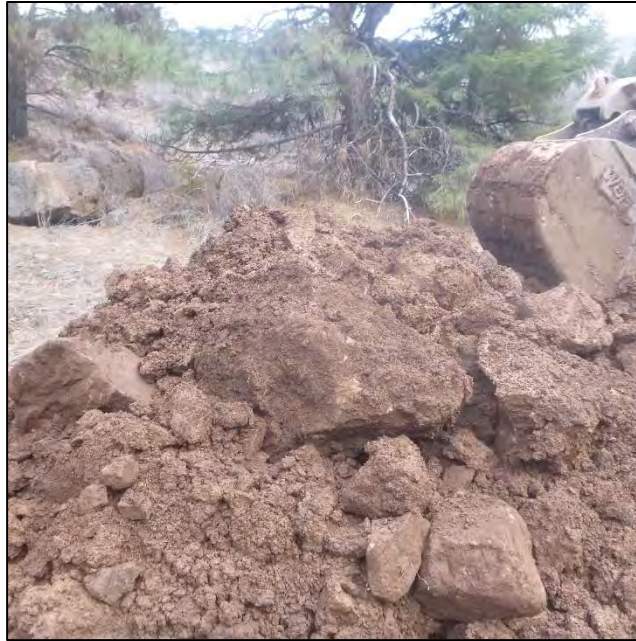
PHOTO 145 – TP-JCB-F spoils and boulders from depth 6.4 to 8.5 ft

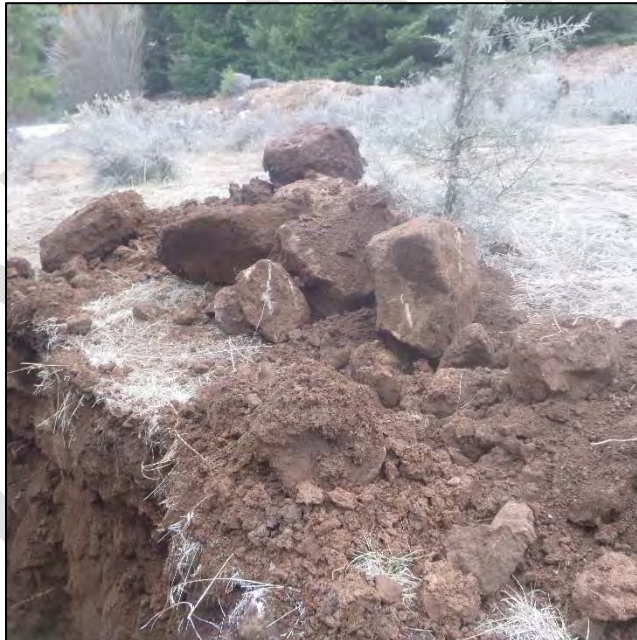
PHOTO 146 – TP-JCB-F boulders from depth 6.4 to 8.5 ft

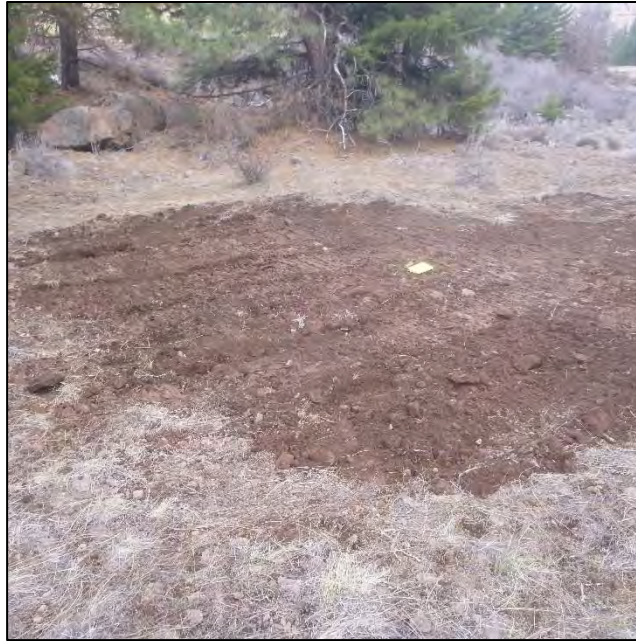
PHOTO 147 – TP-JCB-F site post-excavation

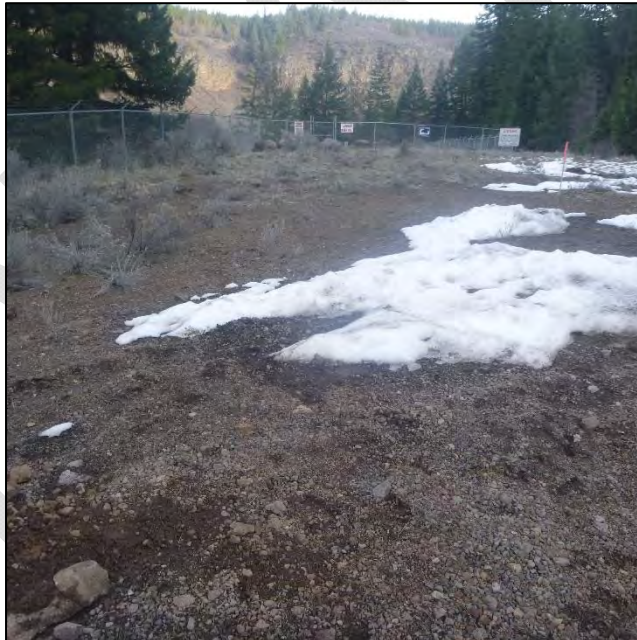
PHOTO 148 – TP-JCB-G site pre-excavation

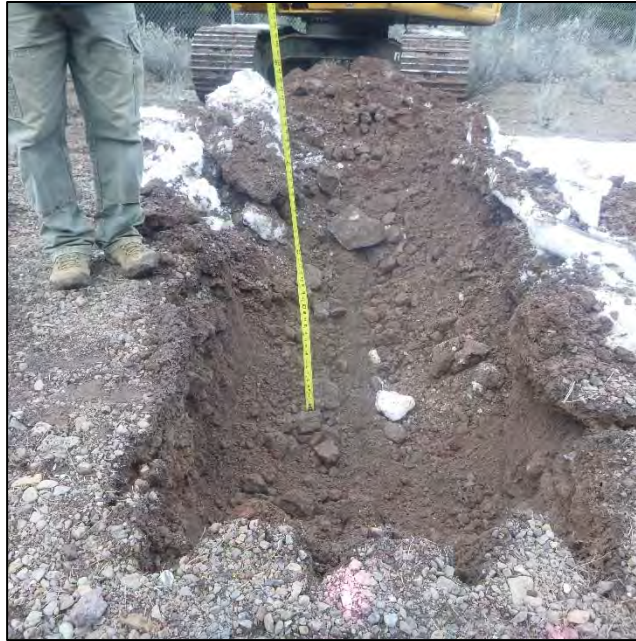
PHOTO 149 – TP-JCB-G pit excavated to depth 1.8 ft

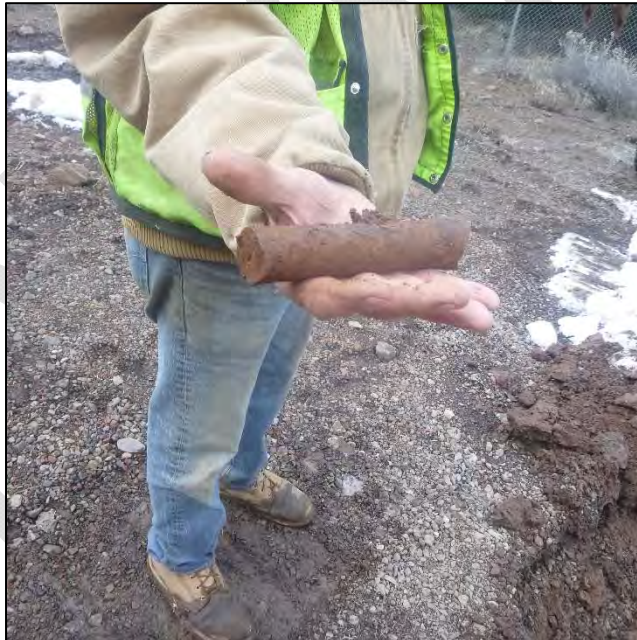
PHOTO 150 – TP-JCB-G metal bar uncovered from depth 0.0 to 1.8 ft

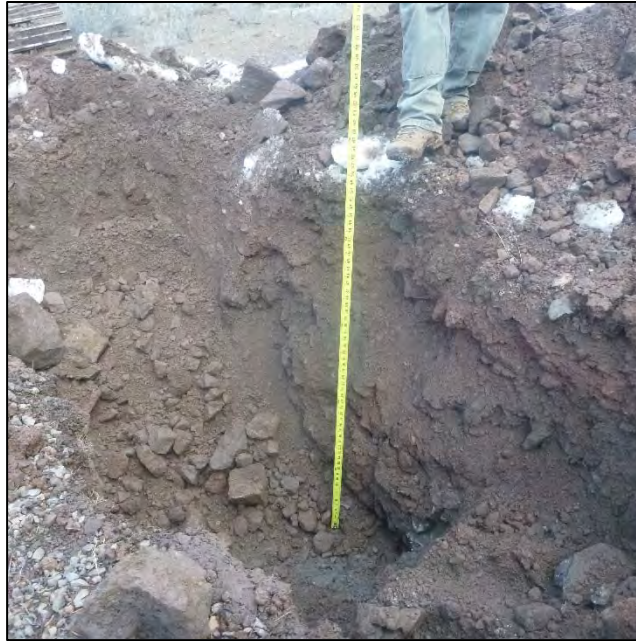
PHOTO 151 – TP-JCB-G pit excavated to depth 4.9 ft

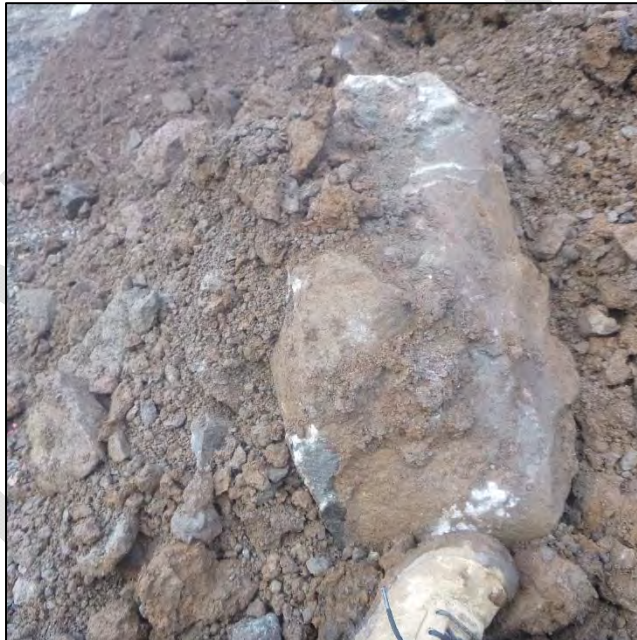
PHOTO 152 – TP-JCB-G boulder uncovered from depth 4.9 ft

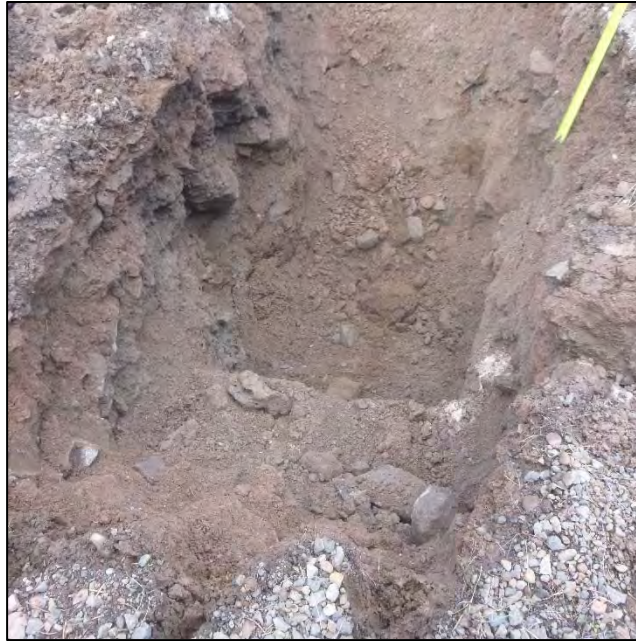
PHOTO 153 – TP-JCB-G pit excavated to depth 5.3 ft

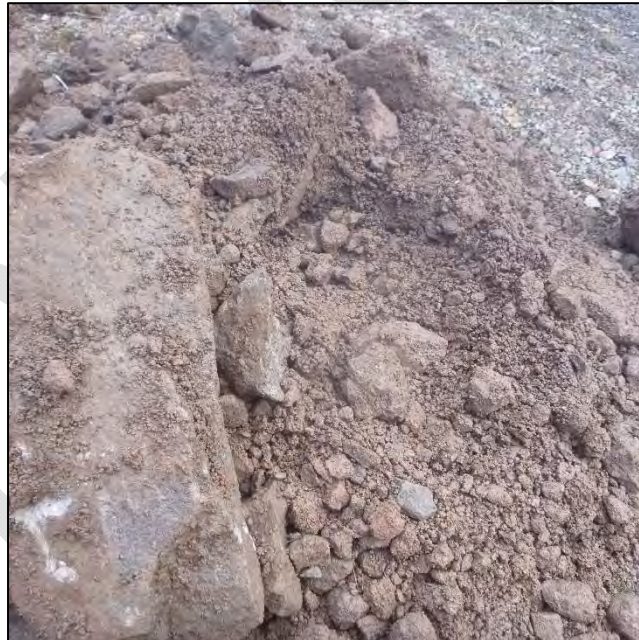
PHOTO 154 – TP-JCB-G spoils from depth 5.3 ft

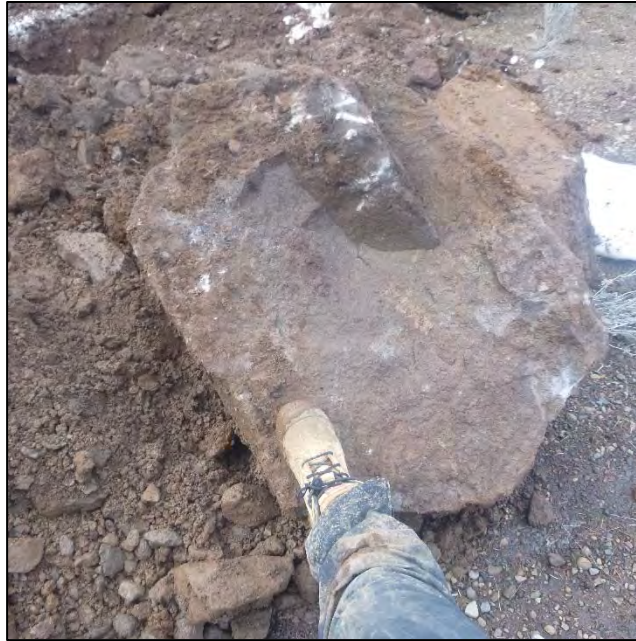
PHOTO 155 – TP-JCB-G boulder uncovered from approximate depth 7.0 ft

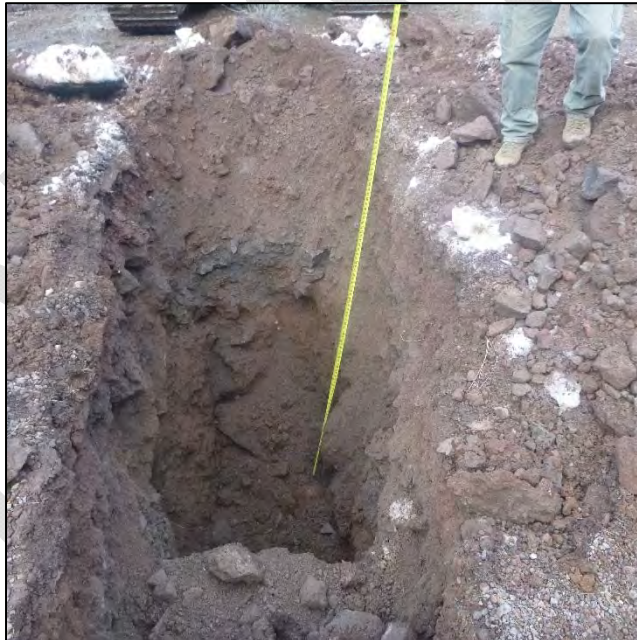
PHOTO 156 – TP-JCB-G pit excavated to depth 7.4 ft

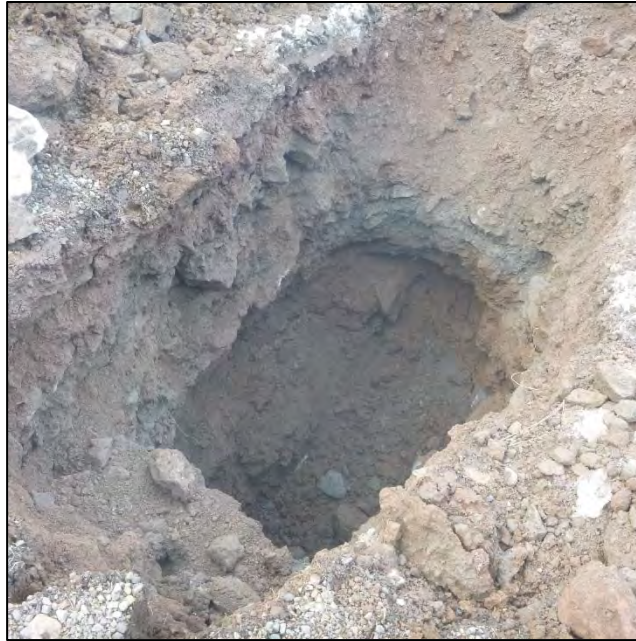
PHOTO 157 – TP-JCB-G pit excavated to depth 9.0 ft

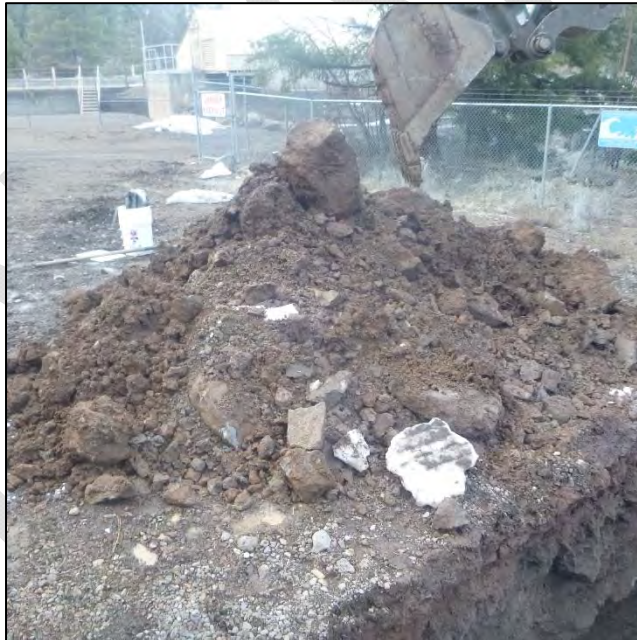
PHOTO 158 – TP-JCB-G final spoils from excavation

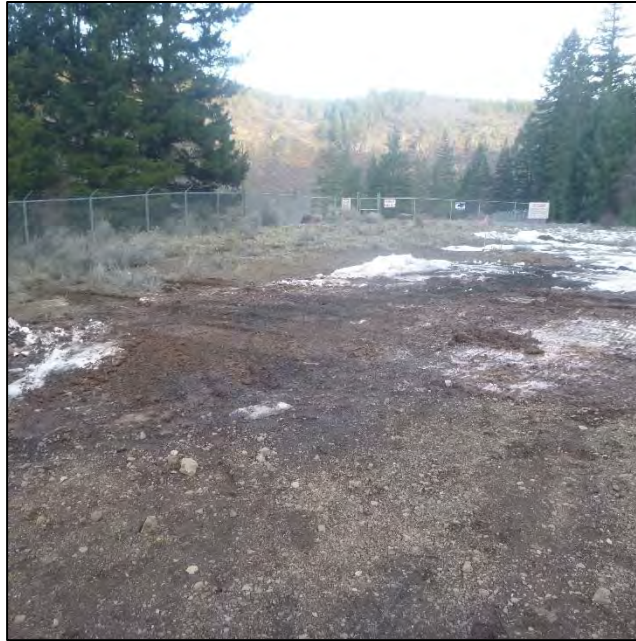
PHOTO 159 – TP-JCB-G site post-excavation

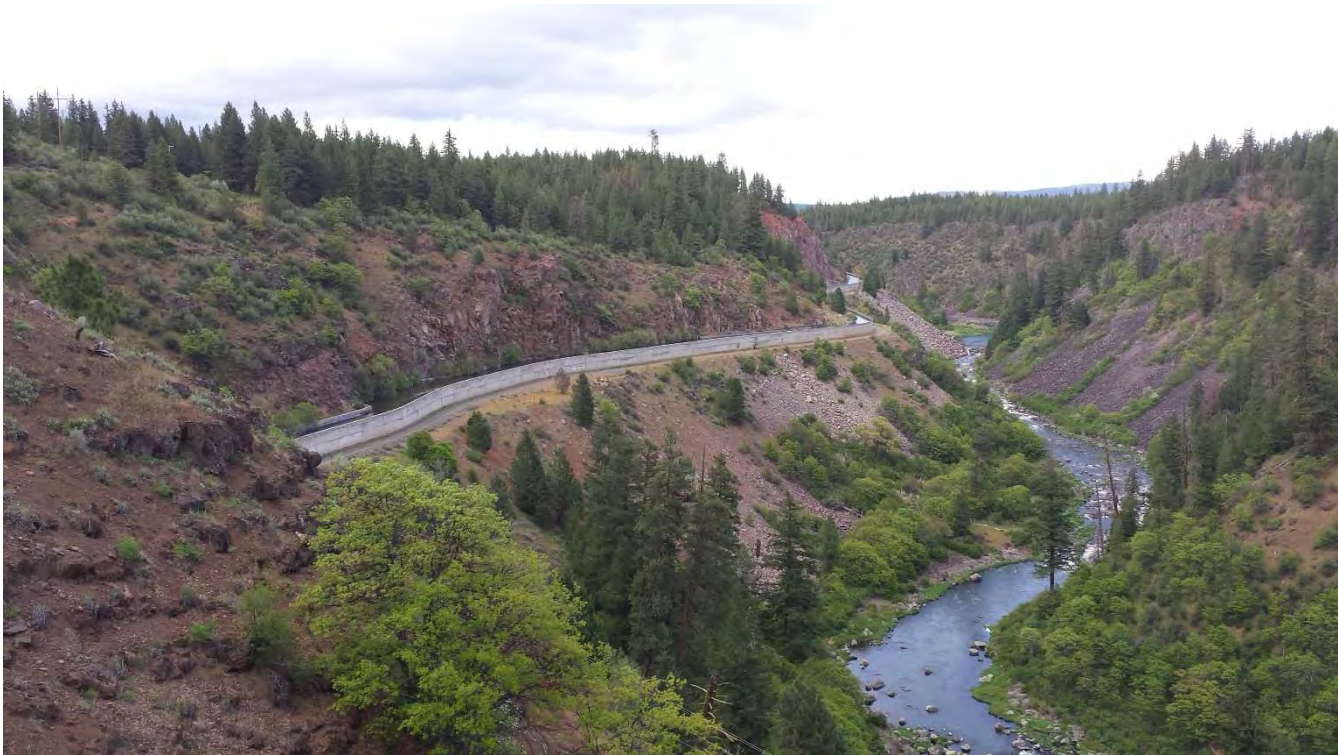
KIEWIT INFRASTRUCTURE WEST CO.				
KLAMATH RIVER RENEWAL PROJECT				
JC BOYLE POWER CANAL ROCK SLOPES ADJACENT TO THE DOWNSTREAM PART OF THE ALIGNMENT

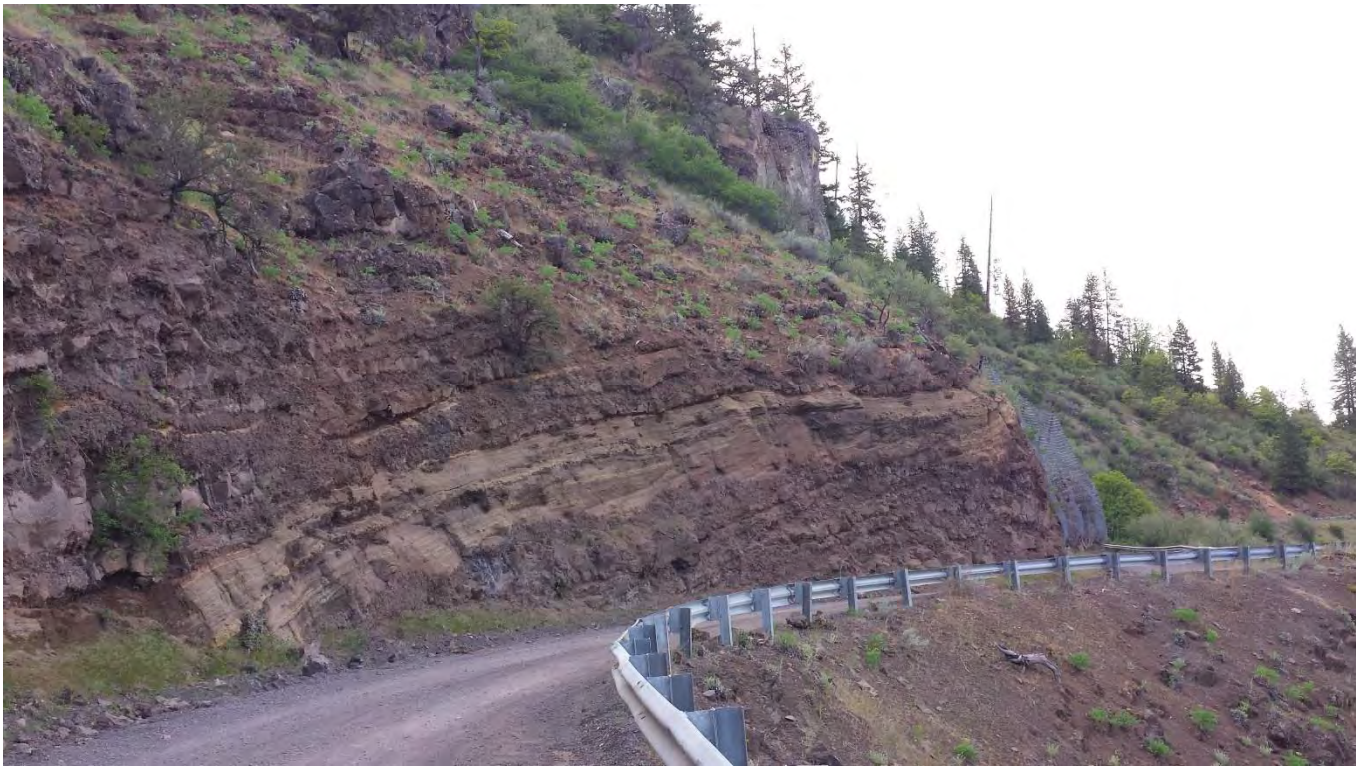
KIEWIT INFRASTRUCTURE WEST CO.		
					KLAMATH RIVER RENEWAL PROJECT		
					JC BOYLE POWER CANAL WESTERN LIMIT OF ROCK FALL FENCE ALONG POWERHOUSE ACCESS ROAD

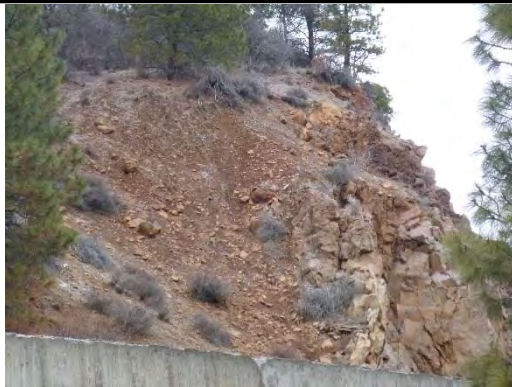
Landslide at approx. STA 54+00

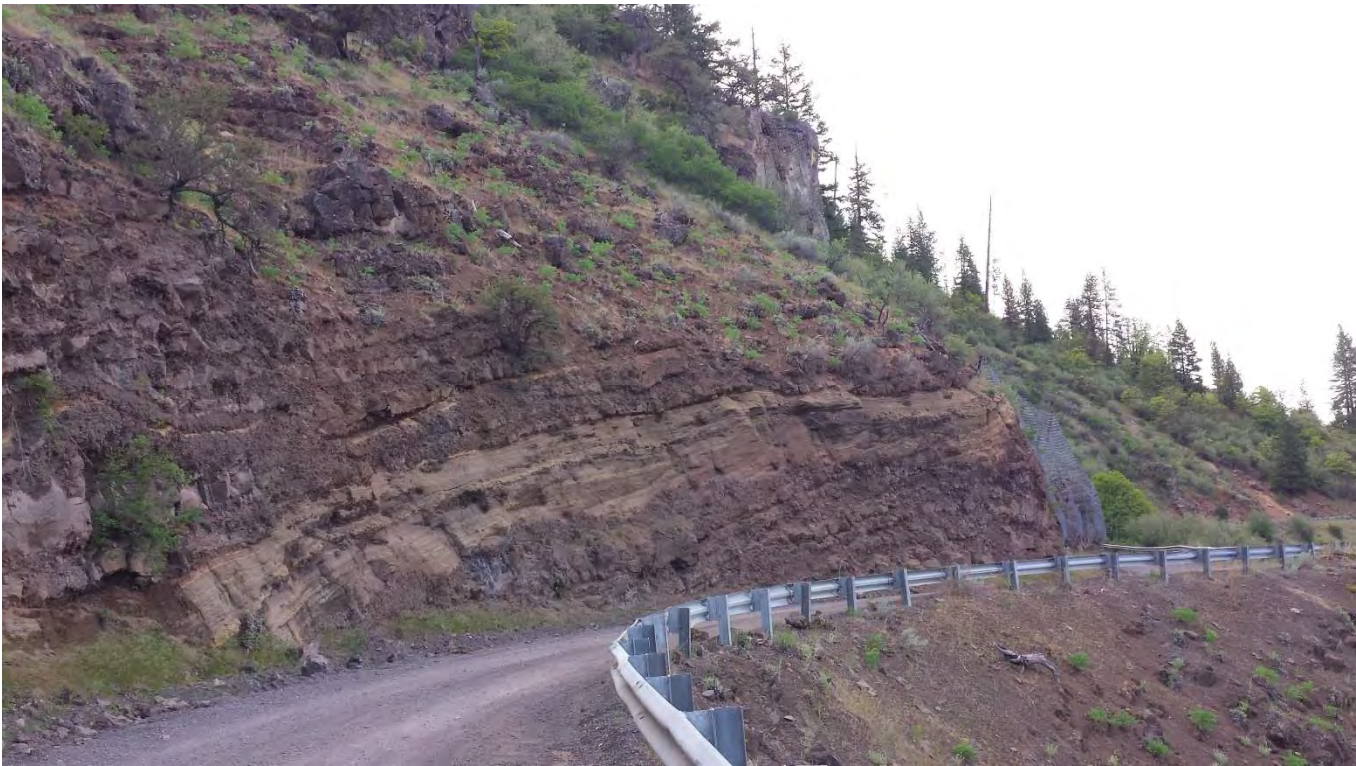
KIEWIT INFRASTRUCTURE WEST CO.		
					KLAMATH RIVER RENEWAL PROJECT		
					JC BOYLE POWERHOUSE ACCESS ROAD WESTERN LIMIT OF ROCK FALL FENCE ALONG POWERHOUSE ACCESS ROAD (LOCATION 1)

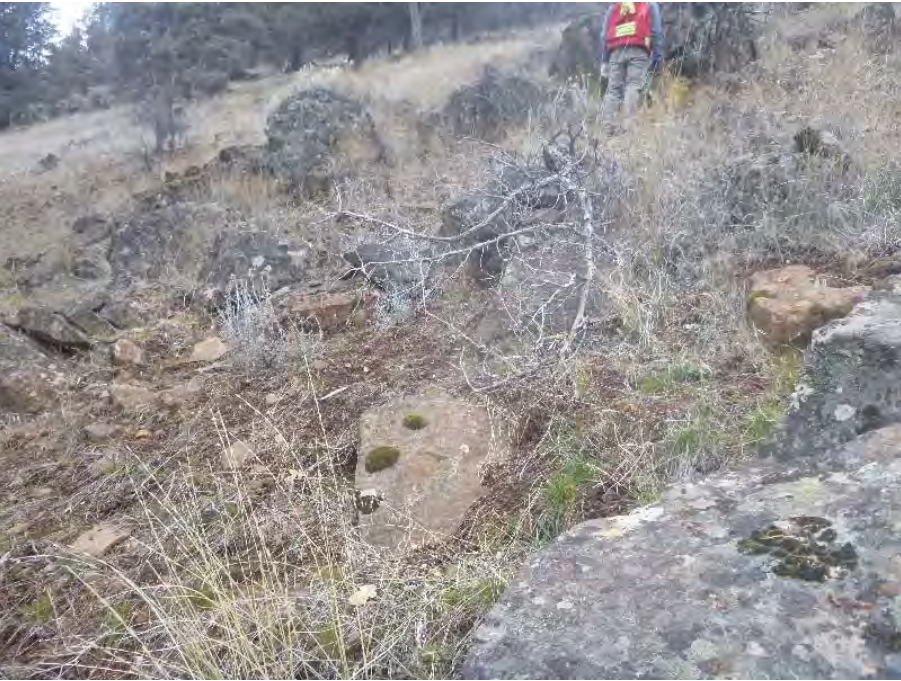
View of natural slope above JC Boyle Surface Penstock

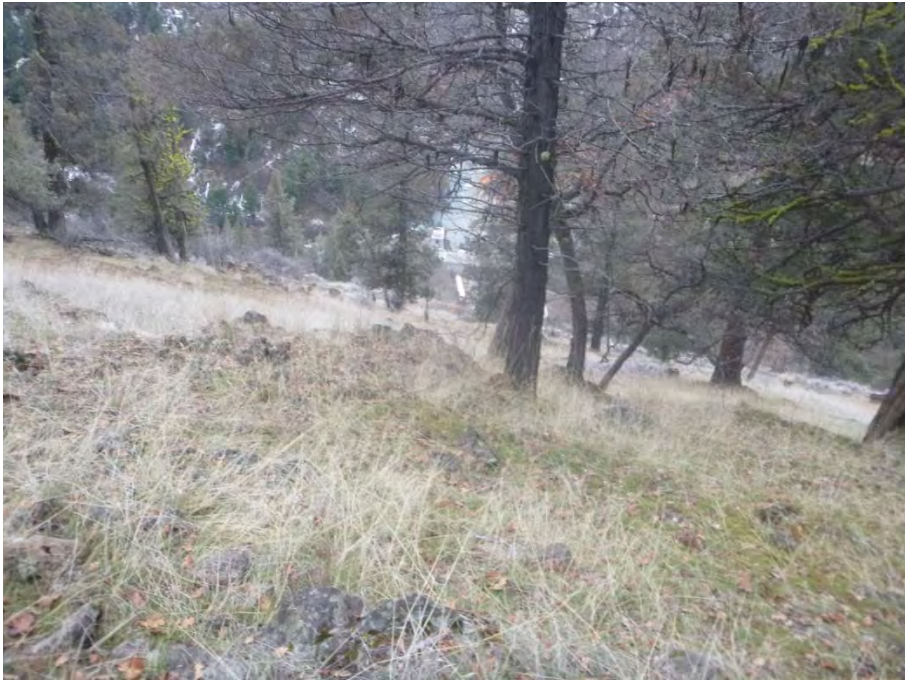
View of natural slope above JC Boyle Surface Penstock

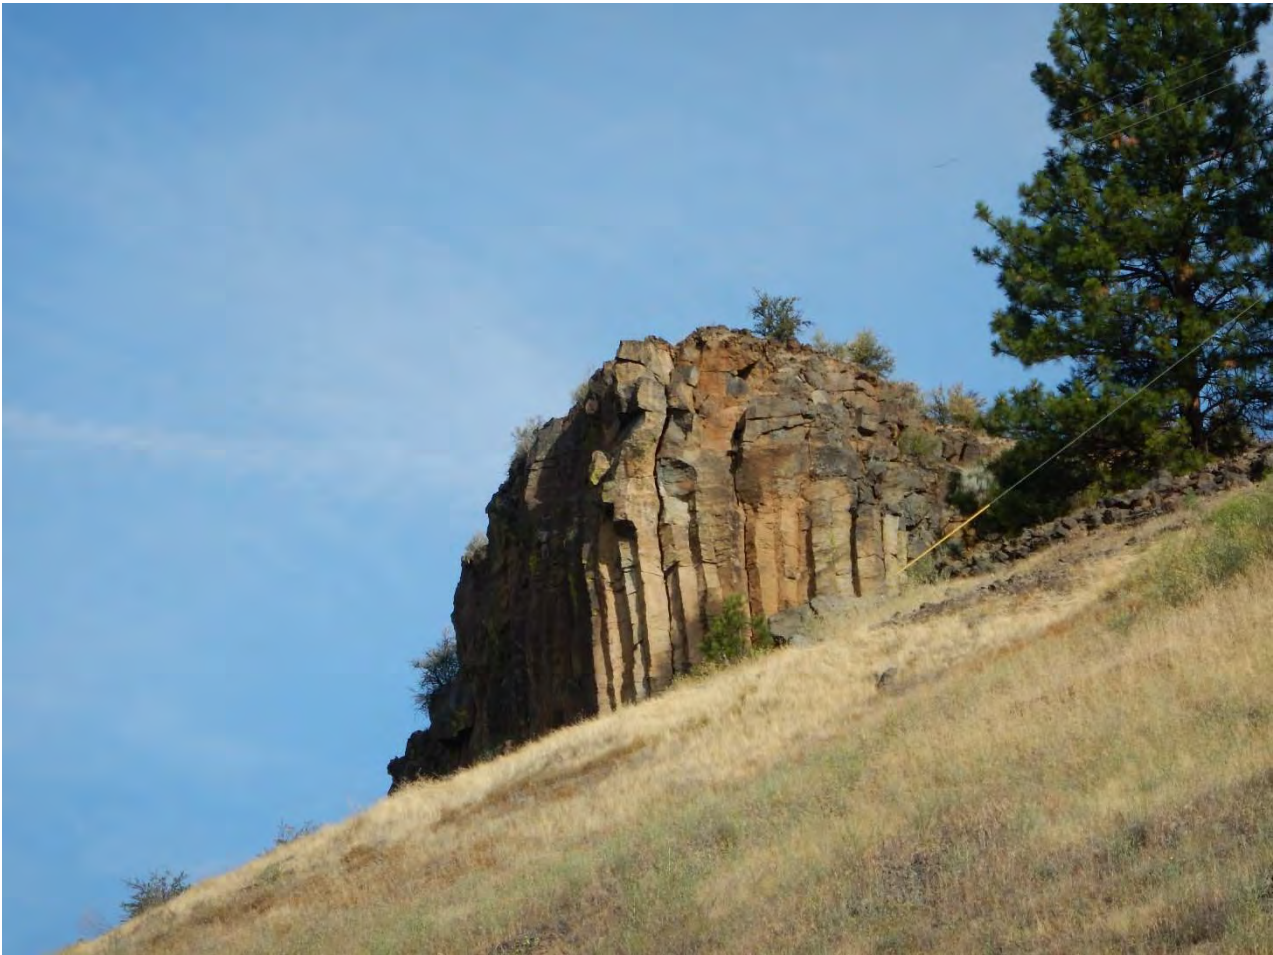
Knight Piesold CONSULTING		P/A NO. VA103-640/1
FIGURE H6.2		REV A					
A	03DEC'19	ISSUED WITH REPORT	JEH	SY			
REV	DATE	DESCRIPTION	PREP'D	RW'W'D

KIEWIT INFRASTRUCTURE WEST CO.			
KLAMATH RIVER RENEWAL PROJECT			
ROCK CLIFF WITH SUBVERTICAL COLUMNAR JOINTS

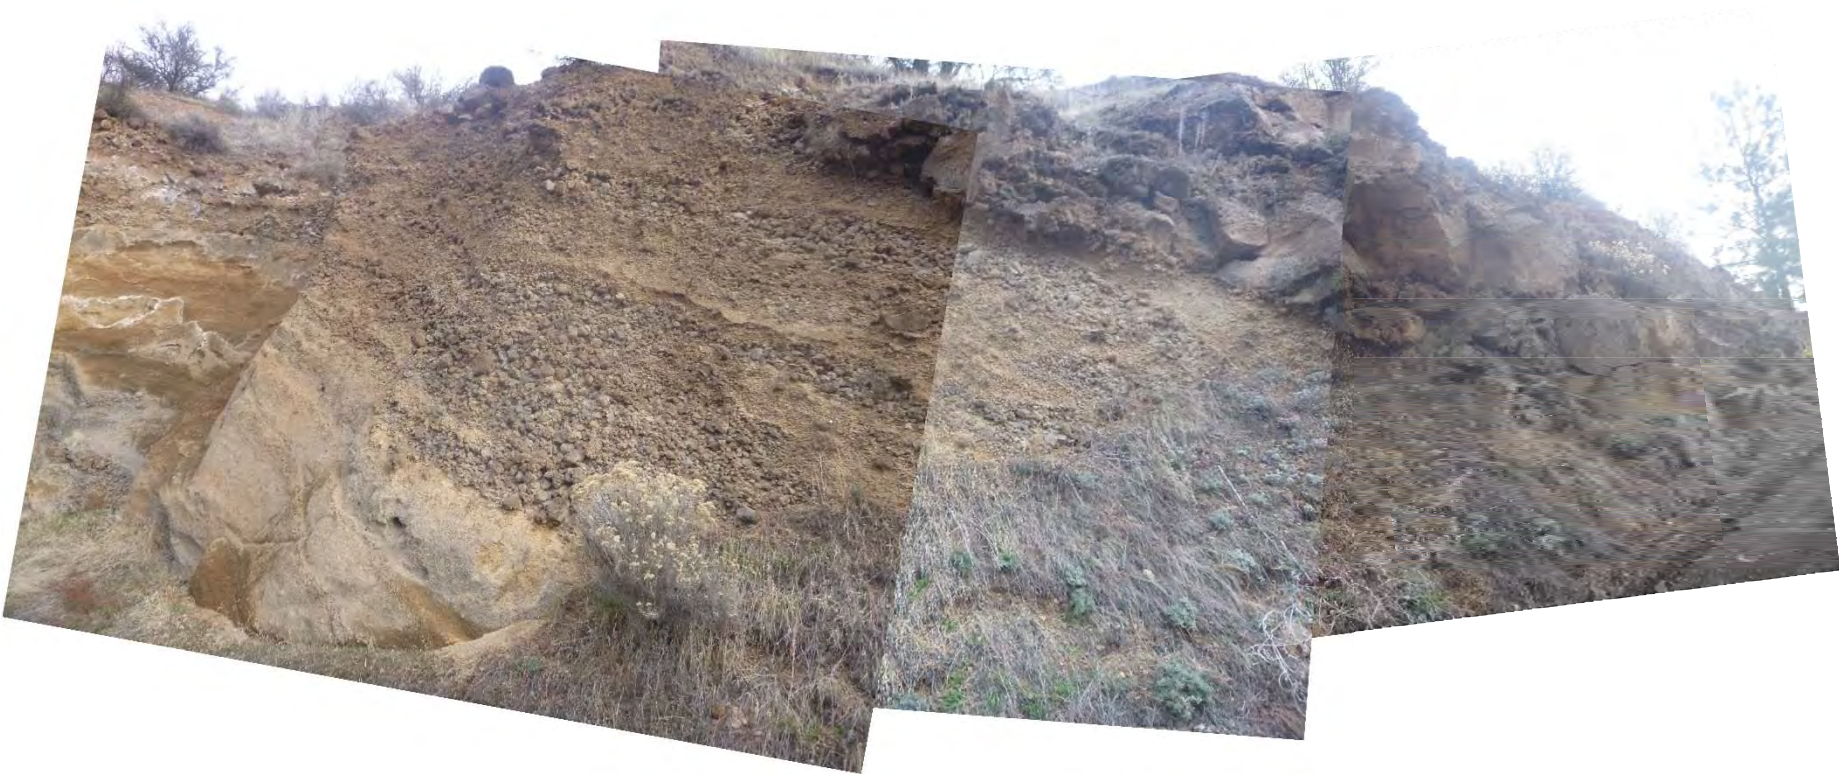
Knight Piésold CONSULTING		P/A NO. VA103-640/1	REF. NO. 2
		FIGURE H6.7	
REV	DATE	DESCRIPTION	PREP'D RVW'D

KIEWIT INFRASTRUCTURE WEST CO.			
KLAMATH RIVER RENEWAL PROJECT			
SURFICIAL GEOLOGY AT THE SITE OF THE RECENT DEBRIS SLIDE AT A SWITCH BACK

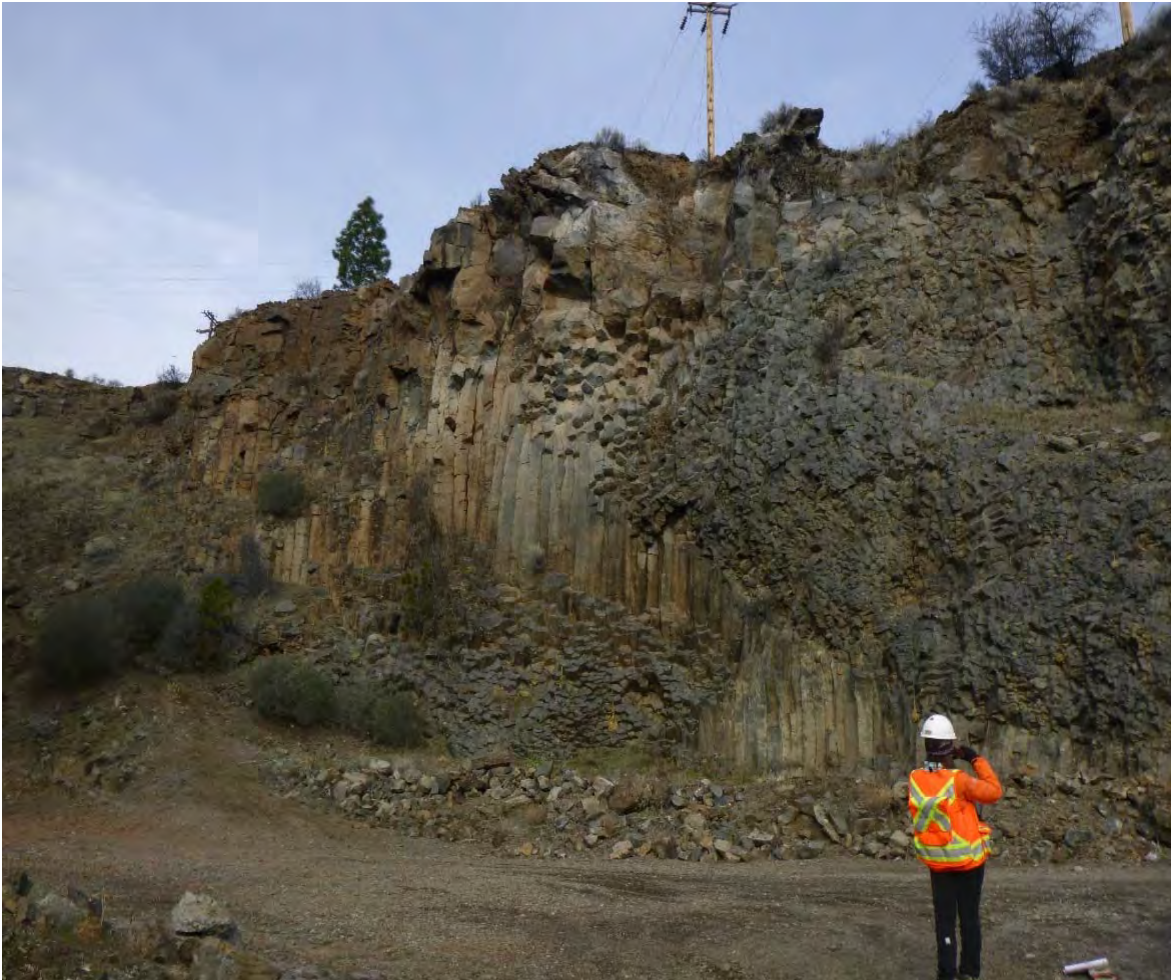
Knight Piésold CONSULTING	P/A NO. VA103-640/1		REF. NO. 2
	FIGURE H6.19		REV A

Up to about Sta. 3+050, the lower slope above the proposed Copco Disposal Site Access Road alignment consists mostly of a combination of talus blocks and bedrock outcrops (Figure H6.19). The lower slope is approximately 30 ft. high with a slope angle of approximately 45°. No obvious indicators of slope instability were observed.

The upper slope comprises a 10 to 20-ft-high cliff. The cliff consists of strong blocky volcanic rock with horizontal and vertical fractures. In general, the fractures are rough and stepped, very close to moderately spaced (0.75 inch to 2 ft.) and exhibit low persistence (3 to 10 ft.). The fracture pattern does not indicate clear potential for kinematic failure. Nonetheless, there are local rock blocks with potential to detach as rock falls. The rock fall hazard is exacerbated by environmental factors, including rainfall, freeze-thaw conditions and surface runoff.

**View of the Slope above the Proposed Copco Disposal Site
Access Road Alignment at approximately Sta. 3+00**
