APPENDIX G4

Test Pit Photographs

ROCK SLOPE HAZARDS

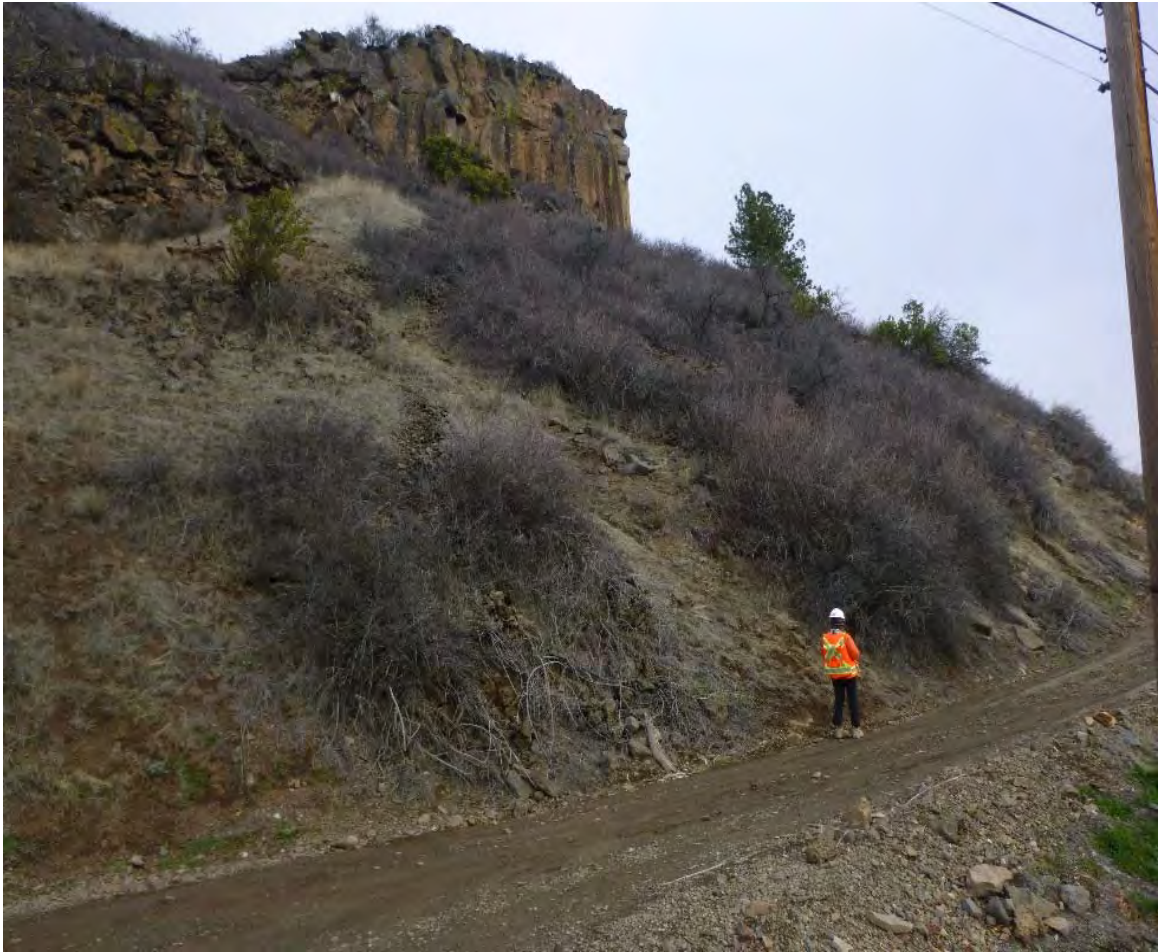
Knight Piésold CONSULTING	P/A NO. VA103-640/1		REF. NO. 2
	FIGURE H6.20		REV A

The slope above this section of the proposed road alignment consists an approximately 60 to 80-ft. high cliff (Figure H6.20). The cliff consists of a combination of medium strong to very strong volcanic bedrock with vertical and inclined, columnar structures (in the order of 10 to 20 ft. in length), and strong, blocky volcanic rock with an interlocked rock mass. No signs of potential large-scale slope instability were observed. However, local areas on the cliff face present rock fall hazards. These include overhangs beneath columnar structures that create potential for toppling failure and potential sliding surfaces in the blocky bedrock. The rock fall hazard is exacerbated by environmental factors, including rainfall, freeze-thaw conditions and surface runoff. Rock fall may consist of single blocks or a group of rock blocks detaching off the cliff. Rock fall block sizes can vary from very small to boulder size.

**View of the Slope above the Proposed Copco Disposal Site
Access Road Alignment at approximately Sta. 4+00**

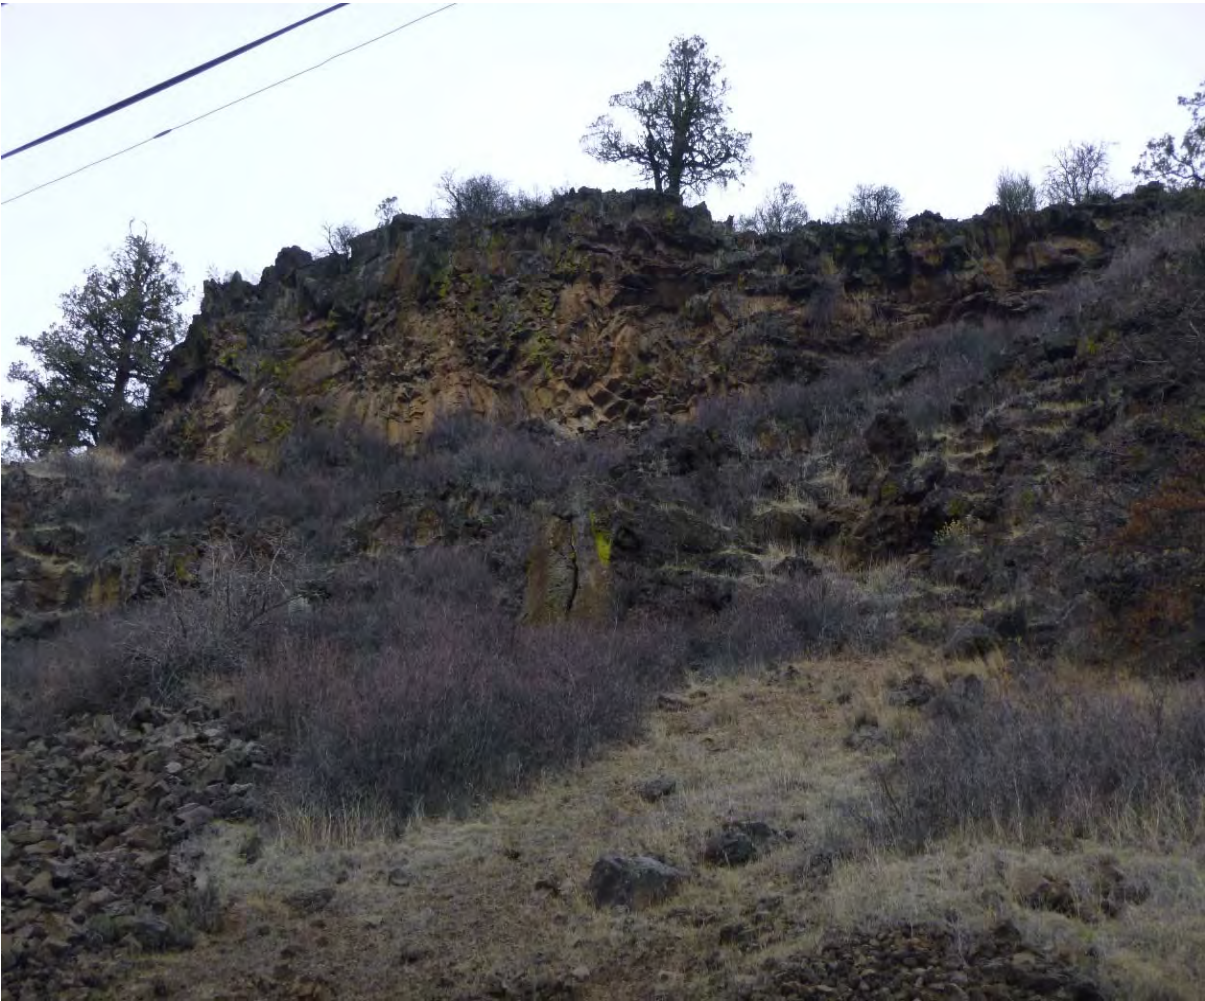
Knight Piésold CONSULTING	P/A NO. VA103-640/1		REF. NO. 2
	FIGURE H6.21		REV A

The lower slope immediately above this section of the road is approximately 40° (Figure H6.21). The slope surface is vegetated and consists of a combination of dense sandy gravel soil with some organics, and some bedrock outcrops. No obvious indicators of slope instability were observed.

The upper slope is a sub-vertical cliff consisting of a medium strong to very strong volcanic bedrock with columnar structures that are approximately 20 to 30 ft. high. The columns are prone to toppling, and therefore this cliff is a source of potential rock fall. The rock fall hazard is exacerbated by environmental factors, including rainfall, freeze-thaw conditions and surface runoff.

**View of the Slope above the Proposed Copco Disposal Site
Access Road Alignment at approximately Sta. 5+50 to 11+00**

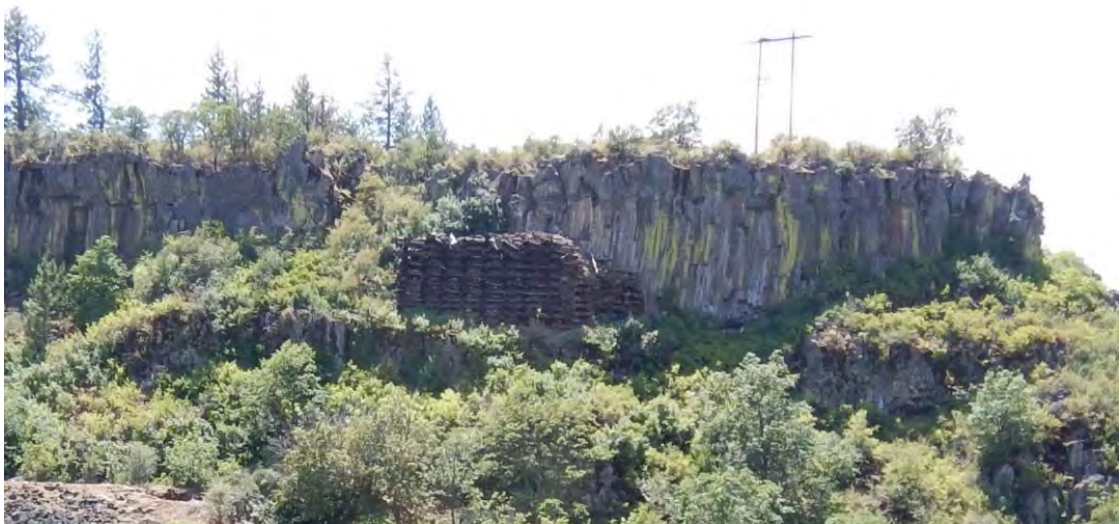
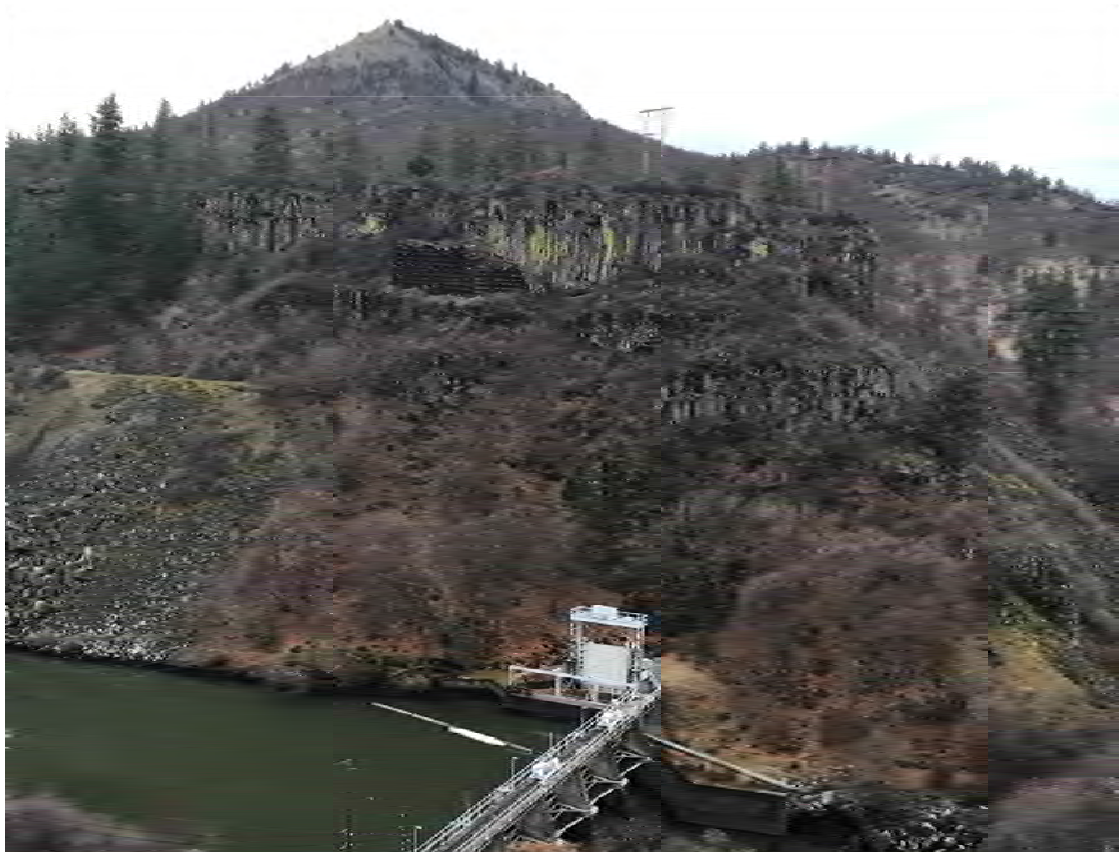
Knight Piésold CONSULTING	P/A NO. VA103-640/1		REF. NO. 2
	FIGURE H6.22		REV A

The proposed Harpin Turn footprint is at the site of an approximately 50 ft. high 35 to 40° uniform slope, as shown on Figure H6.22. The slope surface comprises dense sandy gravel soil with some organics. No bedrock outcrops were observed. The thickness of the overburden material could not be identified in the site reconnaissance. No obvious indicators of slope instability were observed.

There is an approximately 30 to 50 ft. high sub-vertical cliff located upslope from the 40° slope. The cliff consists of a combination of medium strong to very strong volcanic bedrock with sub-vertical, columnar structures, which are approximately 5 to 10 ft. long, and, strong blocky volcanic rock. No signs of large-scale slope instability were observed. However, there are local rock fall hazards related to overhangs at the base of columnar structures and to discontinuities with potential for planar failure in the blocky rocks. Rock fall potential is exacerbated by environmental conditions prevalent at the site including rainfall, freeze-thaw conditions and surface runoff.

View of the Slope at the Footprint area of the Proposed Hairpin Turn

It is recommended that more detailed mapping of the rock mass and the rock slope hazards be undertaken for additional characterization of the rock fall hazards for worker safety. Key data that needs to be collected includes the identification of the key source zones, and the determination of block sizes and impact energies for any mitigation measures.

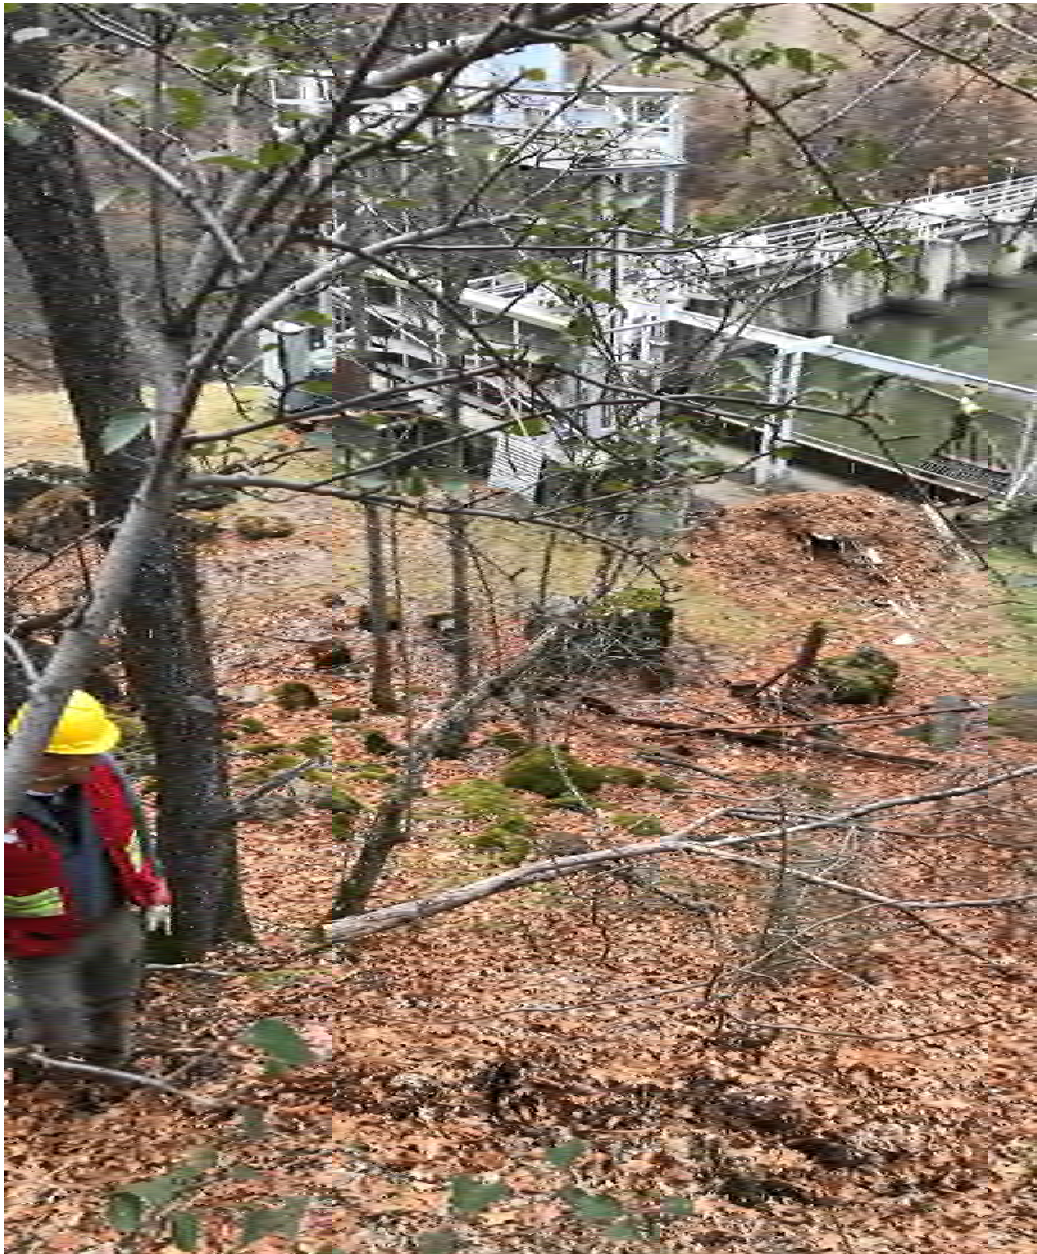
Knight Piésold CONSULTING	P/A NO. VA103-640/1
	REF. NO. 2
FIGURE H7.3	
REV A

**Rock fall talus at toe of the Cliff South West
of the Copco No. 2 Dam**

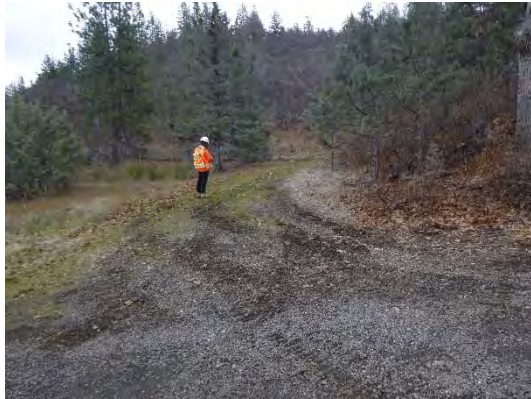
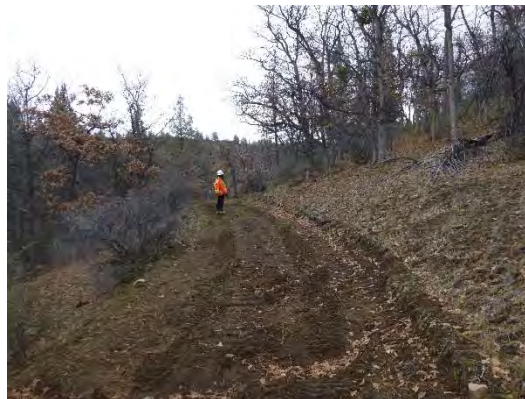
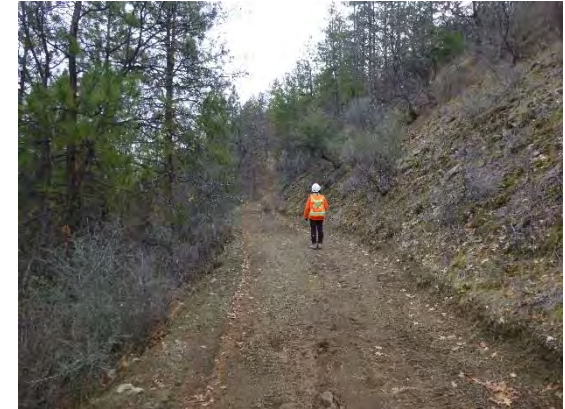
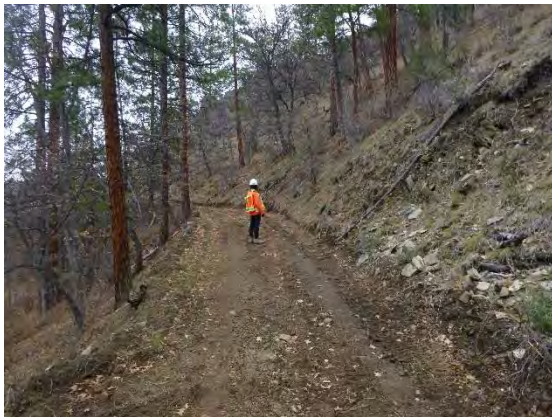
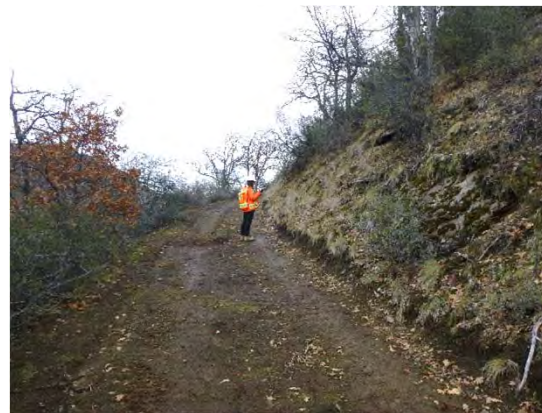
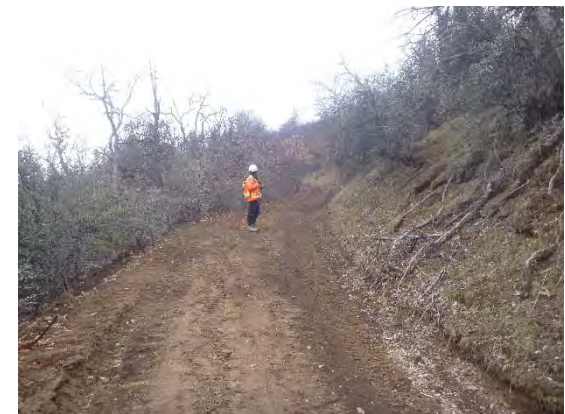
Knight Piésold CONSULTING	P/A NO. VA/103-640/1	REF. NO. 2
	FIGURE H8.1	
		REV A

**Views of Slopes Above the Proposed
Copco No. 2 Access Road
(Photos Taken on December 18, 2020)**

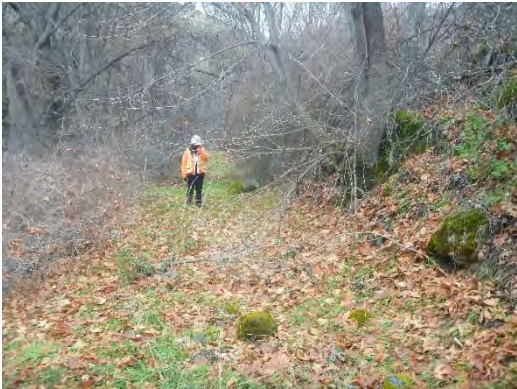
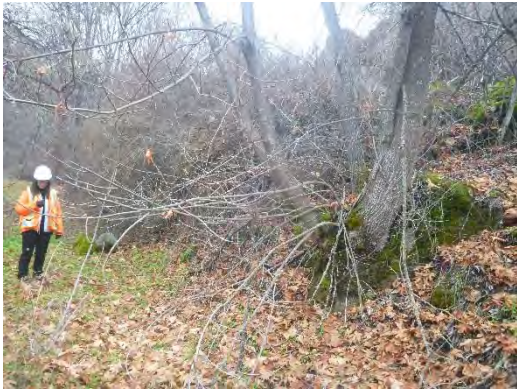
Sta. 36+00. Looking Up the Chainage

bedrock generally with curved columnar jointing. No obvious indicators of large-scale slope instability were observed. However, boulder sized talus has accumulated on the slope below the cliff as shown on Figure H8.4 and extends below the road alignment and therefore there is a potential of rock falls affecting this portion of the road. In addition, overhangs and some possible 'loose' rock fragments were observed on the slope that provide additional evidence of a rock fall hazard. The talus material on the slope might limit the run-out of some rock falls. Talus was not observed on the slope above the road between approximately STA. 38+00 to 39+00.

It is recommended that more detailed mapping of the rock mass and the rock slope hazards be undertaken to characterize the varying rock fall hazard for worker safety. Key data that needs to be collected includes the identification of the key source zones, and the determination of block sizes and impact energies for the design of any mitigation measures.
